CLADDING MOISTURE REPORT

Cladding Inspection Report

Subject Property : Sample Address, Houston, TX 77077

Evaluator: Joshua Donaho, Lic #23369 11/24/2021
(Name of Inspector) (Date)

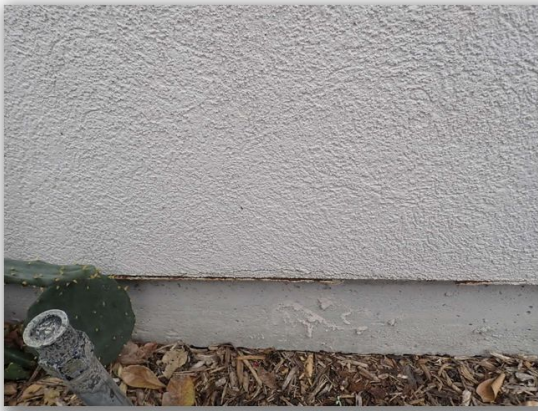
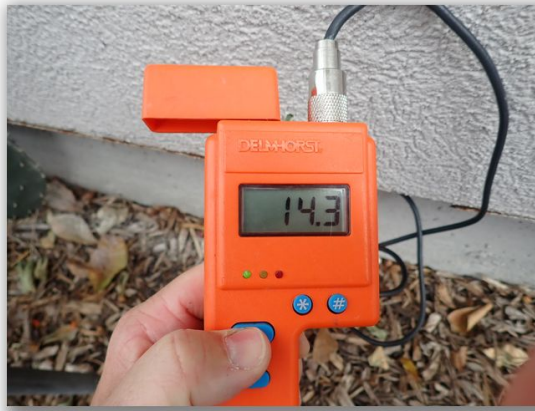
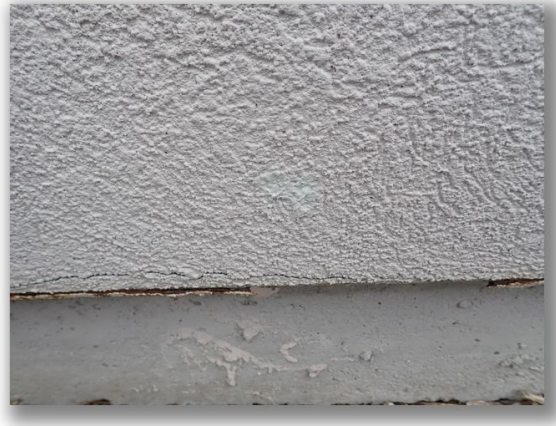
Drill Location F2

Substrate Condition: Compromised

Moisture Reading: 14.3%

- The substrate (sheathing) behind the stucco finishes appear to be compromised. This condition needs to be further evaluated and repaired as necessary. It is my professional opinion that the stucco in the affected areas will need to be removed, the substrate replaced and the stucco finishes replaced.

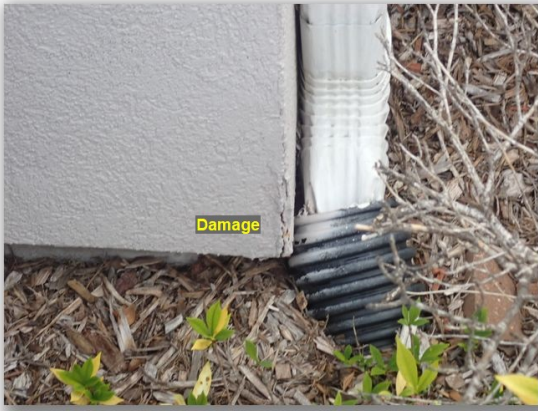
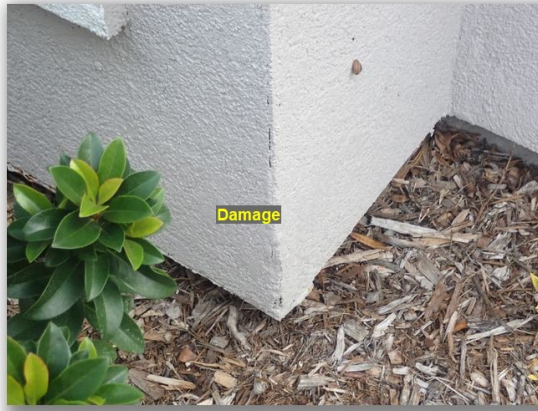
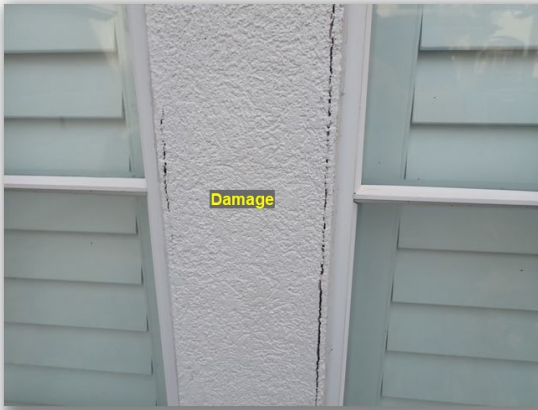
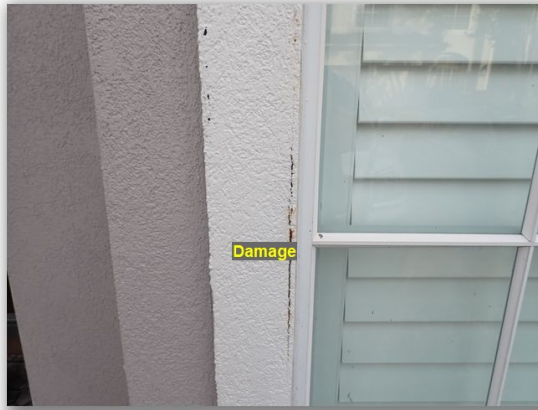
Item Number 1

- Some deterioration and/or damage to the stucco was observed. [Repairs are recommended.](#)
- Rust was observed on the stucco finish. This is an indication that water intrusion behind the stucco finish has occurred. [Repairs are recommended.](#)

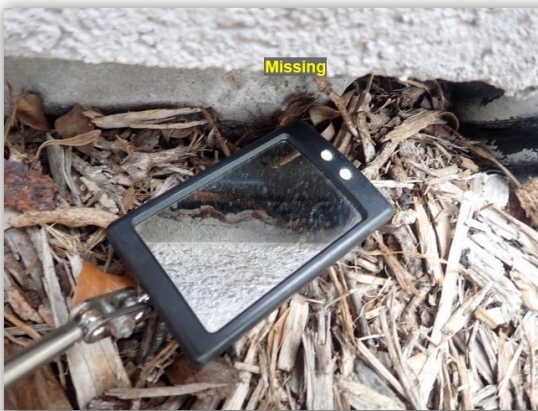
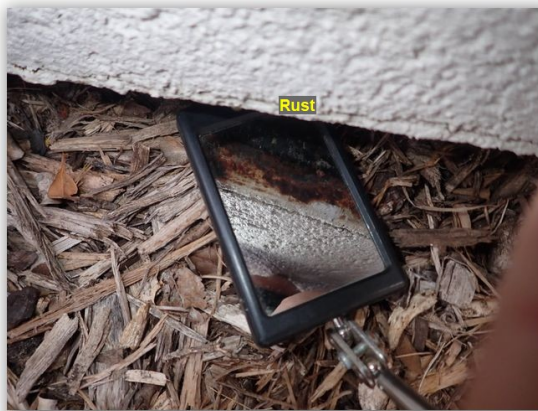
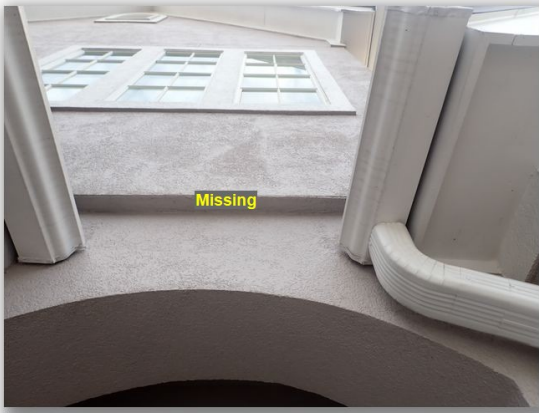
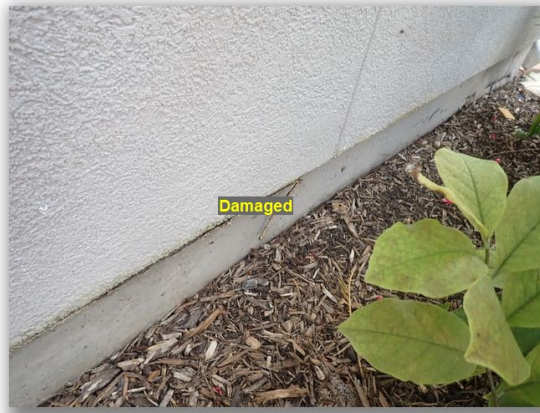
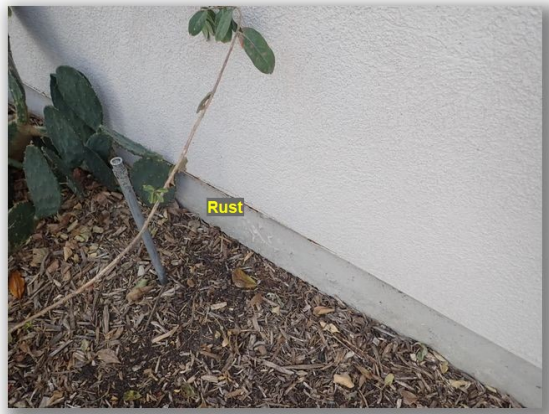
Item Number 2

- The weep screed was observed to be missing.
- The lower termination weep screed track was observed to be damaged. There are visible defects related to this condition at this time and repairs are recommended.

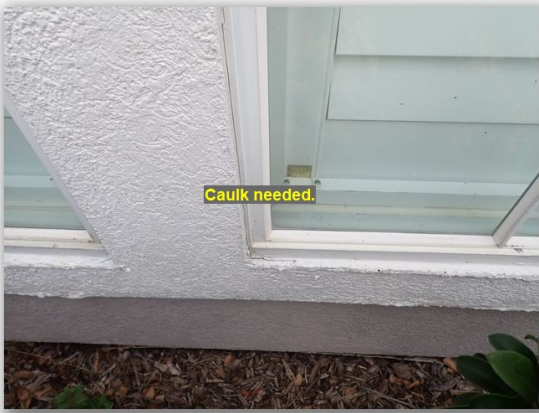
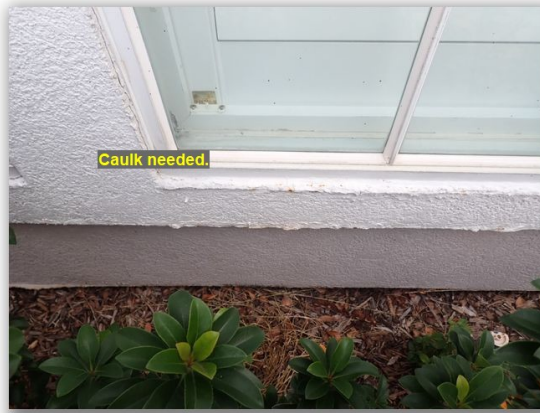
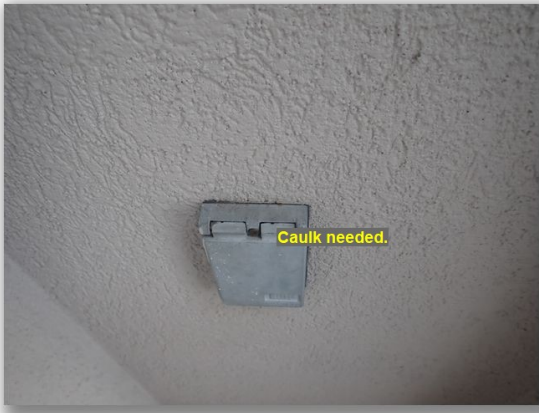
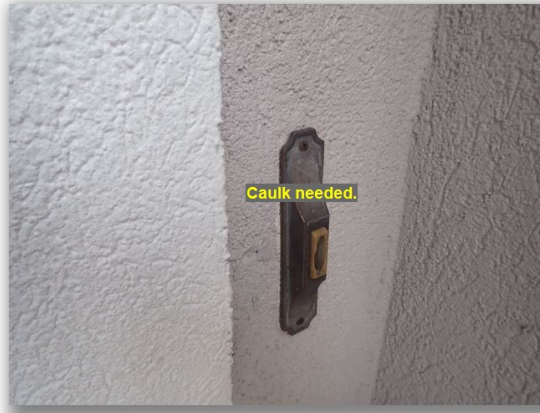
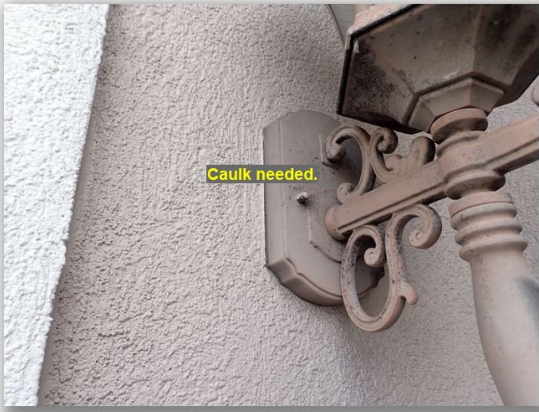
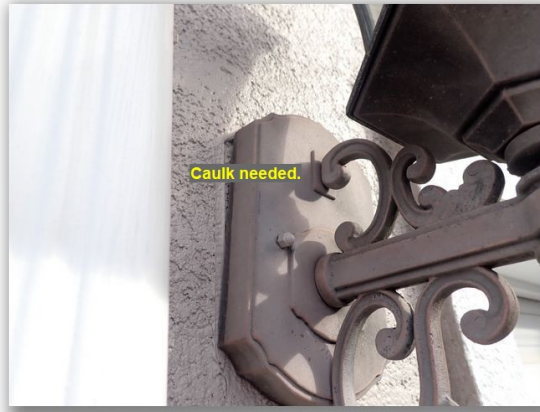
Item Number 3

- There is failing and/or missing sealant at and around the window openings. It is recommended to remove and replace all old and failing sealant around the windows to help prevent water intrusion at these locations. It is recommended to use an industry approved NP1 sealant.
- The area between the exterior cladding / veneer and all of the wall penetrations / openings need to be properly sealed. Areas such as utility connections, downspouts, hose bibbs, lighting fixtures, receptacles etc. It is recommended to use an NP1 sealant.

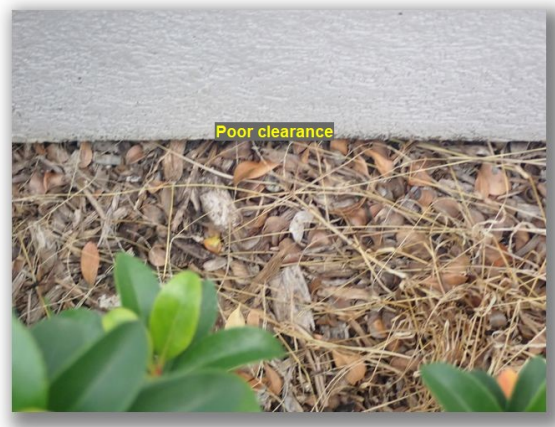
Item Number 4

- The stucco has poor clearance from the finished grade / earth. Under current installation standards, there should be at least 4 to 6-inches of clearance between the finished grade / earth and the stucco material. These condition can cause moisture damage to the stucco finishes and hold moisture within the wall cavities. It is recommended to lower the soil line below the stucco finishes.

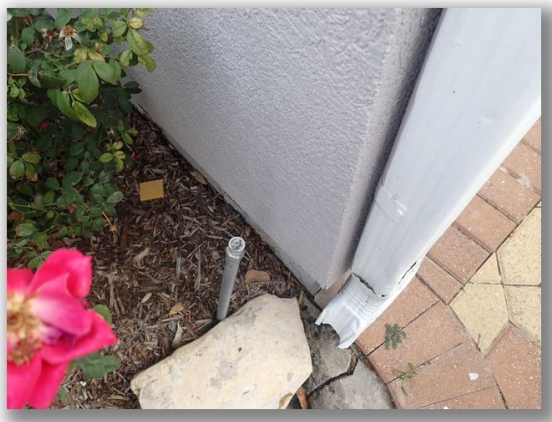
Item Number 5

- All sprinkler heads within 12-inches of the exterior walls should be relocated a minimum of 12-inches away from the walls and directed so that water does not spray directly onto the walls.

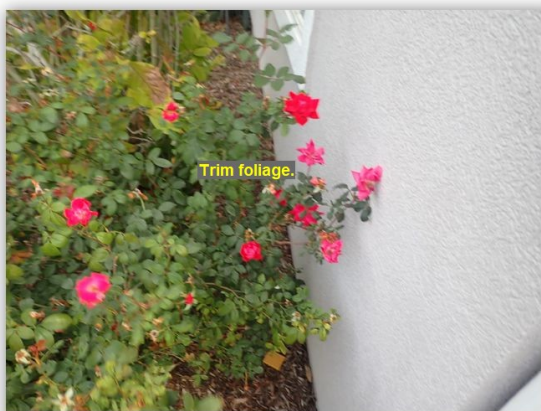
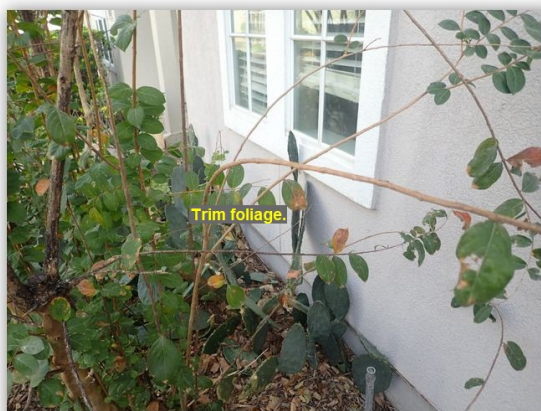
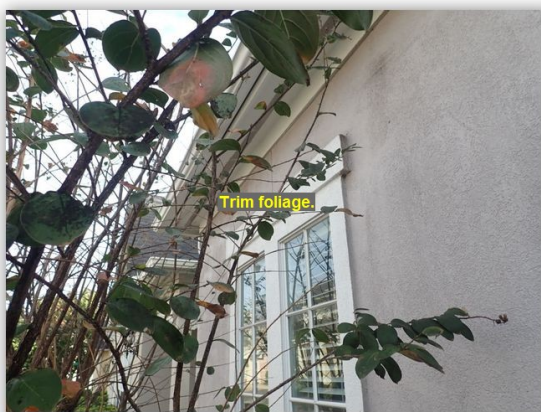
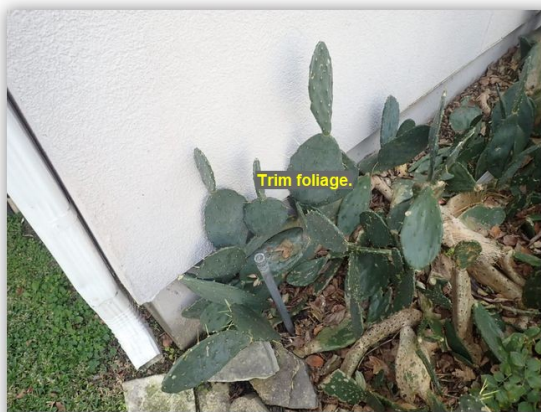
Item Number 6

- There is foliage in contact with the exterior stucco finishes. It is recommended to trim the foliage at least 18-inches off the exterior walls.

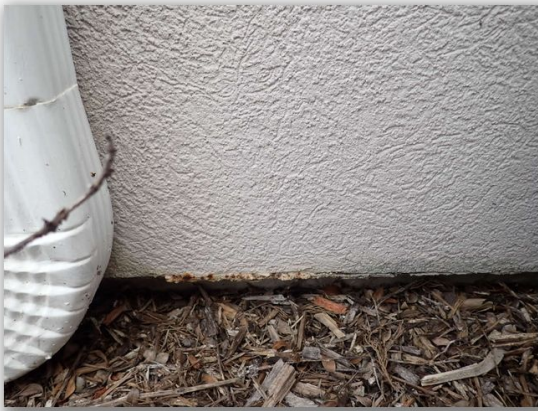
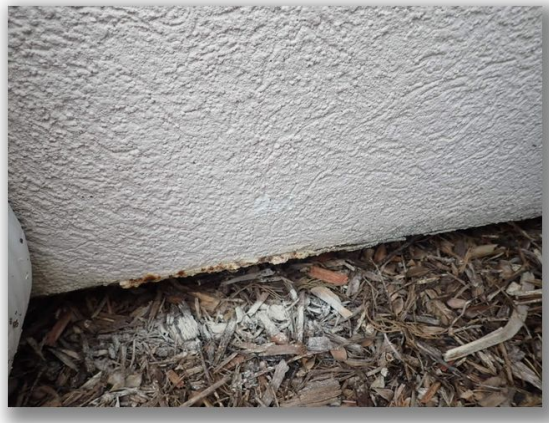
Substrate Condition: Firm

Moisture Reading: 19.8%

- Elevated moisture readings in the substrate were observed at this location. The cause should be further evaluated and corrections made to prevent further damage to the substrate.

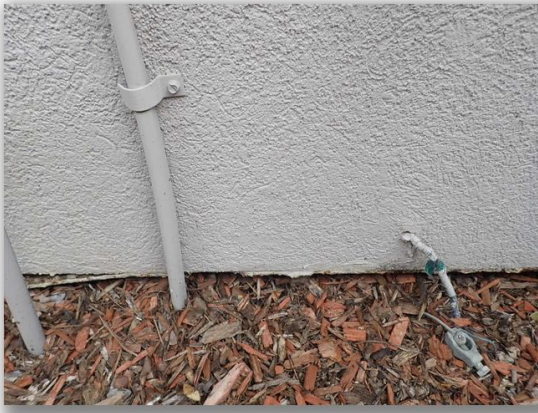
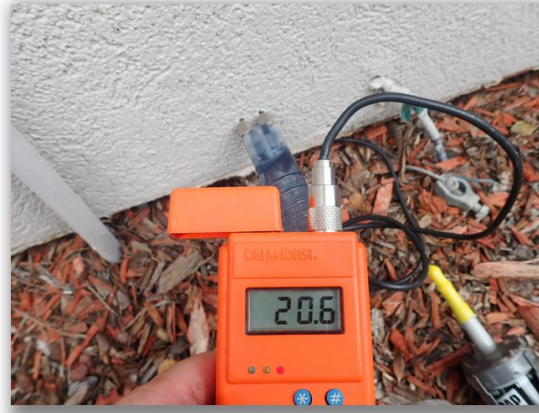
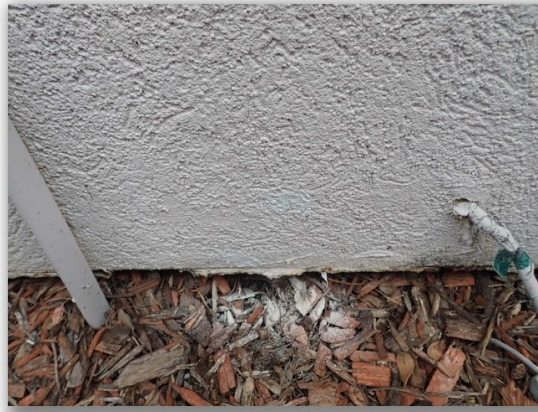
Drill Location E4

Substrate Condition: Compromised

Moisture Reading: 20.6

- Elevated moisture readings in the substrate were observed at this location. The cause should be further evaluated and corrections made to prevent further damage to the substrate.
- The substrate (sheathing) behind the stucco finishes appear to be compromised. This condition needs to be further evaluated and repaired as necessary. It is my professional opinion that the stucco in the affected areas will need to be removed, the substrate replaced and the stucco finishes replaced.

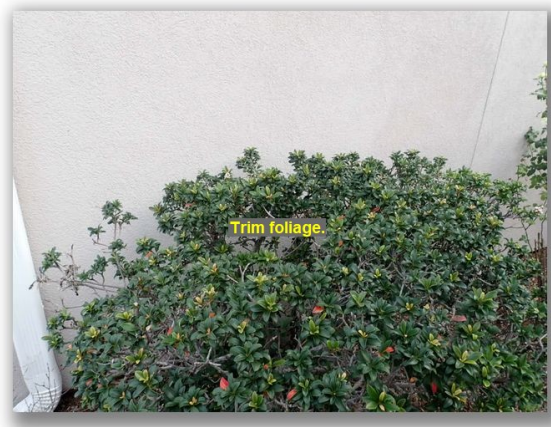
Item Number 1

- There is foliage in contact with the exterior stucco finishes. It is recommended to trim the foliage at least 18-inches off the exterior walls.

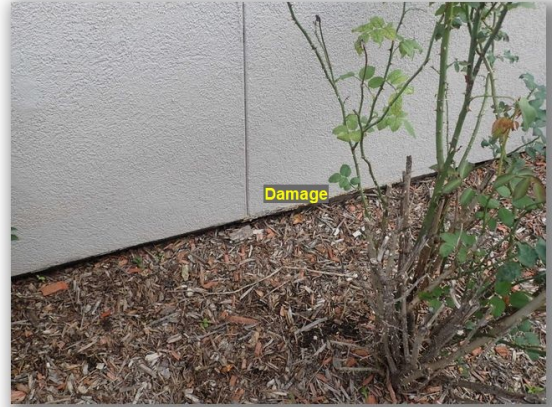
Item Number 2

- The weep screed was observed to be missing.
- The lower track / weep screed was observed to be rusted in one or more locations. There are visible defects related to this condition at this time and repairs are recommended.

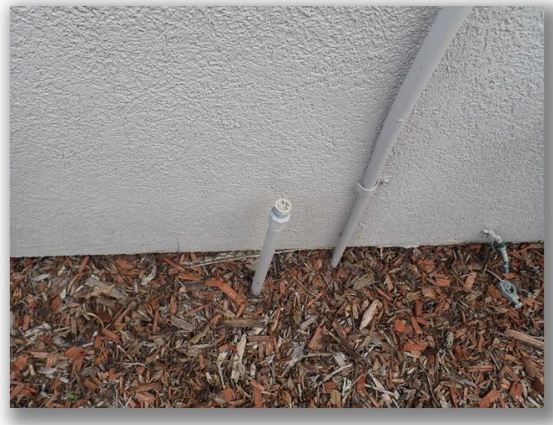
Item Number 3

- All sprinkler heads within 12-inches of the exterior walls should be relocated a minimum of 12-inches away from the walls and directed so that water does not spray directly onto the walls.

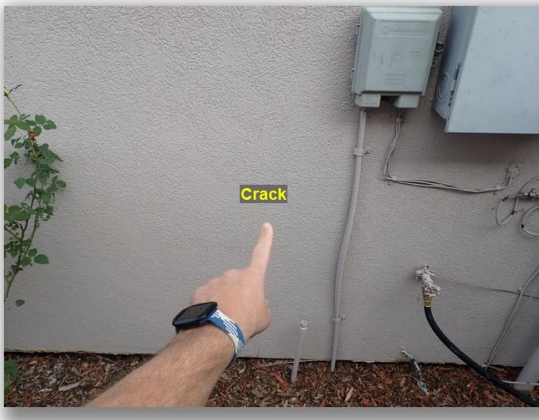
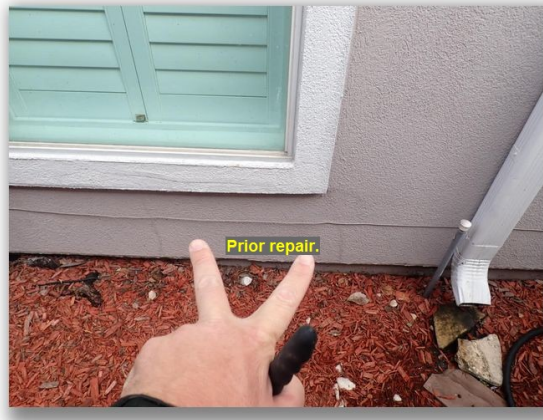
Item Number 4

- Some minor cracking of the stucco finish was observed in one or more locations at the time of this inspection. The cracks observed were less than 1/16-inch and are consistent to be within accepted industry standards and no remedial repairs are recommended.

Note: Prior repairs to the stucco were observed.

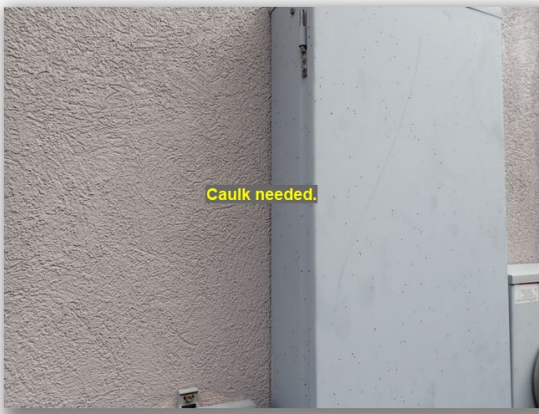
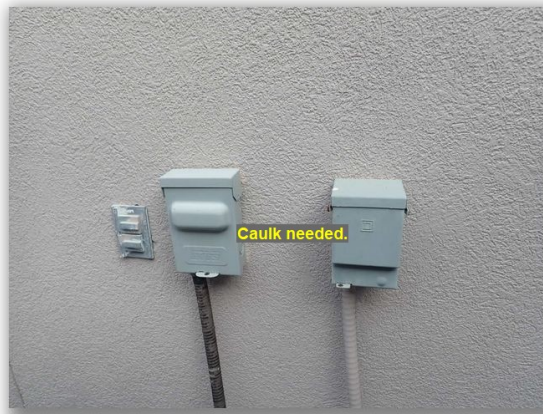
Item Number 5

- The area between the exterior cladding / veneer and all of the wall penetrations / openings need to be properly sealed. Areas such as utility connections, downspouts, hose bibbs, lighting fixtures, receptacles etc. It is recommended to use an NP1 sealant.

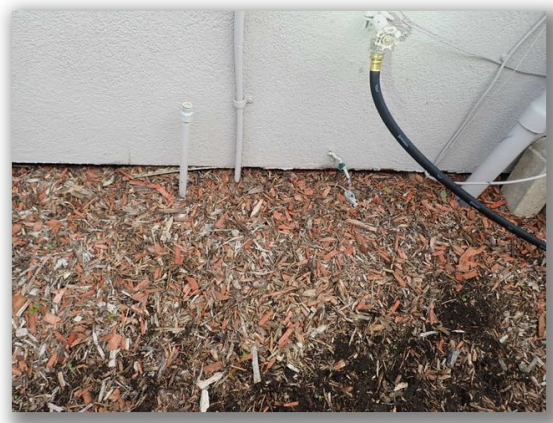
Item Number 6

- The stucco has poor clearance from the finished grade / earth. Under current installation standards, there should be at least 4 to 6-inches of clearance between the finished grade / earth and the stucco material. These condition can cause moisture damage to the stucco finishes and hold moisture within the wall cavities. It is recommended to lower the soil line below the stucco finishes.

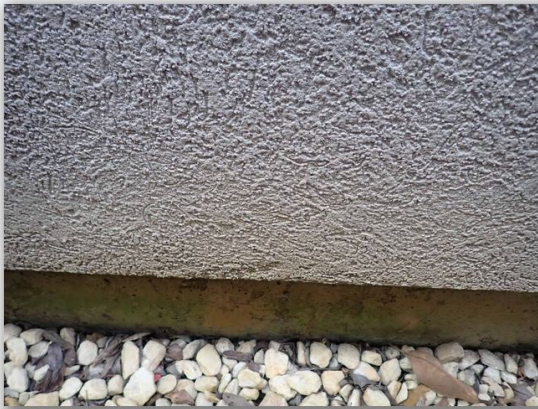
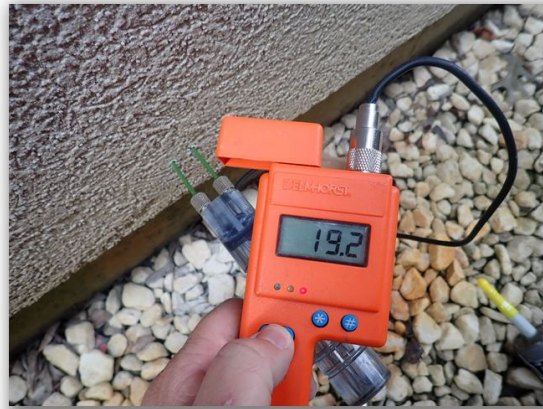
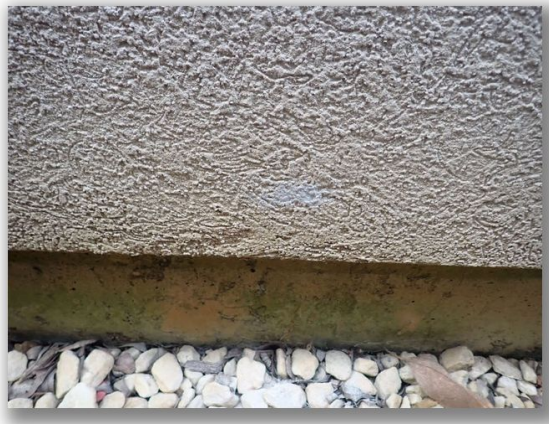
Substrate Condition: Compromised

Moisture Reading: 19.2%

- Elevated moisture readings in the substrate were observed at this location. The cause should be further evaluated and corrections made to prevent further damage to the substrate.
- The substrate (sheathing) behind the stucco finishes appear to be compromised. This condition needs to be further evaluated and repaired as necessary. It is my professional opinion that the stucco in the affected areas will need to be removed, the substrate replaced and the stucco finishes replaced.

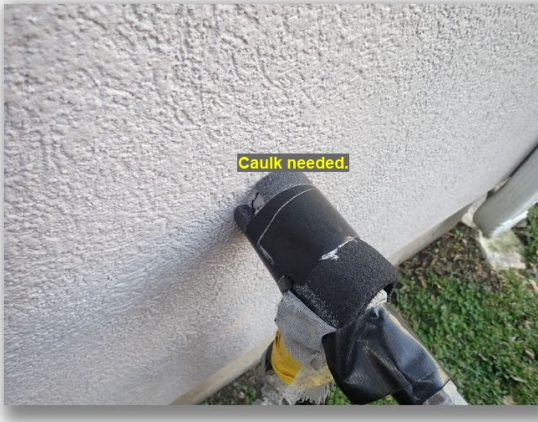
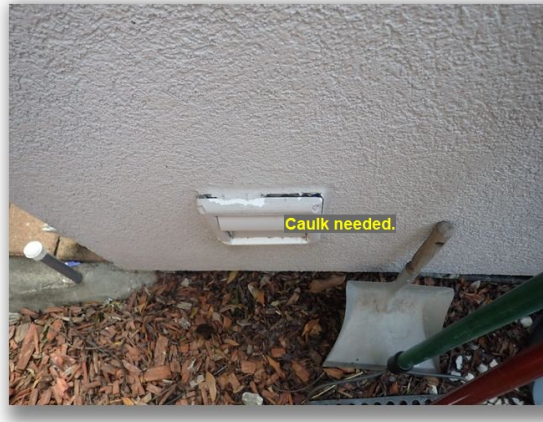
Item Number 1

- The area between the exterior cladding / veneer and all of the wall penetrations / openings need to be properly sealed. Areas such as utility connections, downspouts, hose bibbs, lighting fixtures, receptacles etc. It is recommended to use an NP1 sealant.

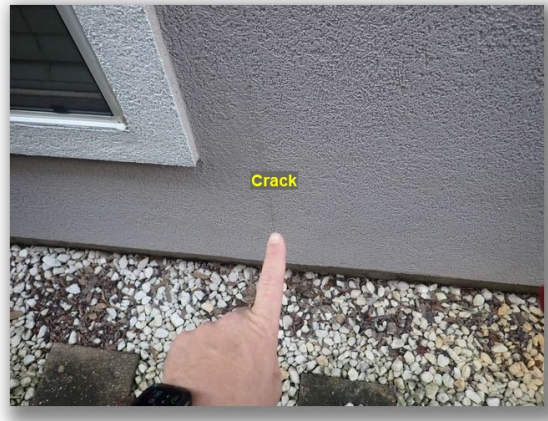
Item Number 2

- Some minor cracking of the stucco finish was observed in one or more locations at the time of this inspection. The cracks observed were less than 1/16-inch and are consistent to be within accepted industry standards and no remedial repairs are recommended.

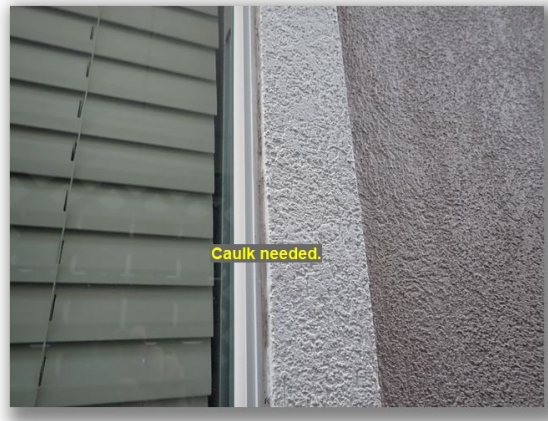
Item Number 3

- There is failing and/or missing sealant at and around the window openings. It is recommended to remove and replace all old and failing sealant around the windows to help prevent water intrusion at these locations. It is recommended to use an industry approved NP1 sealant.

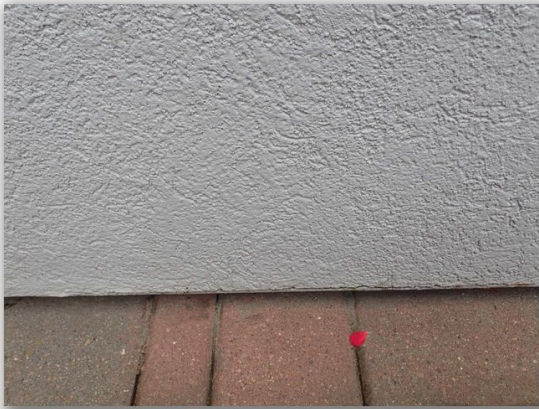
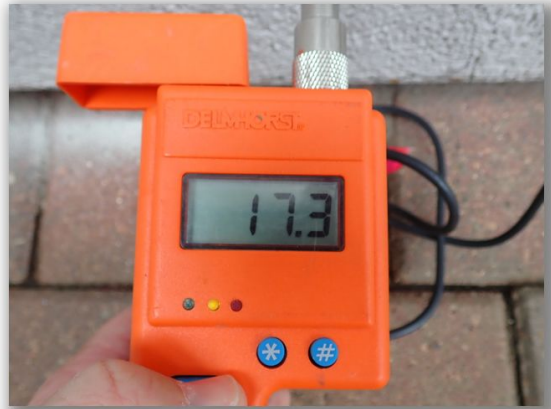
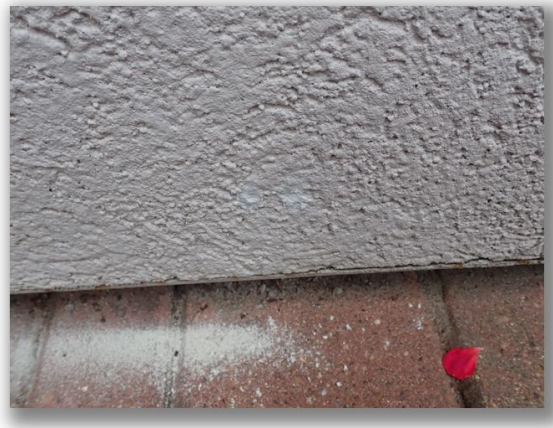
Substrate Condition: Compromised

Moisture Reading: 17.3%

- Elevated moisture readings in the substrate were observed at this location. The cause should be further evaluated and corrections made to prevent further damage to the substrate.
- The substrate (sheathing) behind the stucco finishes appear to be compromised. This condition needs to be further evaluated and repaired as necessary. It is my professional opinion that the stucco in the affected areas will need to be removed, the substrate replaced and the stucco finishes replaced.

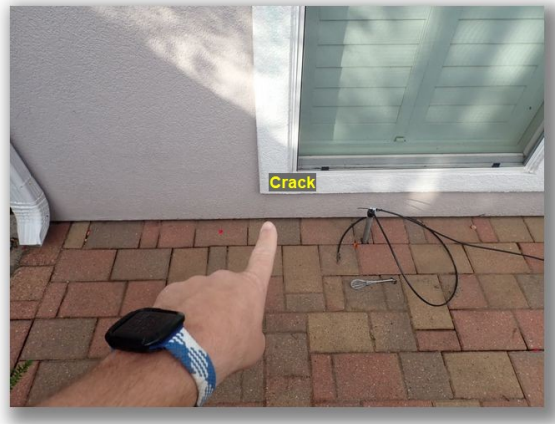
Item Number 2

- Some minor cracking of the stucco finish was observed in one or more locations at the time of this inspection. The cracks observed were less than 1/16-inch and are consistent to be within accepted industry standards and no remedial repairs are recommended.

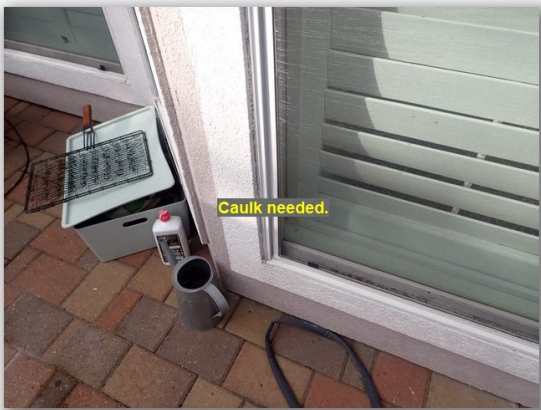
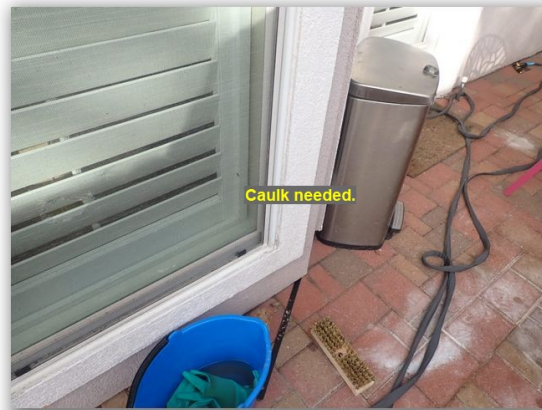
Item Number 3

- There is failing and/or missing sealant at and around the window openings. It is recommended to remove and replace all old and failing sealant around the windows to help prevent water intrusion at these locations. It is recommended to use an industry approved NP1 sealant.

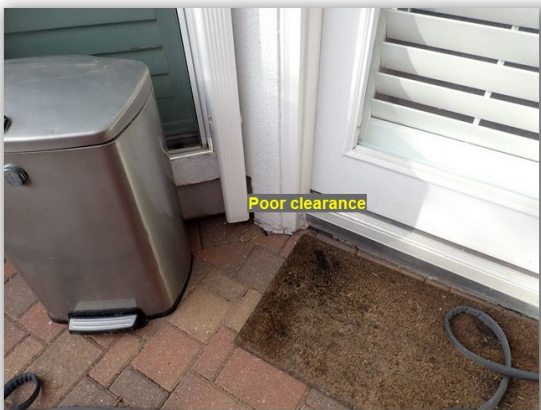
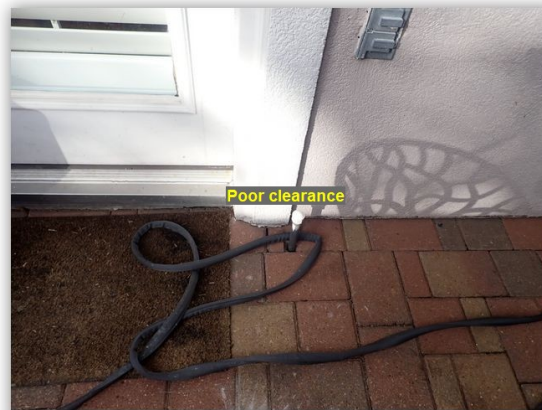
Item Number 4

- The stucco has poor clearance from the concrete flatwork. Under current installation standards, there should be at least 1.5 to 2-inches of clearance between the concrete flatwork and the stucco material. There are no visible defects related to this application at this time and no remedial repairs are recommended.

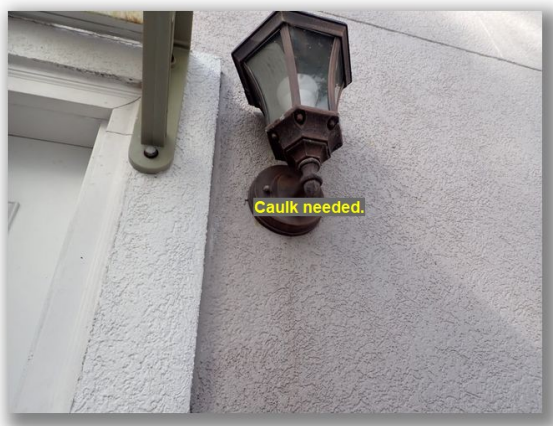
Item Number 5

- The area between the exterior cladding / veneer and all of the wall penetrations / openings need to be properly sealed. Areas such as utility connections, downspouts, hose bibbs, lighting fixtures, receptacles etc. It is recommended to use an NP1 sealant.

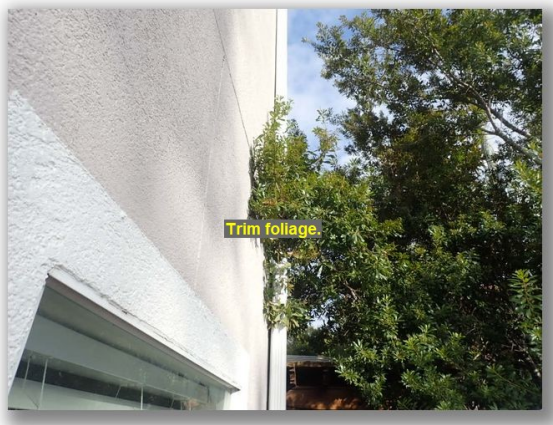
Item Number 6

- There is foliage in contact with the exterior stucco finishes. It is recommended to trim the foliage at least 18-inches off the exterior walls.

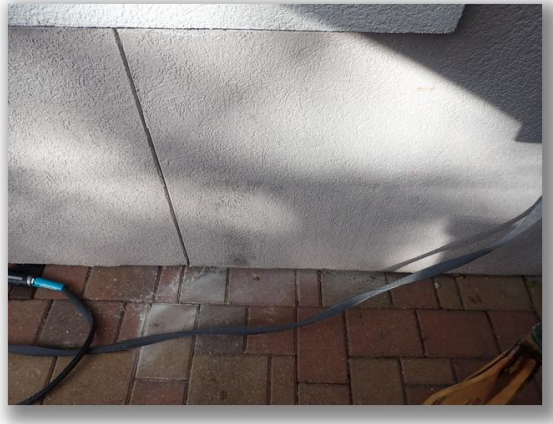
Item Number 7

- Some discoloration and/or staining of the stucco was observed.
