## **PHASE 1 PRE-POUR INSPECTION REPORT**

**Sample Report  
1234 Any Street  
Anytown, TX 12345**

**March 25, 2020**

**By:** Joshua Gibson, Lic #23054 03/25/2020  
(Name of Inspector) (Date)

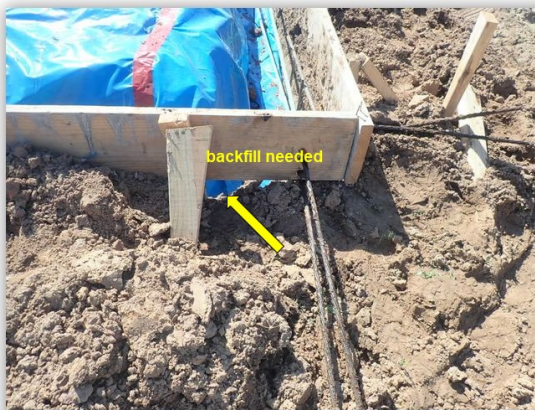
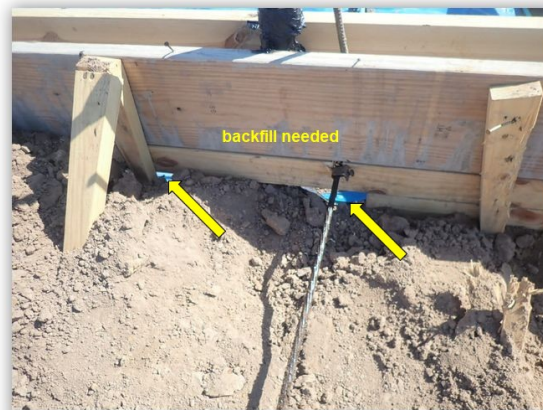
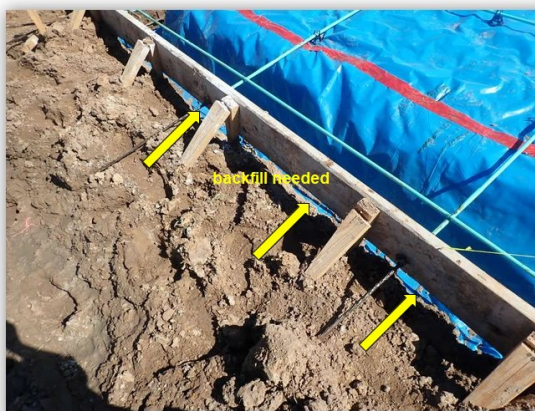
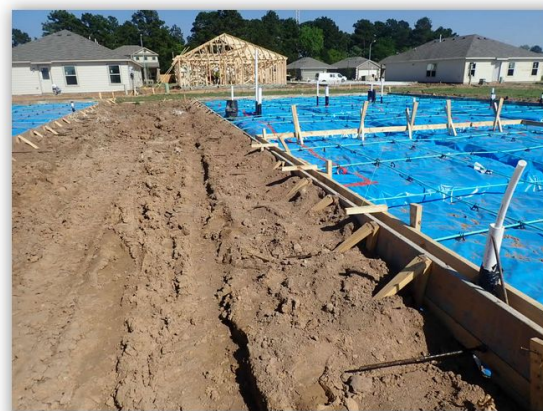
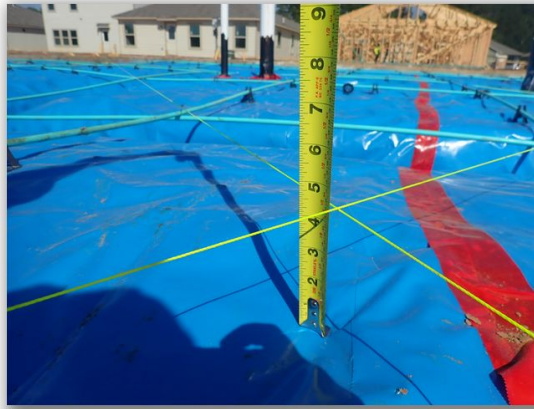
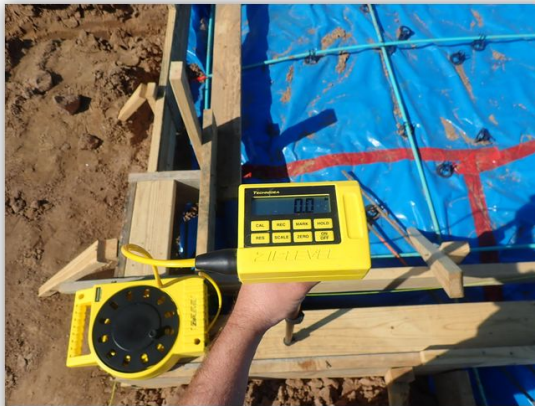
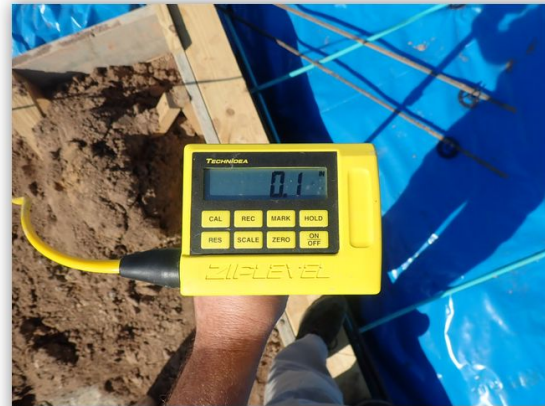
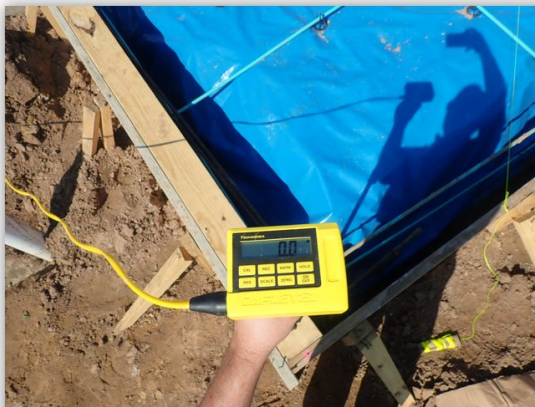
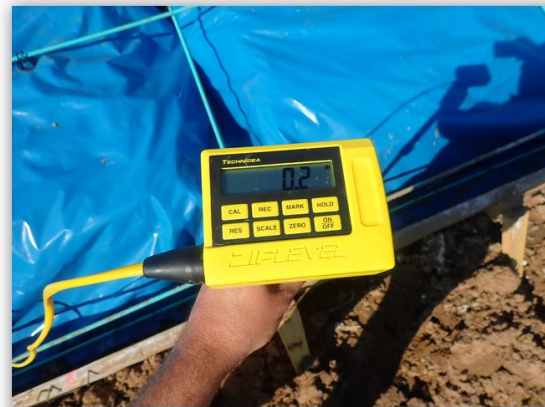
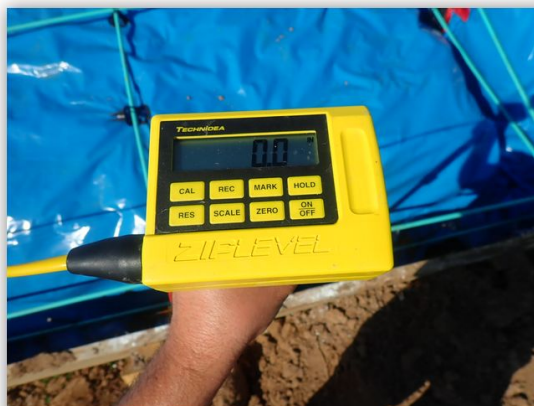
- The form boards are not properly backfilled to help prevent blowouts on the north side, east side, west side of the foundation.

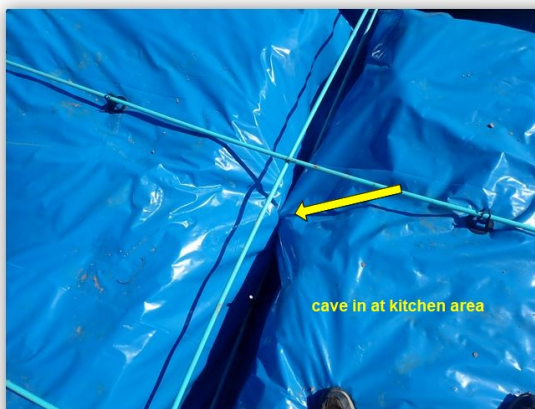
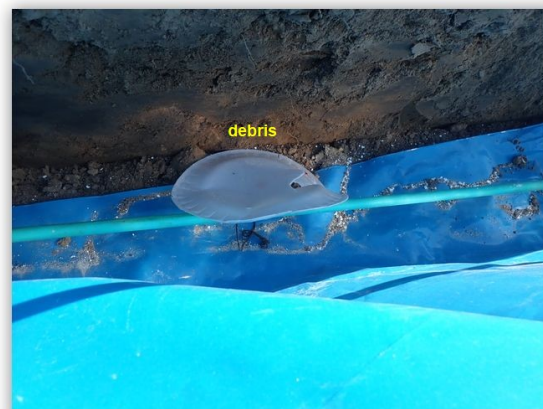
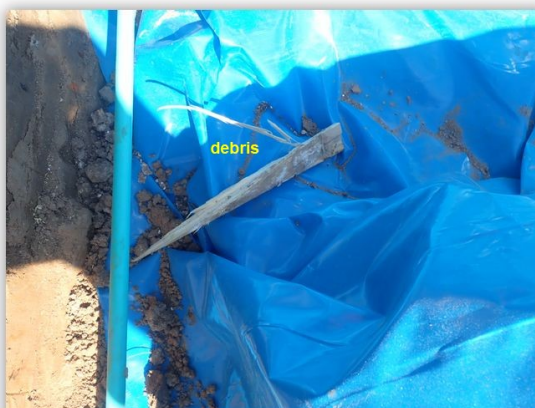
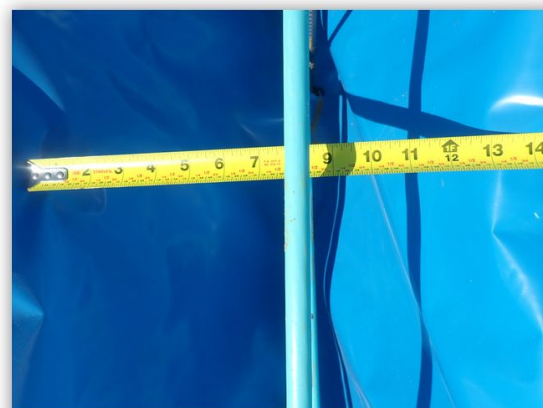
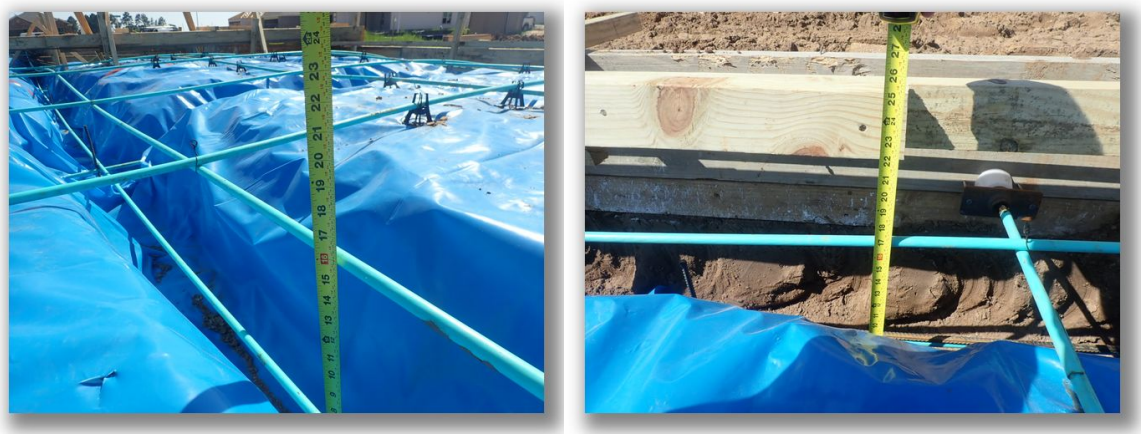
- There is a cave-in in the beam in the area of the kitchen. The cave-in needs to be cleaned out to maintain the proper beam depth and width.
- All debris in the foundation beam trenches need to be cleaned out before the concrete is poured.

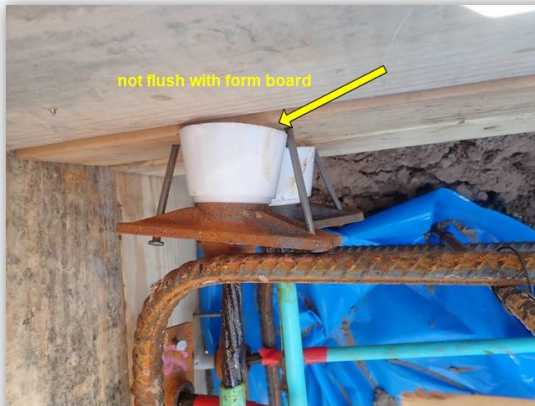
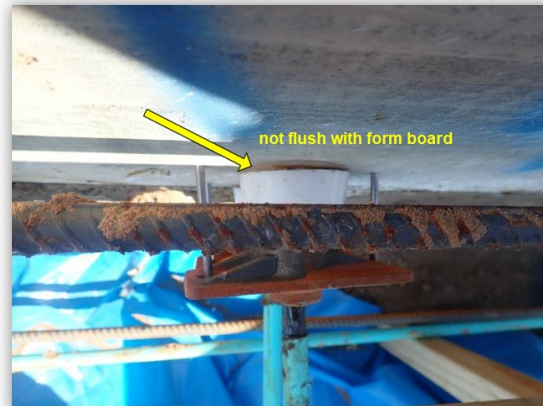
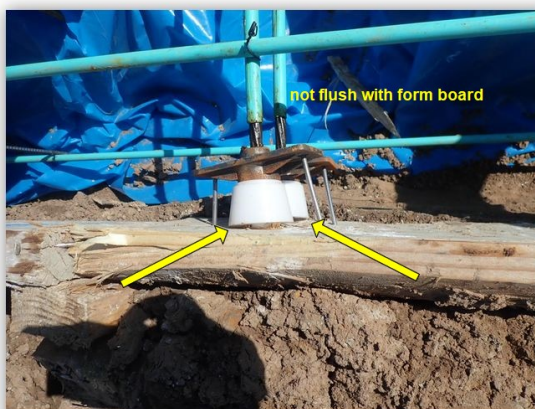
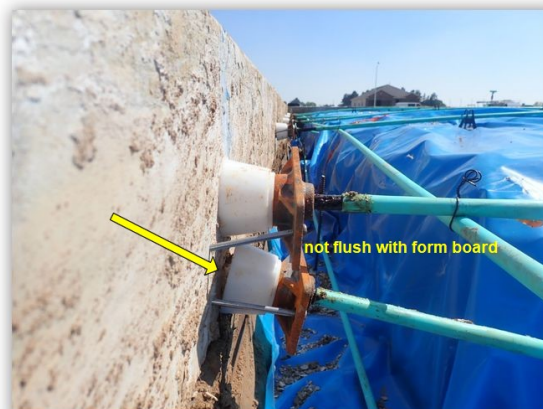
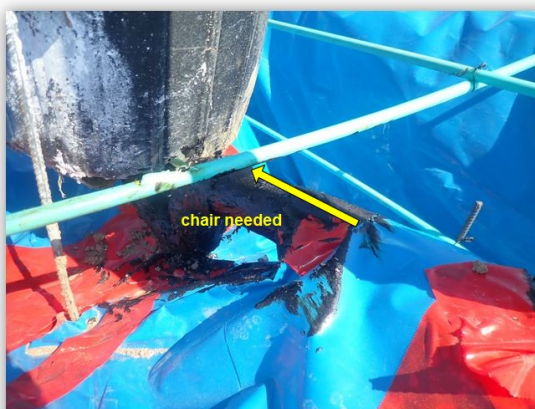
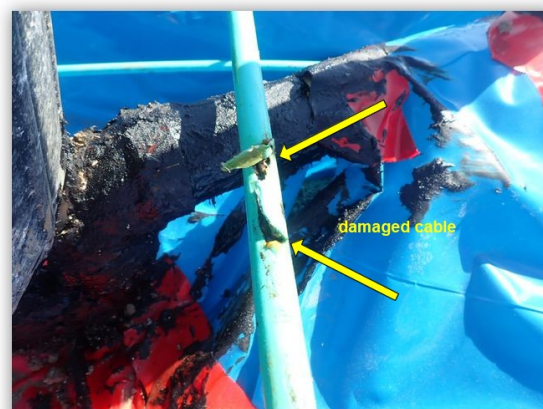
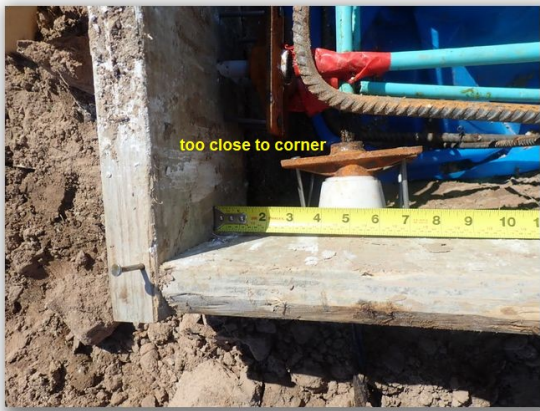
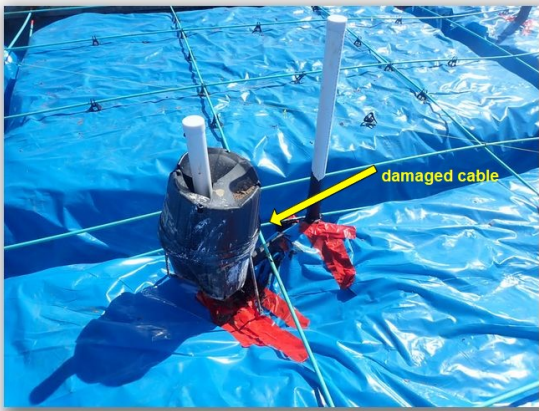
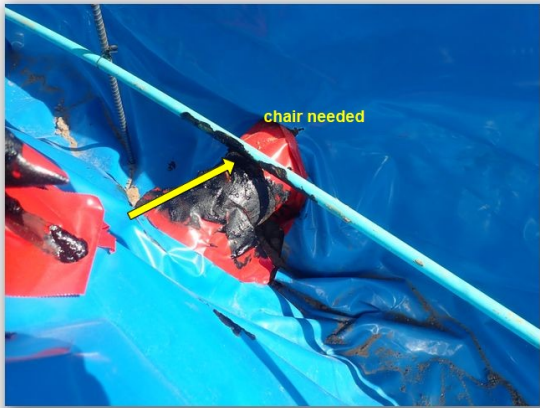
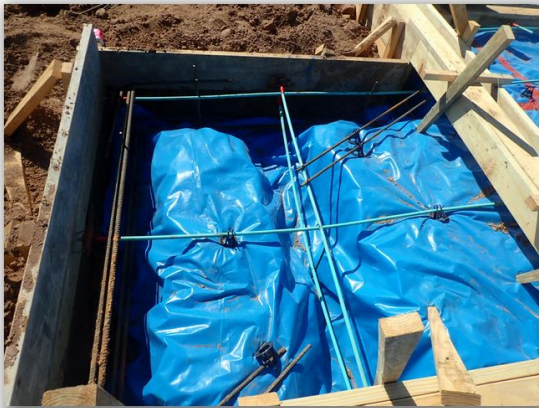
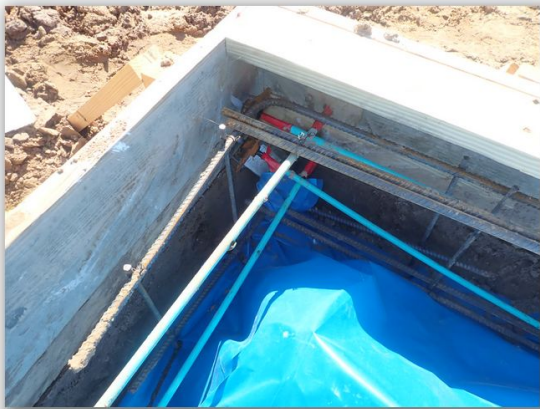
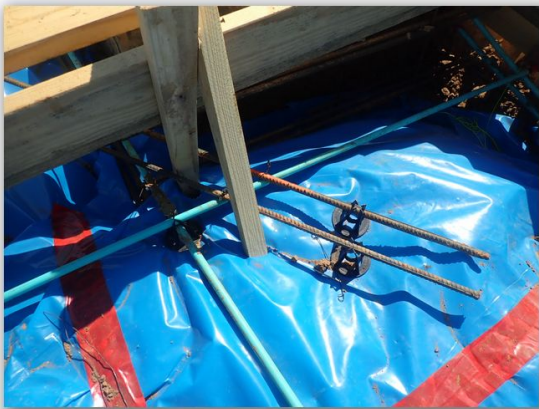
- The post tension tendon should have a minimum of 3-inches of clearance from waste pipes through the beams footings. A support chair can be placed between the pipe and the tendon tied in place to correct this condition.
- The post tension anchors are installed within 6-inches of the form corners on the east side of the foundation. The anchors should be moved a minimum of 6-inches away from the corners to help prevent blowouts from occurring when tension is applied to the tendons.
- The pocket former at the end of cable is not installed flush with the form on the north side, east side of the foundation.
- There is damaged sheathing on the post tension cables in the area of the master bathroom. This should be corrected to help prevent concrete from adhering to the metal post tension cable.

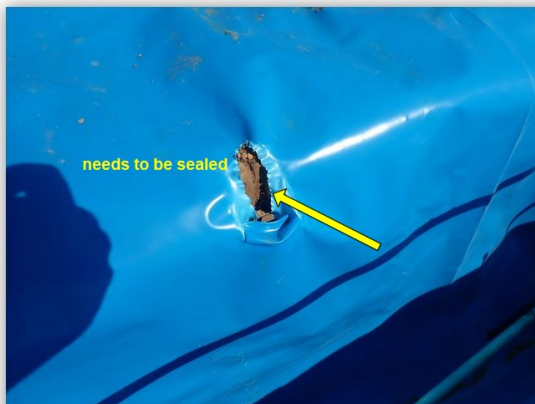
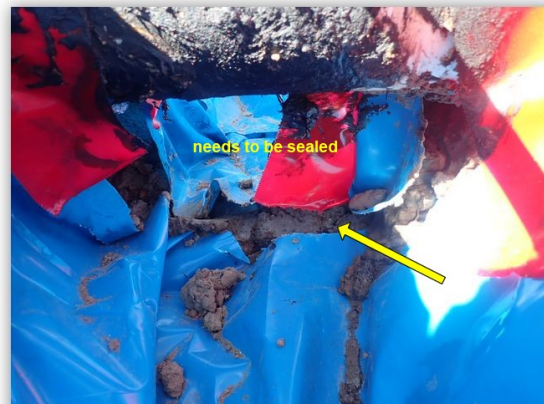
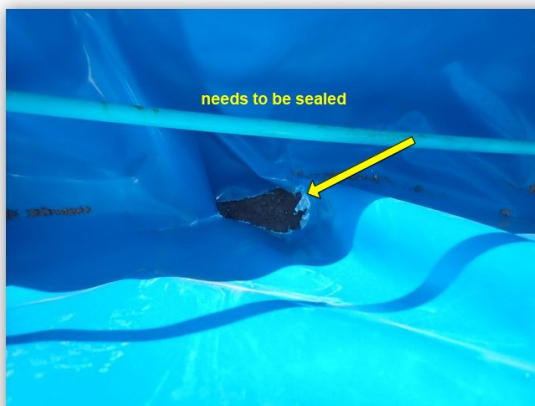
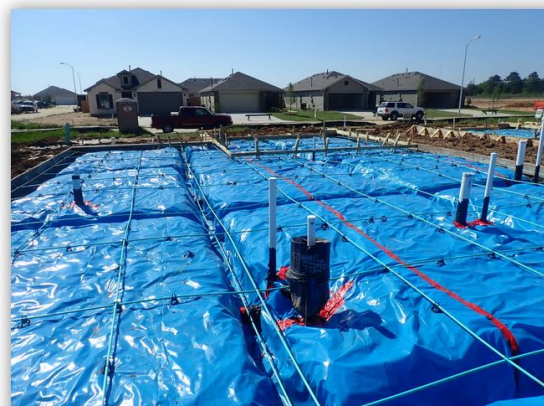
- All openings in the moisture/vapor barrier should be closed and/or taped.
- The moisture/vapor barrier is not properly overlapped in the master bathroom, hall bathroom, kitchen area. The moisture/vapor barrier should be overlapped a minimum of 6-inches to provide a continuous sheet under the entire foundation and any joints taped to ensure that there is no separation when concrete is placed.

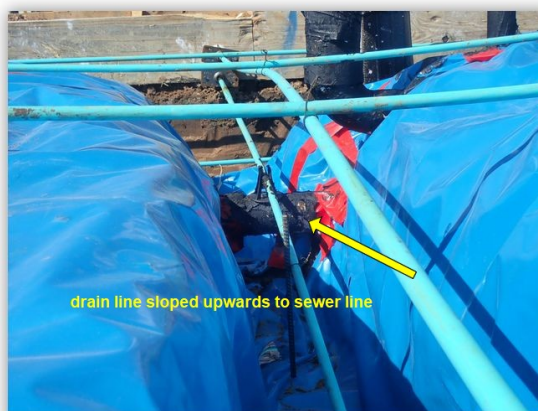
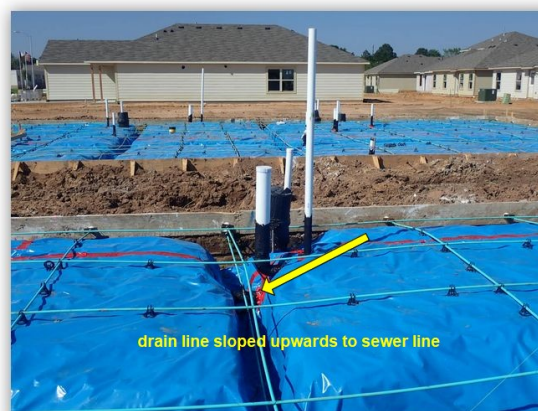
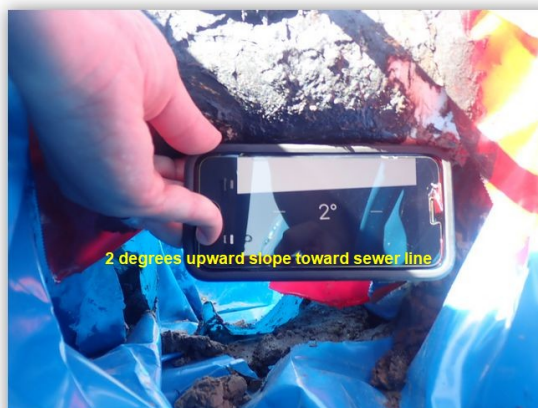
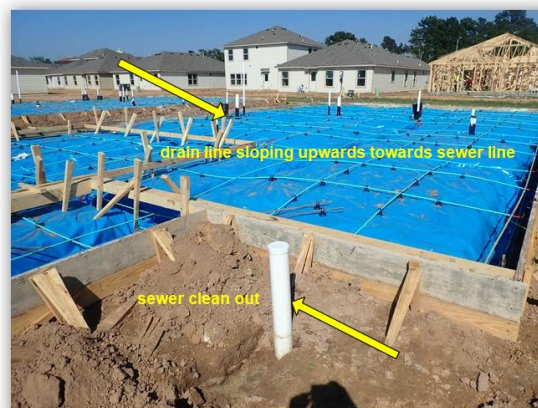
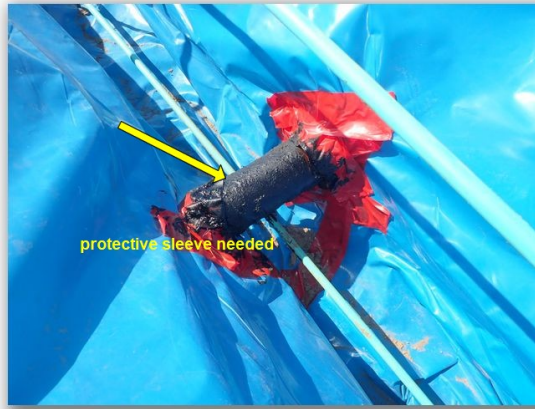
- The drain lines need to be properly protected in the beam / footing areas. The drain line is not properly insulated across the beam / footing. This condition should be corrected prior to the concrete being poured to help prevent future slab leaks from occurring.
- One or more drain lines are not properly sloped towards the sewer line. This condition should be corrected prior to concrete pour to prevent poor drainage/blockage.
