**Sample Report  
1234 Any Street  
Anytown, TX 12345**

**February 28, 2020**

## PROPERTY CONDITION REPORT

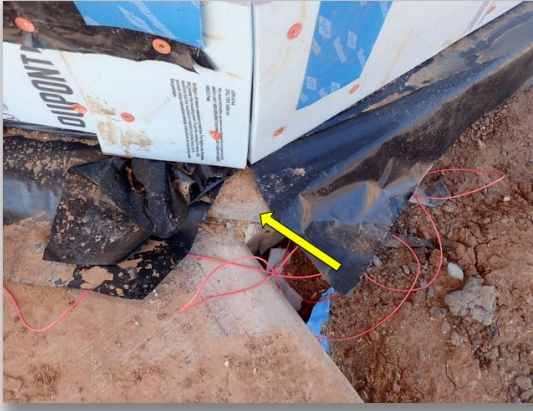
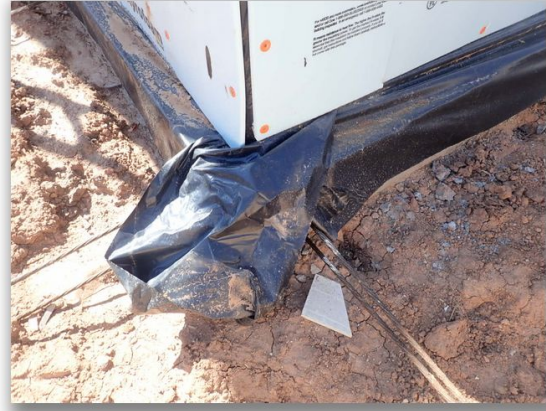
- The poly bond breaker / flashing detail for the foundation veneer ledge does not properly cover the veneer edge on the south side of the structure.

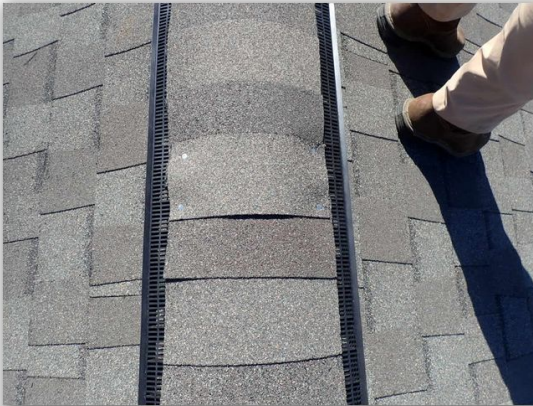
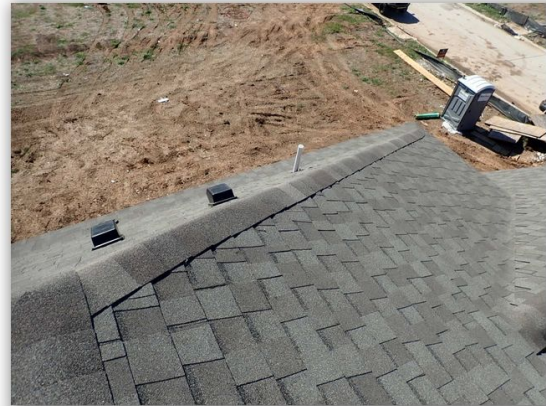
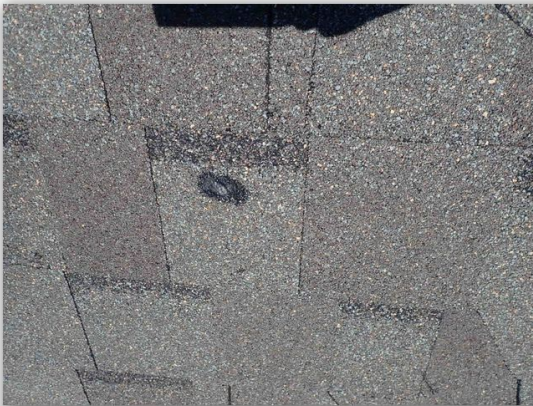
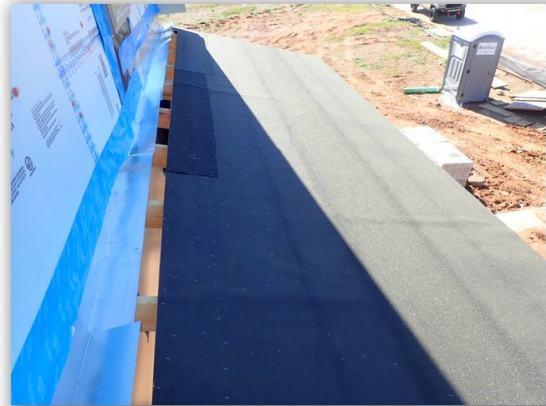
- Damaged shingles were observed on the north side of the roof structure.
- The roof install is not complete at the time of inspection.

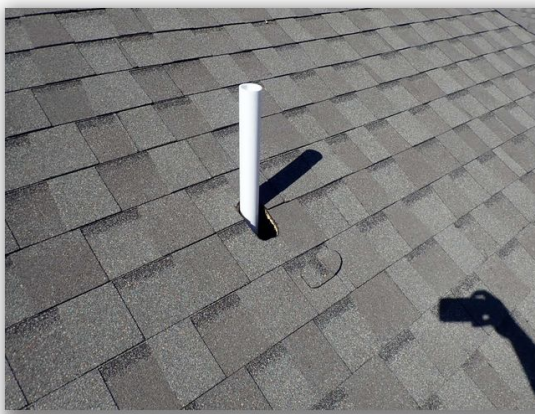
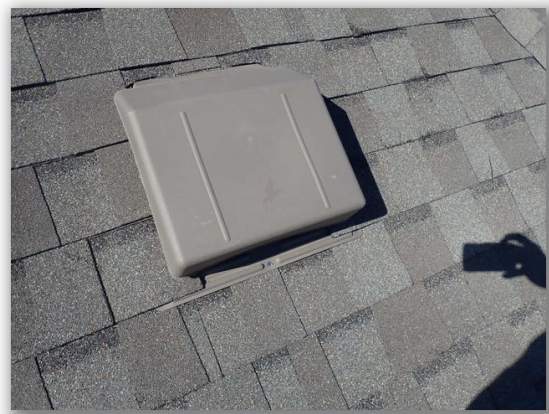
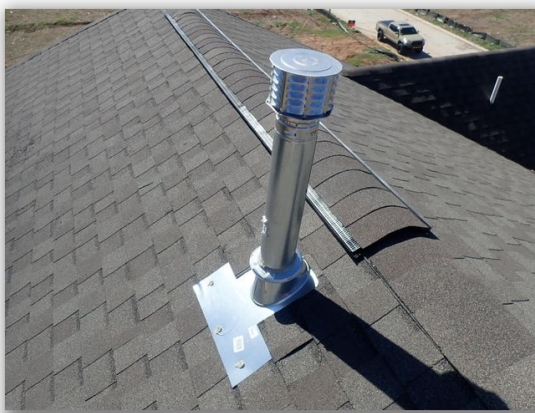
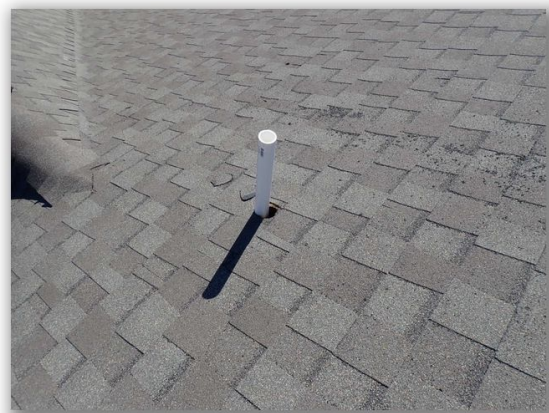
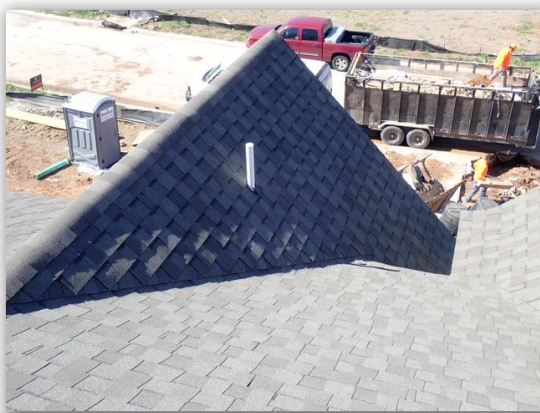
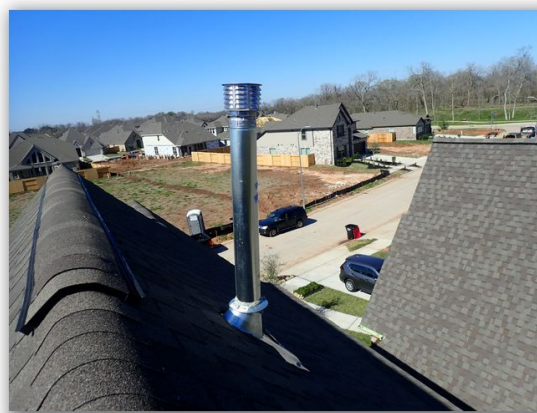
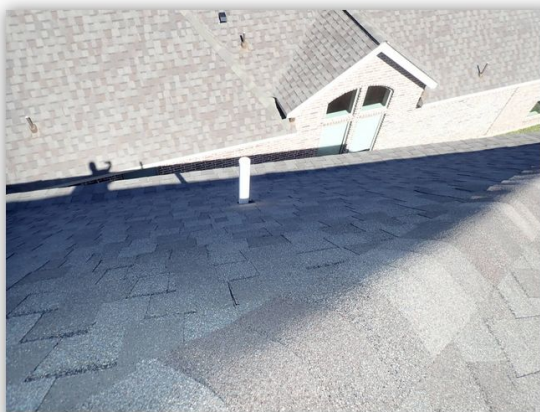
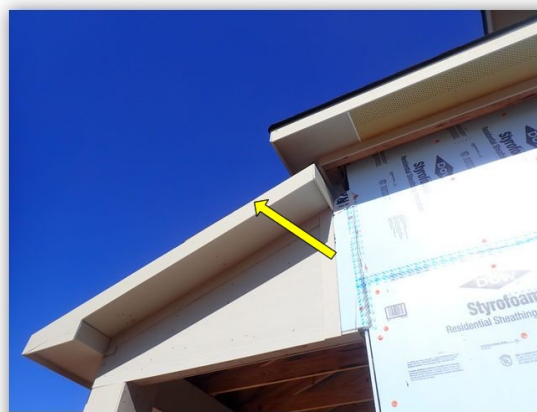
- The drain vent flashing details were observed to be missing on the north, east, west and south sides of the roof structure. This condition could allow water penetration at this point.
- Drip edge flashing details were observed to be missing on the north side, west side of the roof structure. This condition could allow water penetration at this point.

The flashing details needs to be checked, reset or repaired as necessary. The observations made to support the rendering of this opinion are listed but may not be limited to:

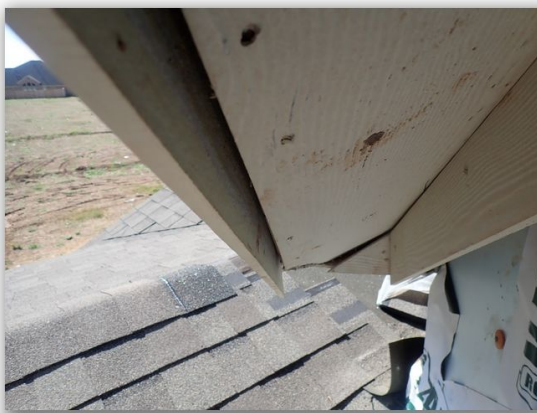
- The fascia board material has some deterioration and/or damage on the north side of the roof structure.
- The soffit material has some deterioration and/or damage on the north side of the roof structure.

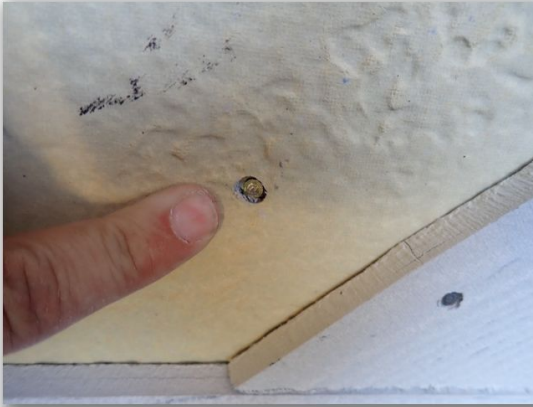
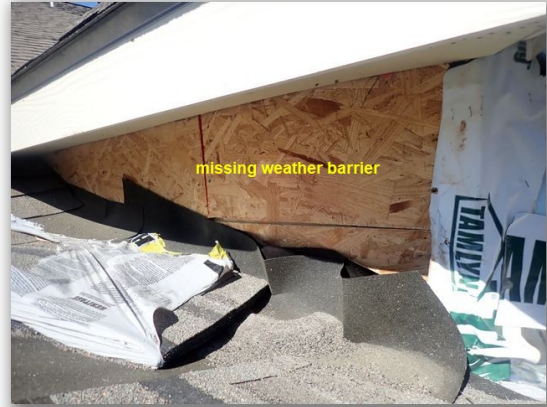
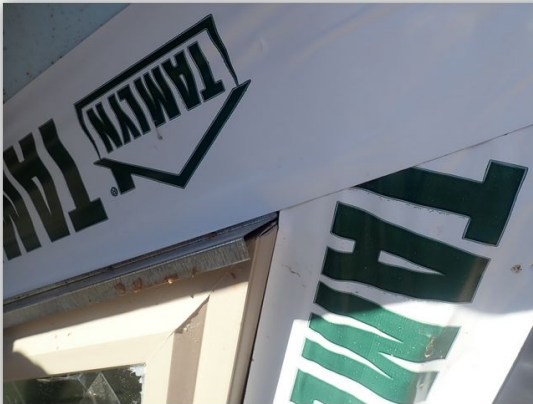
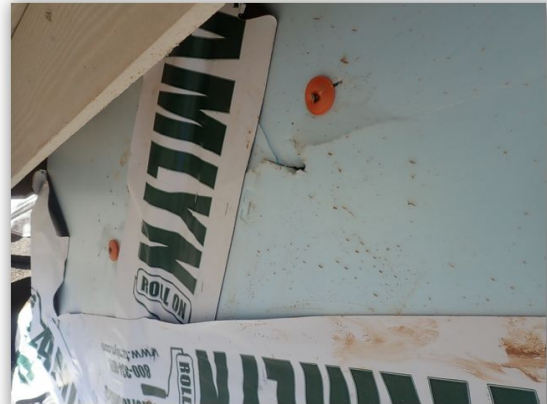
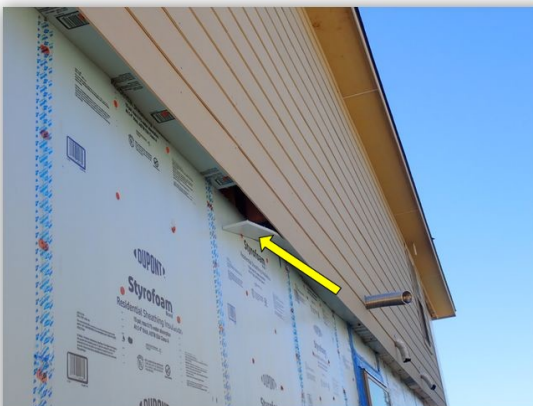
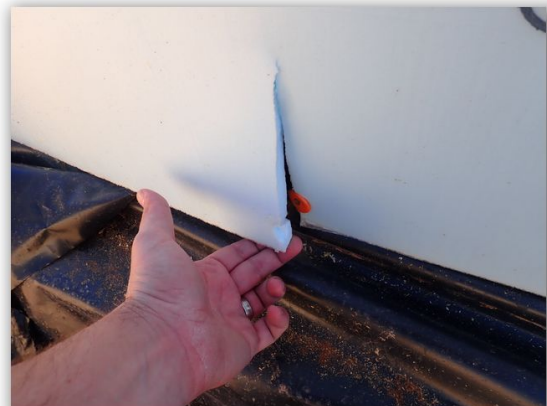
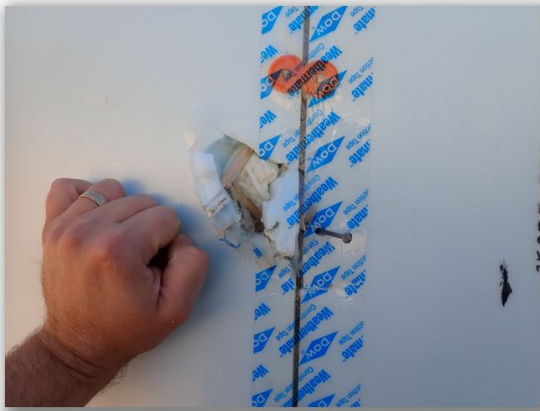
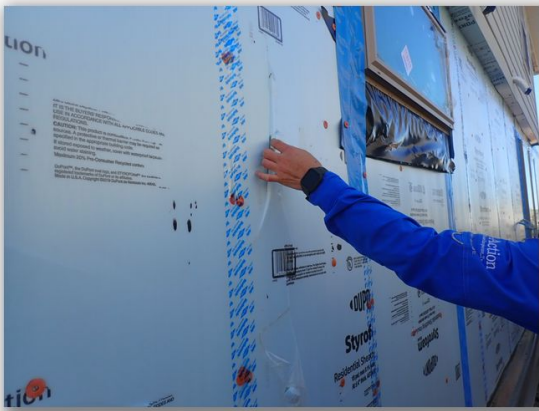
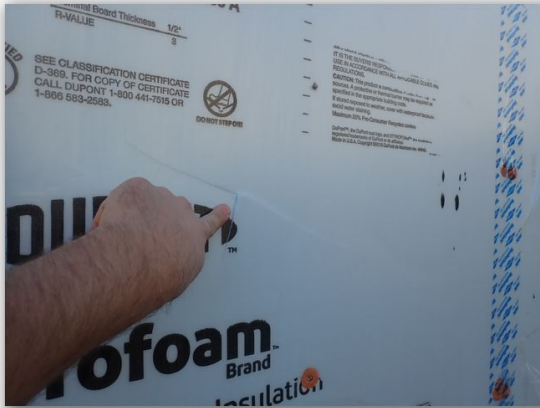
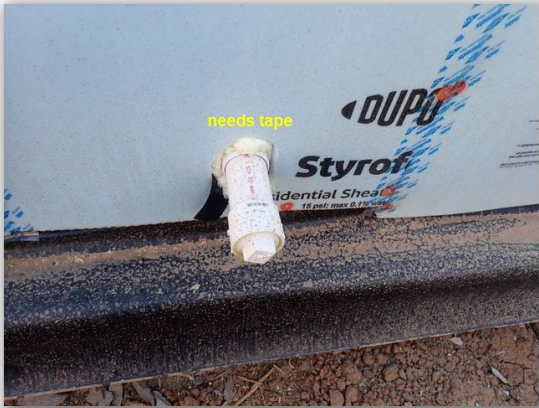
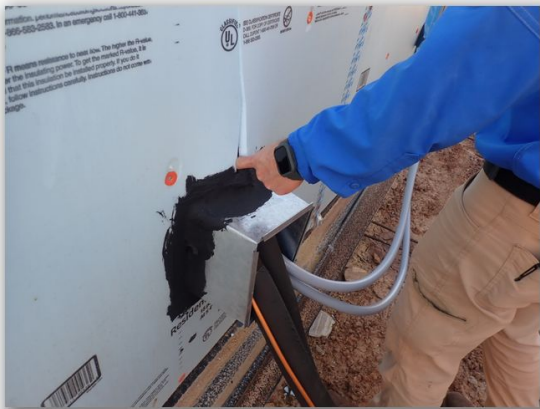
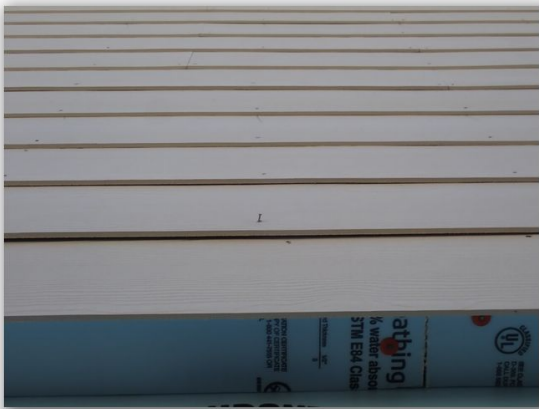
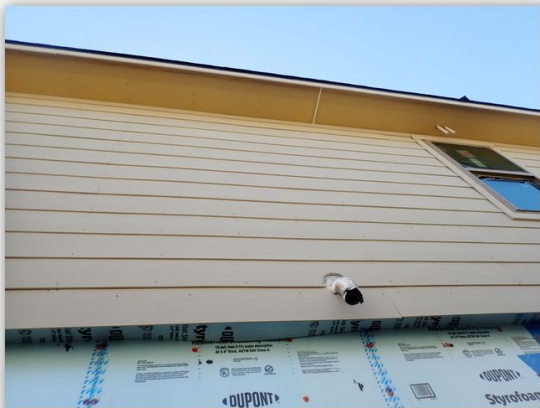
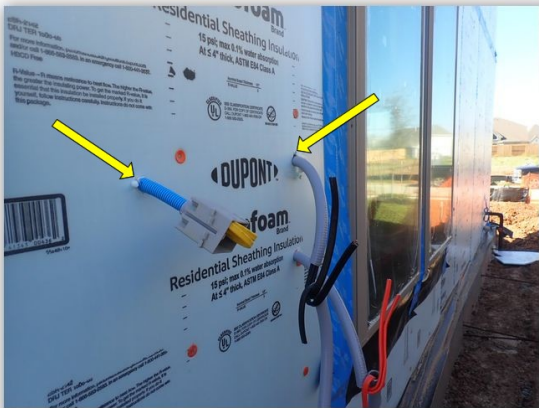
- The holes and/or openings (utility, doors, windows, etc.) in the exterior sheathing / weather barrier should be properly sealed (mastic or tape) on the north, east, west and south sides of the structure.
- The exterior wall moisture barrier is not properly installed at and around the windows on the north side of the structure.
- The fasteners (nails) in the fiber cement siding have been under-driven in various locations on the west side of the structure.
- The fasteners (nails) in the fiber cement siding have been over-driven in various locations on the east side,

west side of the structure. This has caused some damage to the cladding material.

- The tape flashing is poorly installed at and around the doors and/or windows on the south side of the structure.
- The weather barrier is damaged/pulling loose on the east, west sides of the exterior.
- The weather barrier is missing on the east, west sides of the exterior.

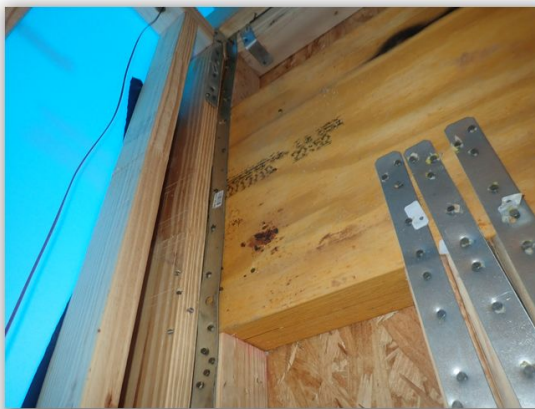
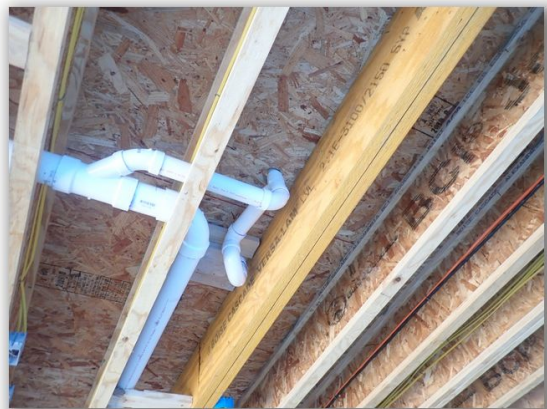
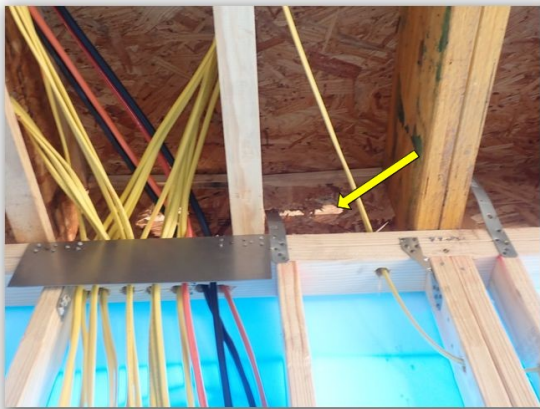
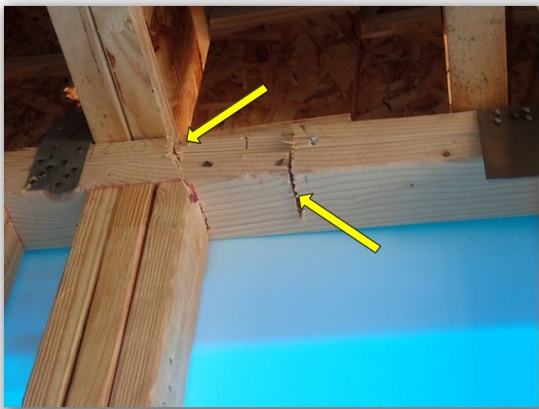
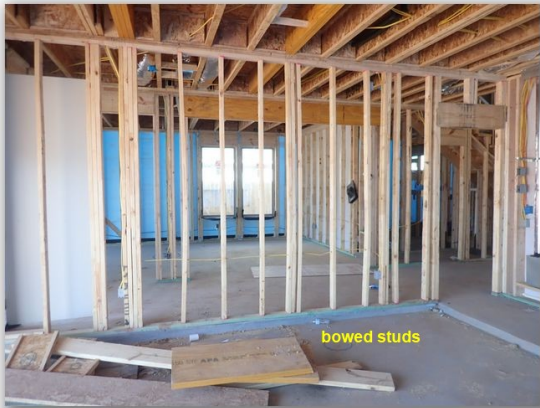
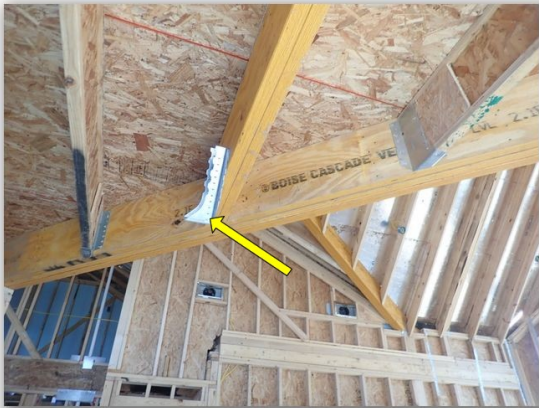
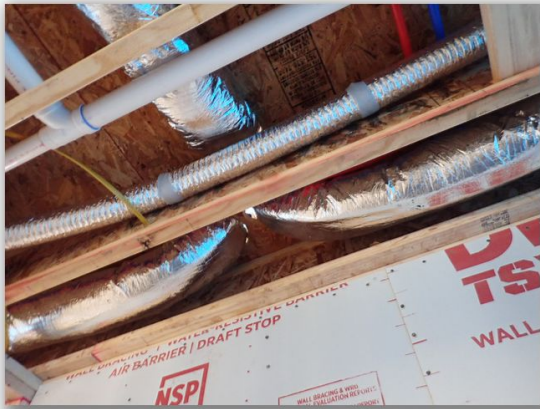
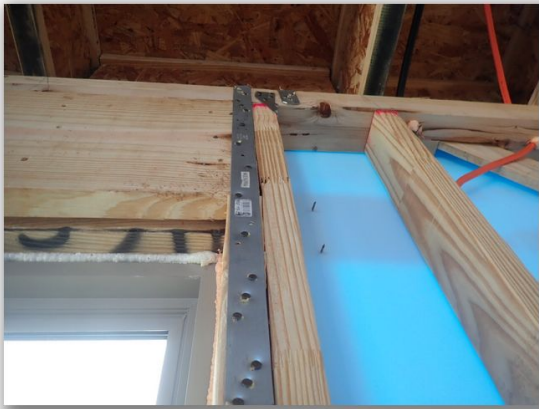
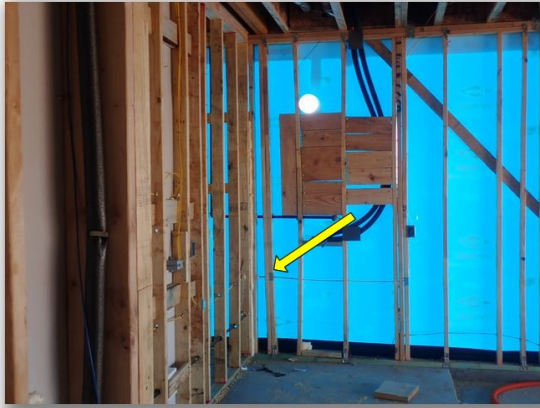
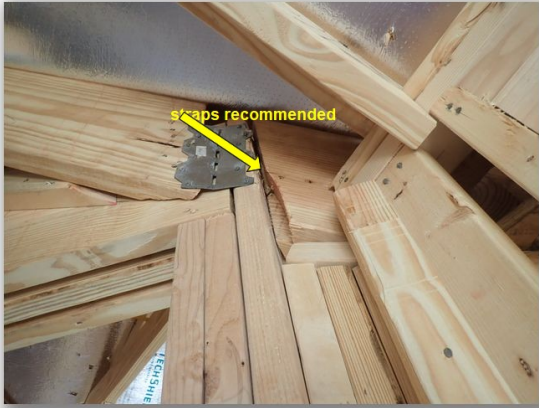
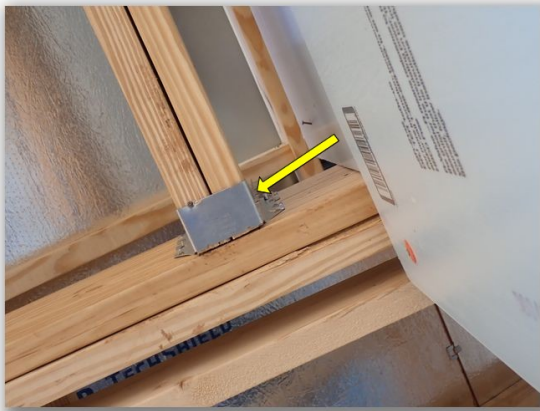
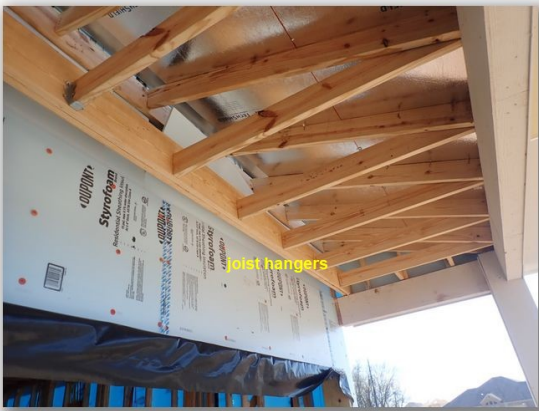
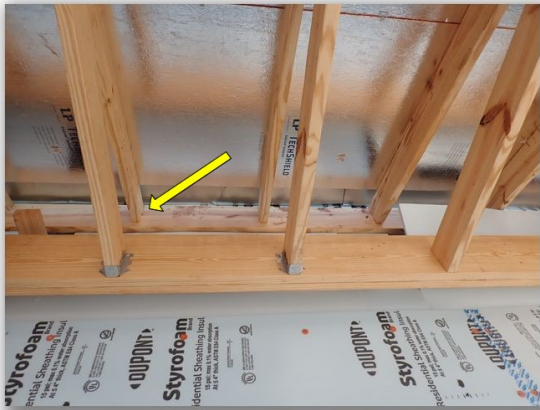
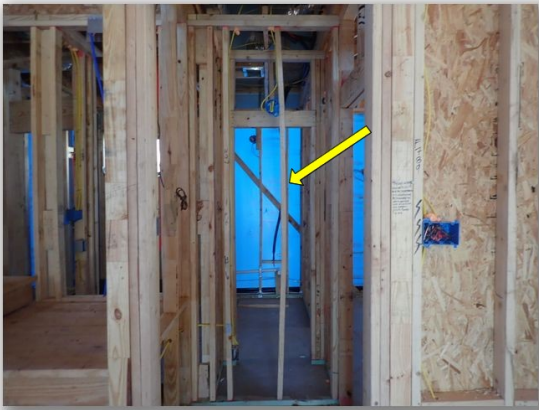
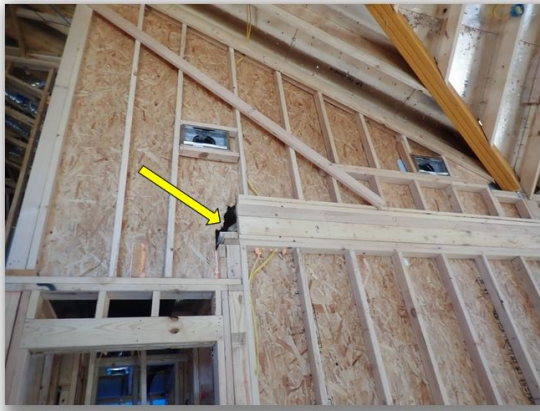
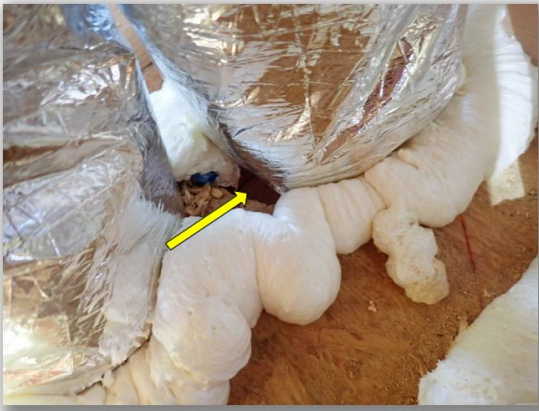
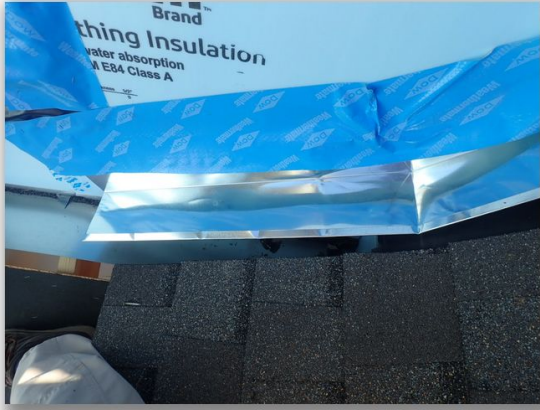
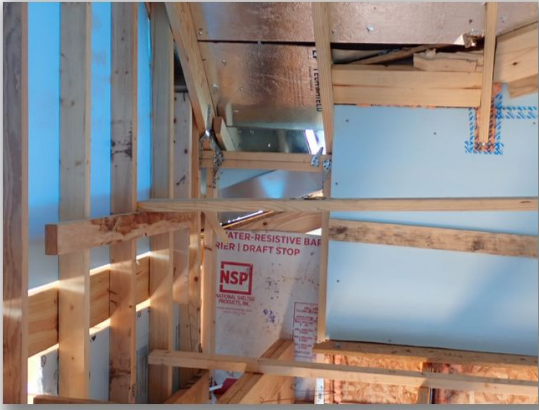
- One or more joist hanger(s) were observed to be missing over the garage, living room.
- One or more joist hanger(s) do not have enough fasteners (nails) installed in the front porch.

- The joist hanger above the kitchen is not properly installed.
- One or more of the wall studs was observed to be damaged in the garage, upstairs front corner bedroom. This condition should be corrected prior to installing the drywall finish.

- Several studs were observed to be bowing. It is recommended to correct this condition prior to drywall installation.
- There does not appear to be enough support for brick/masonry veneer above the front porch.

- The ceiling of two different ceiling heights in front entrance area, garage, master bedroom are not properly fireblocked. This condition needs to be corrected prior to installing the drywall.

- All wind straps around doors/windows should have a nail in every nail hole.
- It is recommended to add straps to better secure the valley support above the living room.

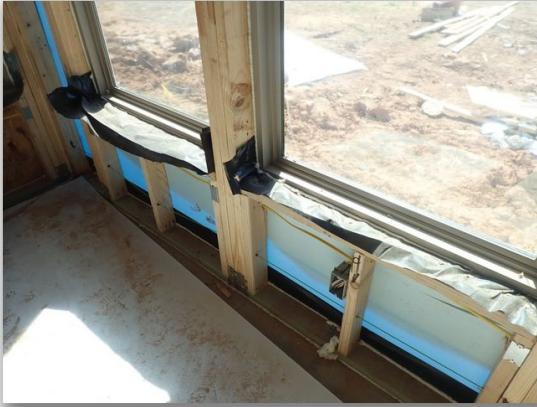
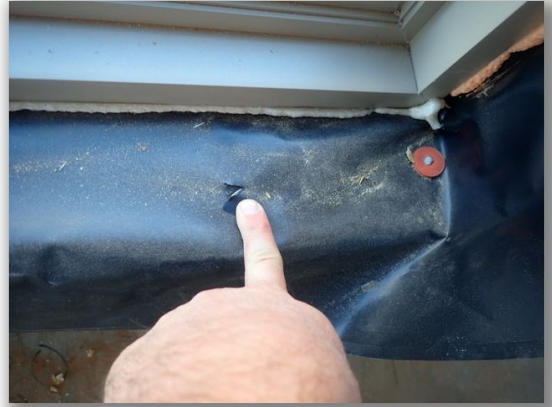
- All holes/openings in the window pan flashing should be properly sealed.

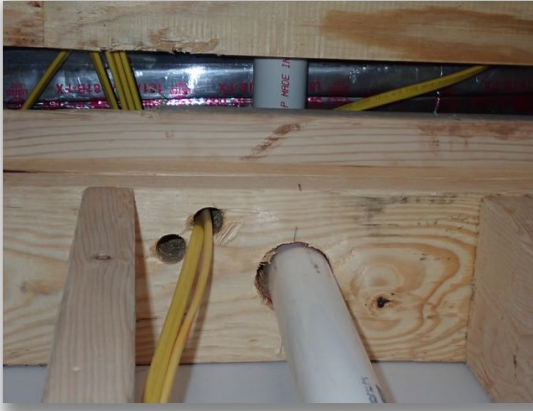
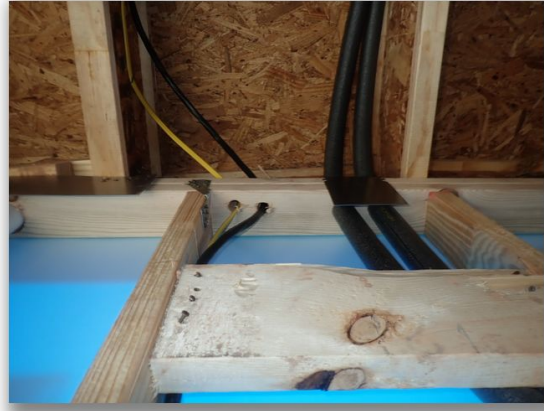
- Striker plates are needed to help protect the electrical branch circuit wiring from fastener (nail or screw) damage in the garage, kitchen.

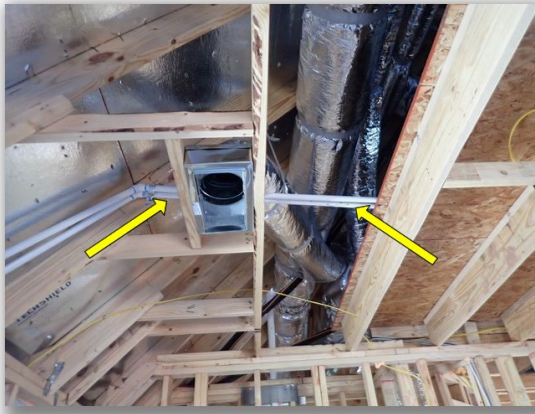
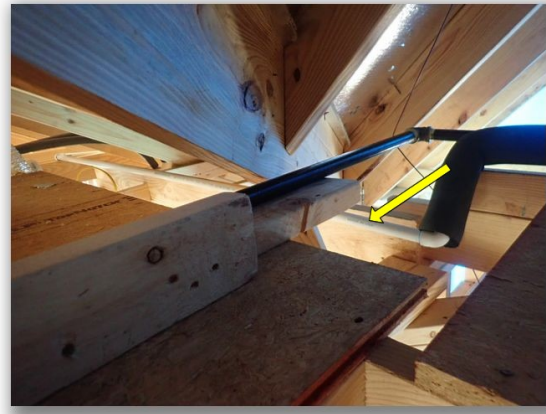
- The slope of the condensate drain line appears to be insufficient. Under current mechanical standards, the condensate drain line should have a minimum slope of 1/8-inch per foot.

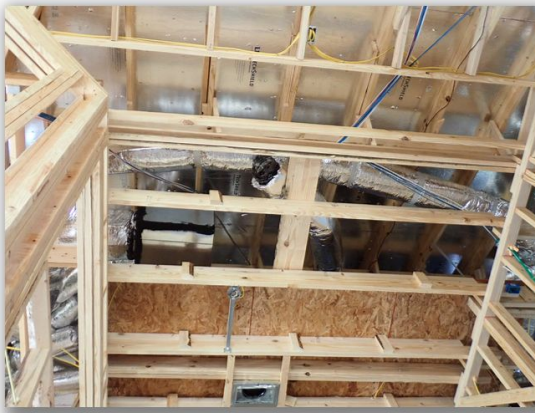
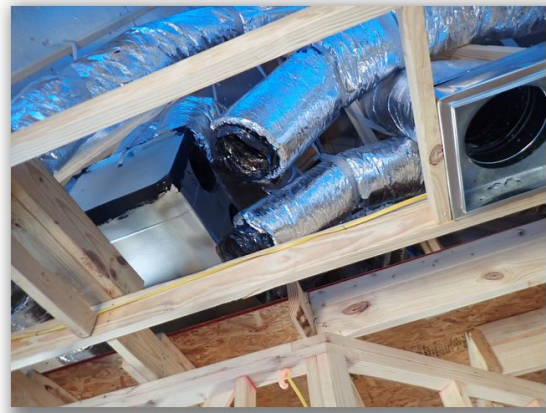
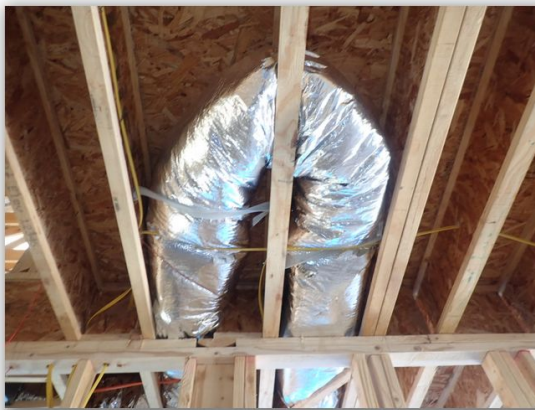
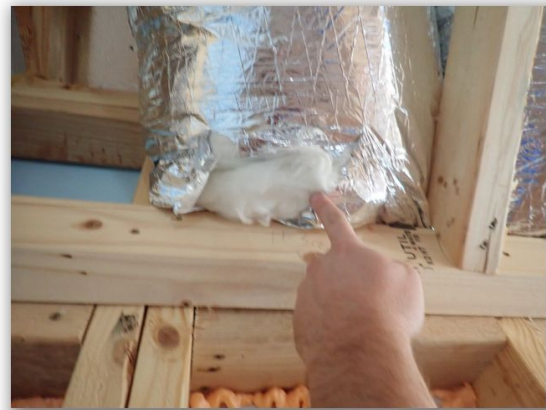
- The flex ducts are turned too sharply in the front entry hallway. This condition does not meet current manufacturers installation standards. This condition should be corrected to help improve proper air balance and flow to the different areas of the structure.
- Several of the ducts are not connected to the plenum box.
- Ductwork insulated covering was observed to be damaged and/or pulling loose.

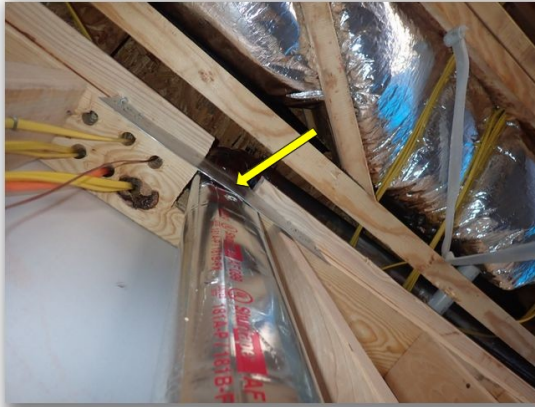
- The dryer duct is damaged/crimped as it passes through the top plate. This condition will cause clogging of the dryer duct line. Repairs are recommended.
