**Sample Report**

**December 8, 2021**

# PROPERTY INSPECTION REPORT FORM

12345 Sample Report, Humble, TX 77346

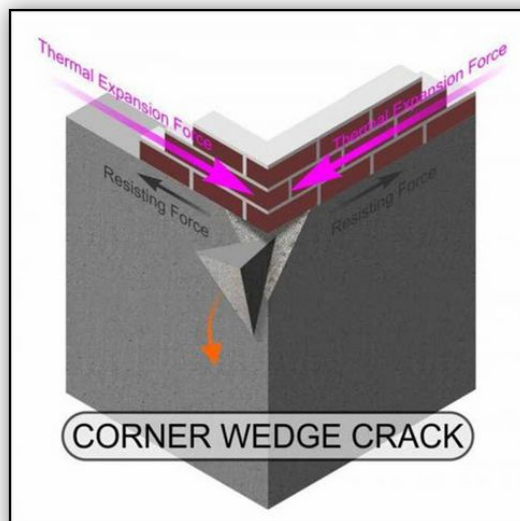
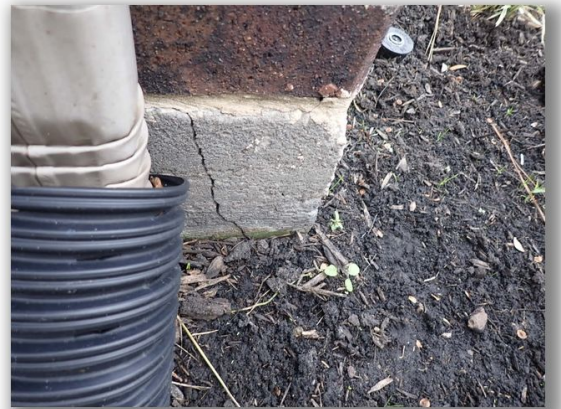
- One or more of the foundation perimeter beam corners were observed to be sheared off (corner pop). This is a common condition to observe and is due to thermal expansion and contraction of the different building materials. This condition does not adversely affect the foundation performance. However, in some cases, some cosmetic improvements may be necessary.

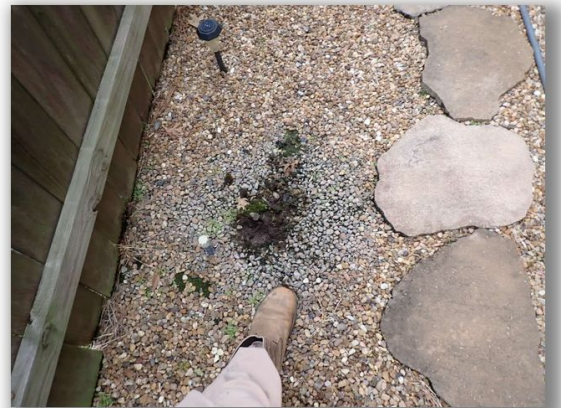
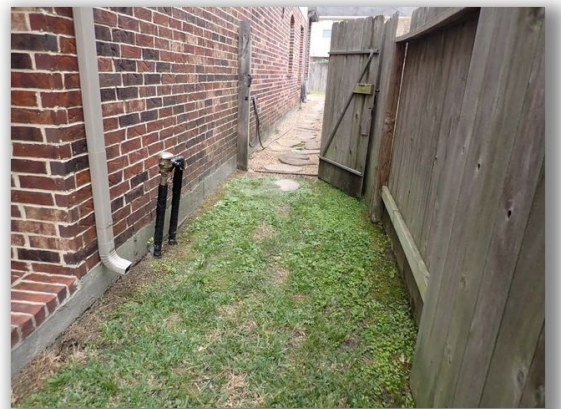
- Fill dirt is needed on the east side of the structure. The low spots in the finished grade (ground) adjacent to the foundation perimeter wall need to be filled in to help prevent water from standing and/or ponding next to the foundation area.
- Marginal site drainage was observed on the east side of the structure. Proper drainage is needed to help prevent water from standing and/or ponding next to the foundation beam. Corrective measures may be needed if the water stands within 10-feet of the foundation perimeter beam for more than 24-hours.

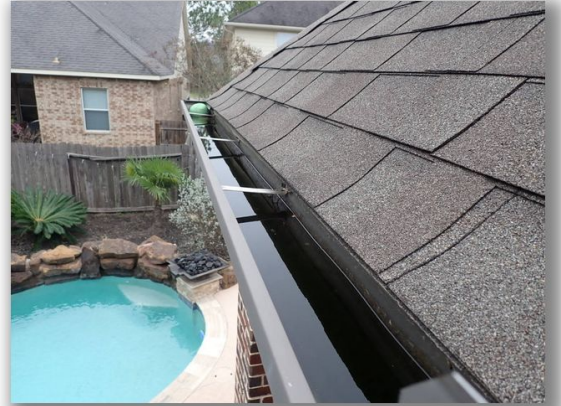
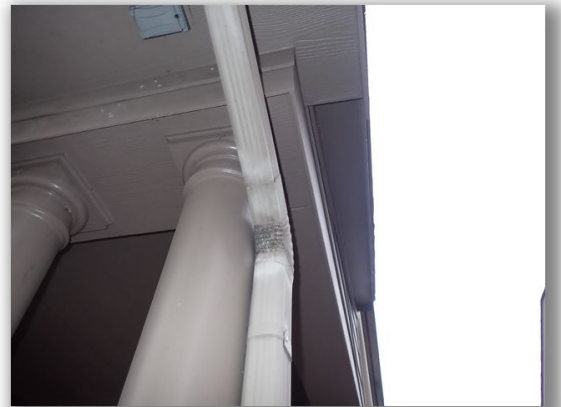
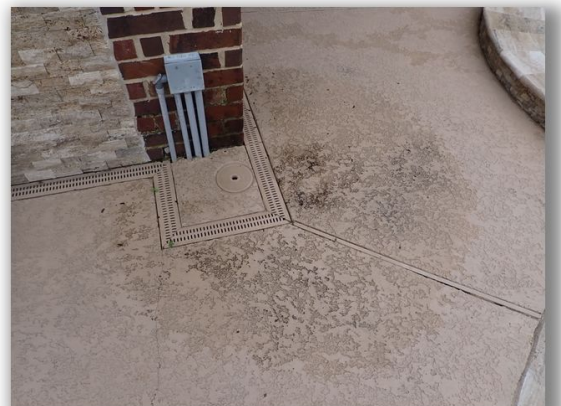
- Minor leaks in the gutter joints and seams should be repaired.
- The gutters require cleaning.
- The gutters do not appear to have sufficient slope to drain properly on the north side of the roof structure. If they do not perform as intended, the slope should be adjusted.

**Note:** The gutter downspouts should discharge water at least thirty-six inches (36") away from the foundation perimeter beam. Storm water should be encouraged to flow away from the structure at the points of discharge.

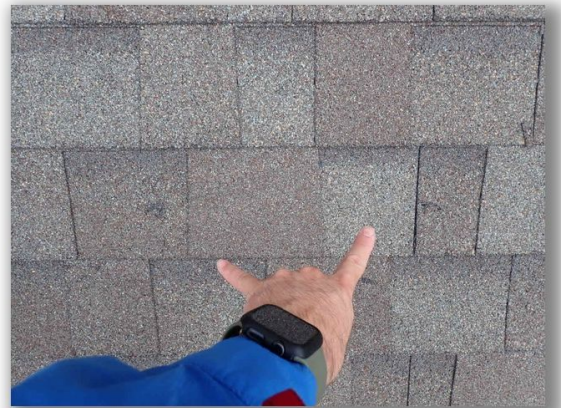
- Damaged shingles were observed on the south side of the roof structure.
- One or more of the ridge cap shingles were observed to be damaged.
- Exposed fasteners were observed at the shingles in one or more locations.
- Shingle fasteners (staples and/or nails) were observed to be pushing through the roofing material in various locations.
- Tack holes were observed on the south side of the structure at the time of inspection. This condition should be further evaluated.

**Note:** Roof fasteners (nails and/or staples) were observed to be exposed and should be properly sealed at the ridge caps and flashing areas.

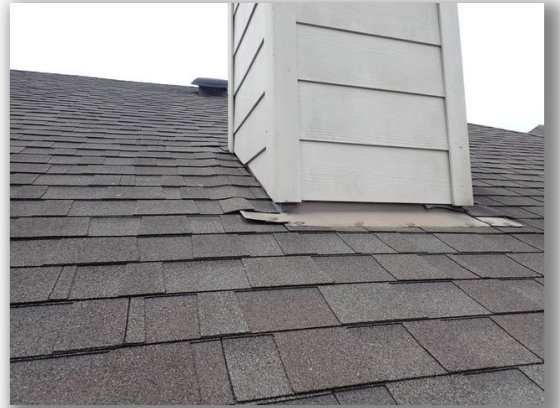
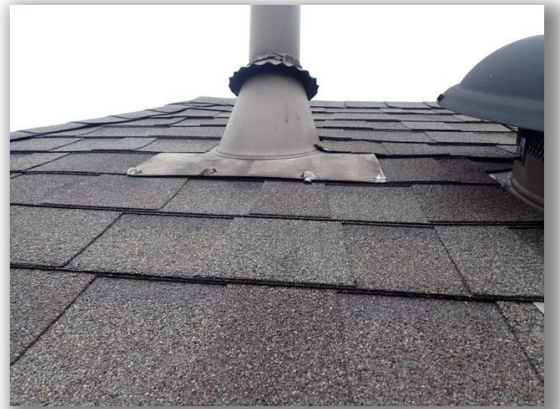
- It is recommended to seal all plumbing stack boots to prevent water intrusion.
- The flashing is lifting and/or pulling loose and should be re-secured on the north side of the roof structure.
- The flashing needs to be painted to prevent rust and/or UV damage.
- The drip edge flashing is not properly installed at the gutter. The drip edge flashing should be installed behind the gutter to prevent water intrusion/damage at this location.

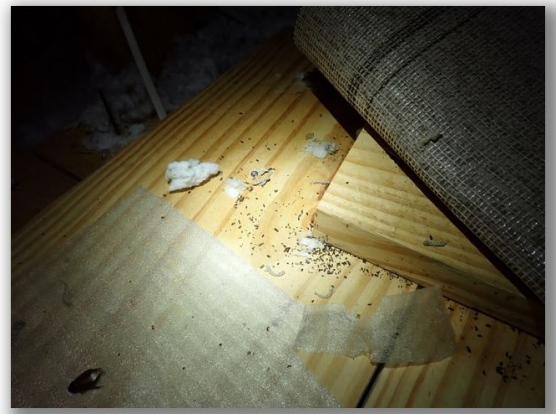
- It is recommended to seal all openings between the soffit and roof covering to prevent pest/rodent intrusion at this point.

**Note:** Visible evidence of rodent activity was observed in the attic area. It is recommended to have a Certified Pest Control Operator further evaluate this condition and make corrections as necessary.

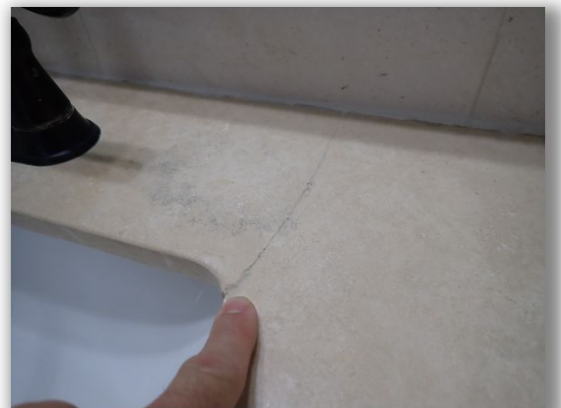
- Wall surface damage was observed in the half bathroom.
- The counter top in the primary bathroom was observed to be cracked at the time of inspection.

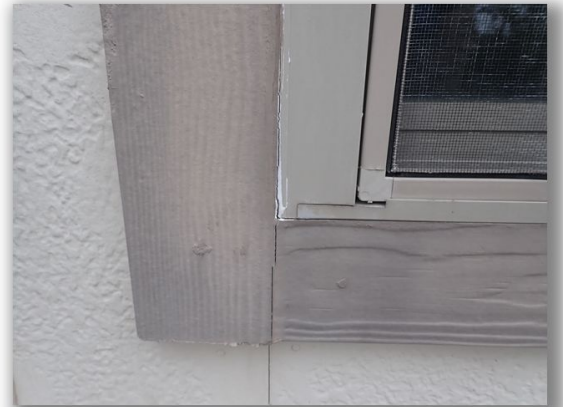
- Mortar improvements are recommended for the exterior masonry veneer on the south side of the structure.
- The exterior veneer / cladding was observed to be pulling loose and needs to be better secured on the north side, east side of the structure.

- All of the exterior wood type surfaces need a fresh coat of paint.
- The flashing needs to be painted to prevent rust and/or UV damage.

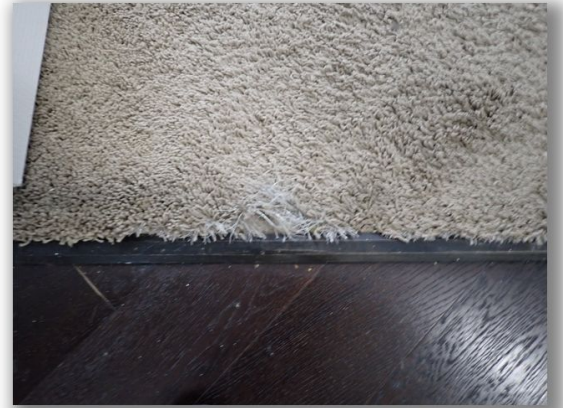
- The floor covering is stained in one or more locations of the home.
- The floor covering is worn and/or damaged in one or more locations of the home.
- The floor covering was observed to be damaged in the upstairs rear corner bedroom.

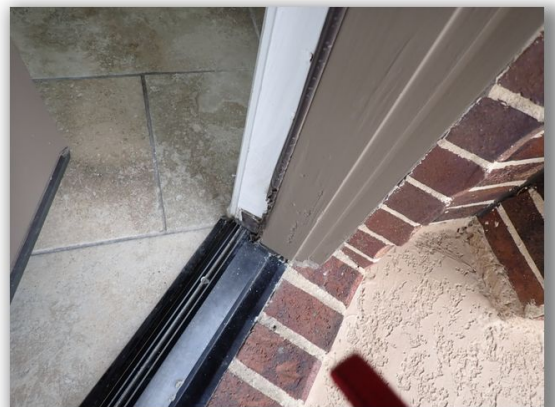
- Weather-stripping improvements are recommended for the front entry, backyard entry exterior door(s).
- The door is not latching properly to the front entry door.

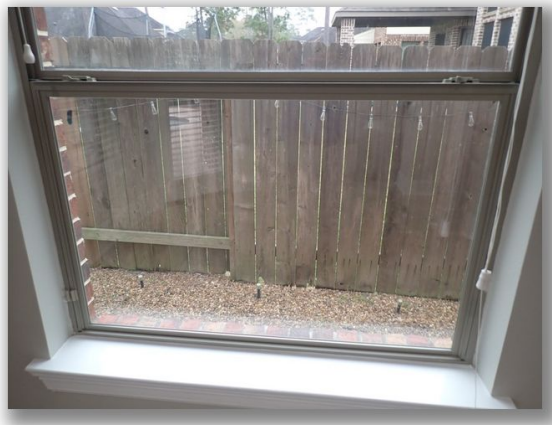
- One or more of the window screens were observed to be missing.

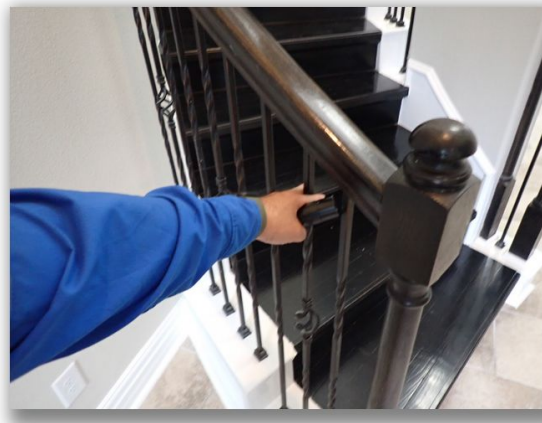
- One or more of the spindles and/or balusters was observed to be loose.

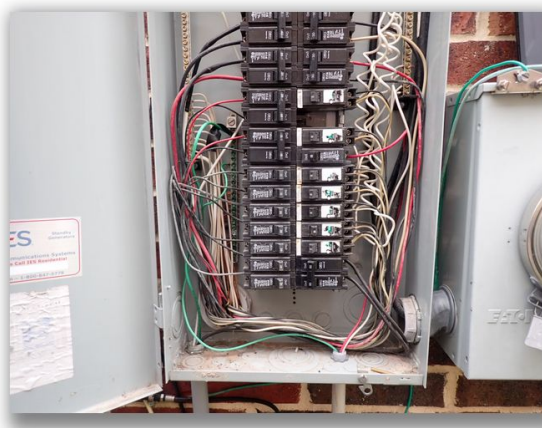
- One or more of the arc-fault circuit interrupter (AFCI) devices in the electrical cabinet did not trip and/or respond properly when tested. This condition should be further evaluated and corrected as necessary.

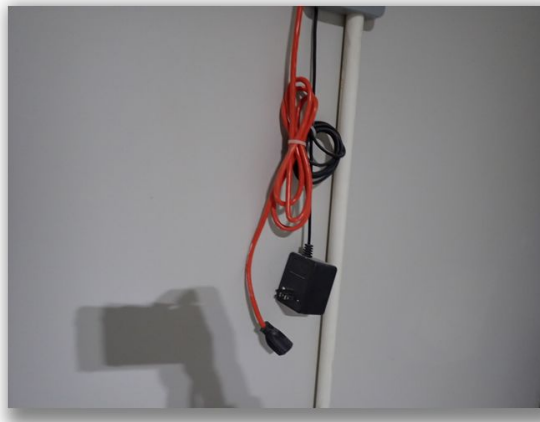
- Electrical flex extension cords should not be used for permanent wiring or pass through walls or ceilings. The improper use of extension cord was observed in or around the garage area.

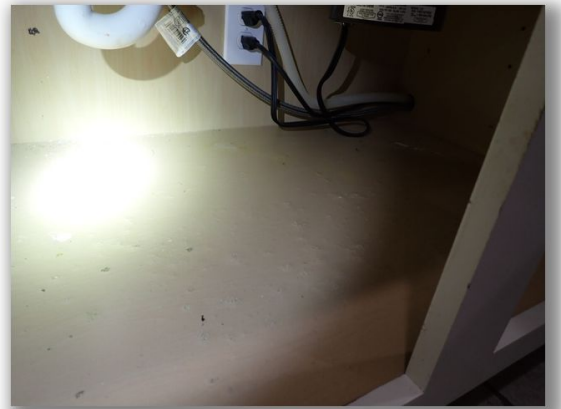
- The shelf in the cabinet under the sink is damaged.

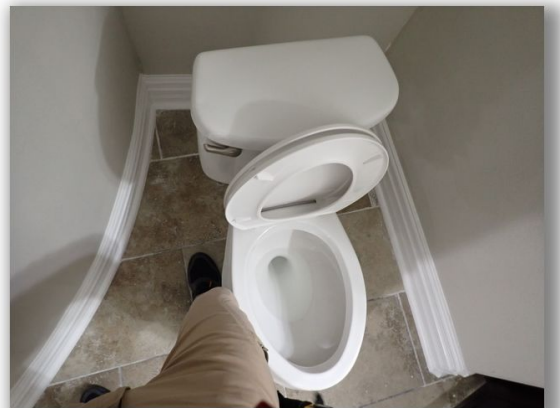
- The commode is loose at the floor mount.

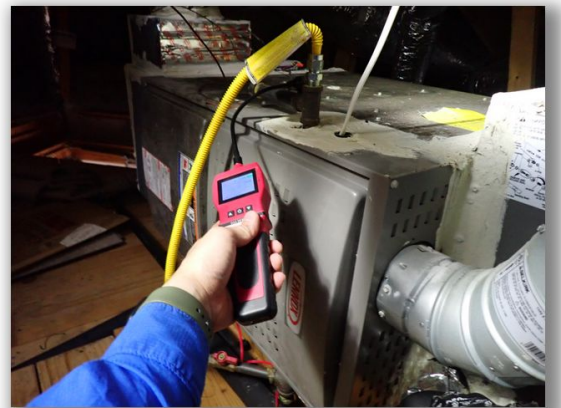
- The heater gas supply line sediment trap was observed to be improperly installed. This condition does not meet current installation requirements and should be corrected.

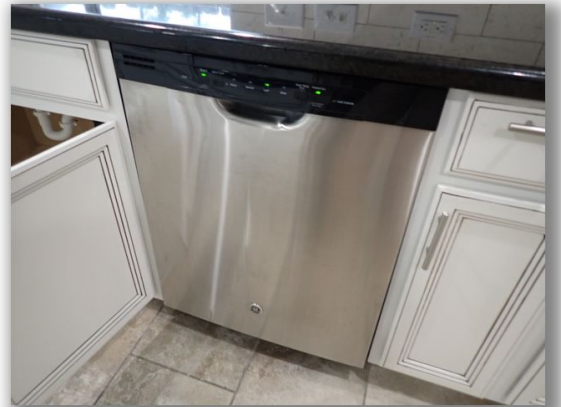
- The dishwasher drain hose is not properly installed to prevent back flow or anti-siphoning. It is recommended that an air gap device or high drain loop be installed in the drain line.

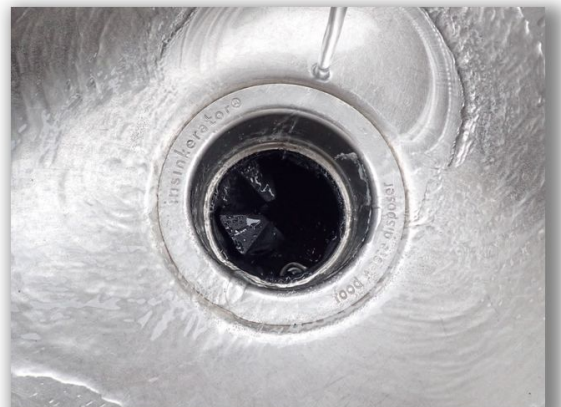
- The splashguard for the food waste disposer is damaged and/or missing.

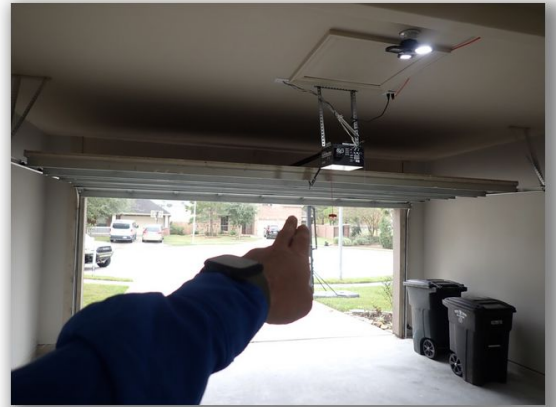
- When an automatic garage door opener is in use, the manual lock should be disabled or removed.
- The garage door opener chain is loose and needs to be better secured and/or adjusted.
- The garage door opener was unusually noisy when operated. The cause and remedy should be further evaluated and corrected as necessary.
- The overhead garage door does not roll smoothly on the track. It is recommended to tune up the components, such as: rollers, tracks, and hinges to prevent the door failure.

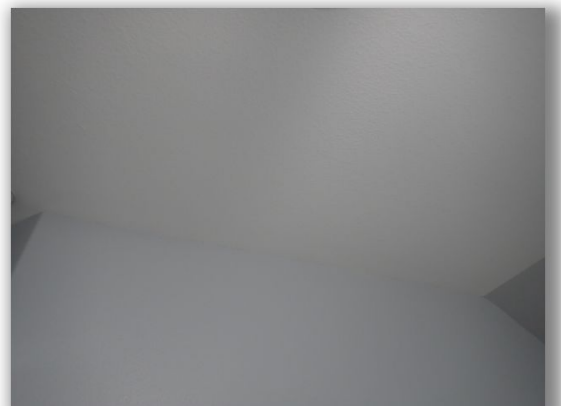
- Missing insulation was observed at the ceiling in the upstairs rear corner bedroom.
