713-730-3151

[www.a-actionhouston.com](http://www.a-actionhouston.com)

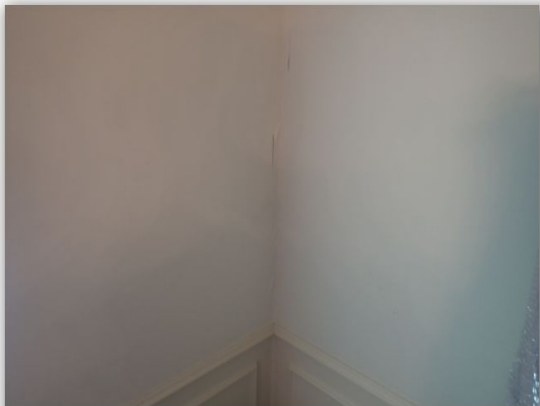
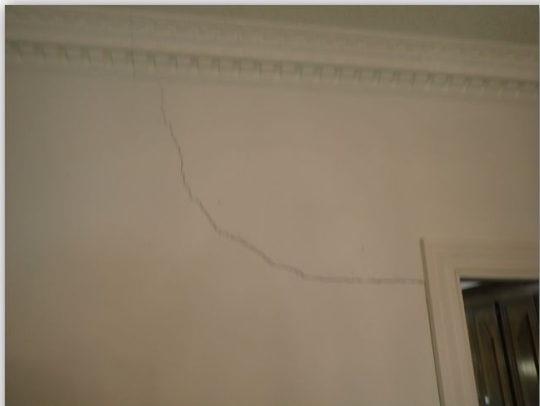
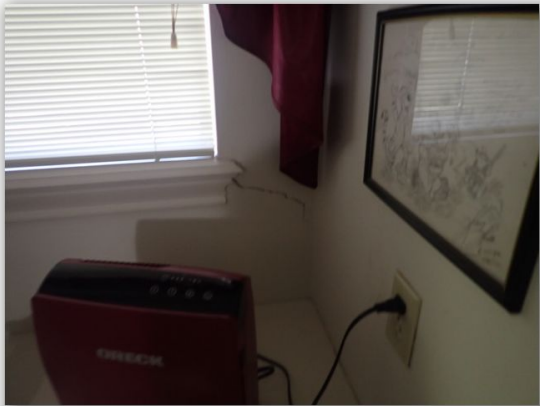
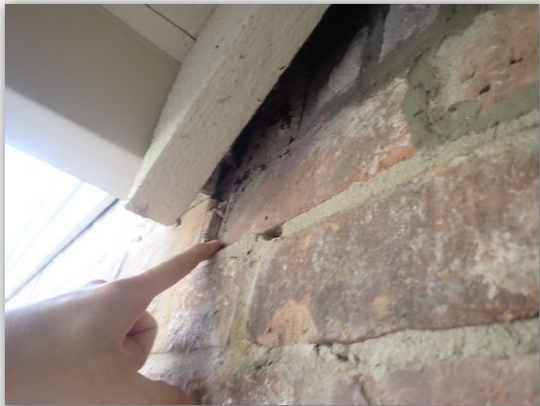
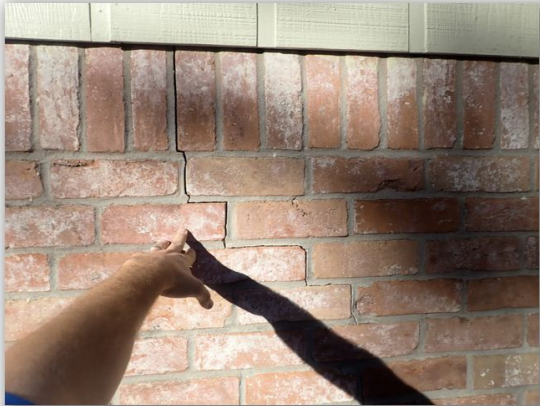
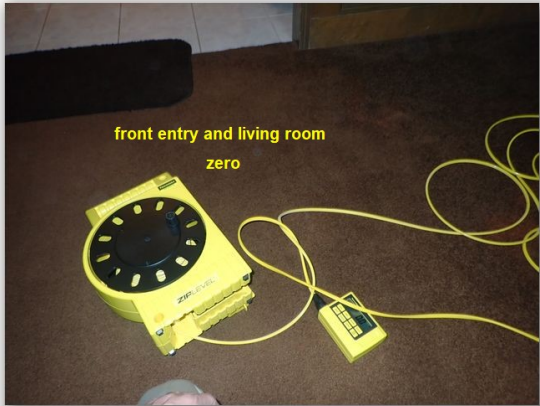
| I=Inspected | NI=Not Inspected | NP=Not Present | D=Deficient |
|---|---|---|---|
| I | NI | NP | D |

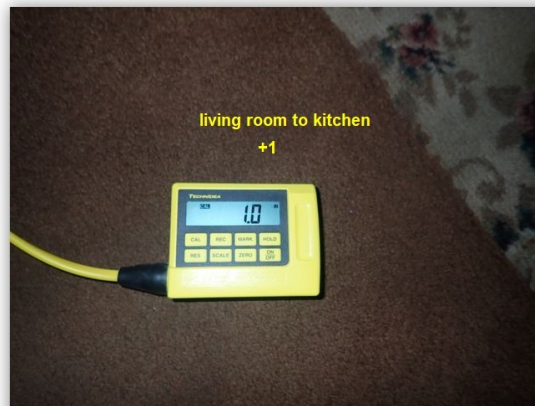
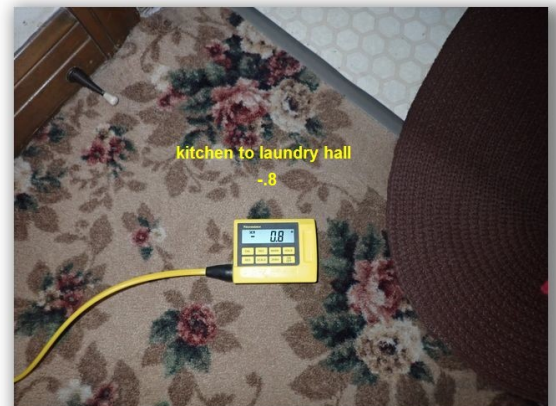
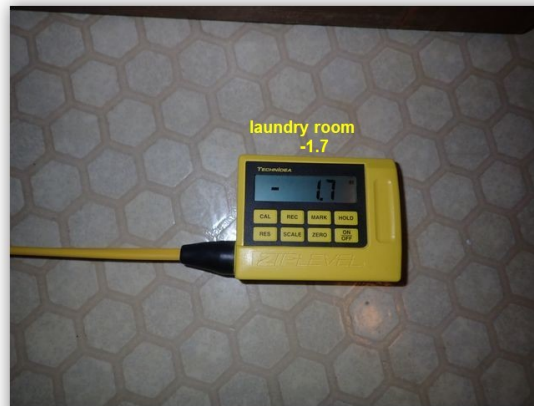
**Notice:** This inspection is one of first impression and the inspector was not provided with any historical information pertaining to the structural integrity of the inspected real property. This is a limited cursory and visual survey of the accessible general conditions and circumstances present at the time of this inspection. Opinions are based on general observations made without the use of specialized tools or procedures. Therefore, the opinions expressed are one of apparent conditions and not of absolute fact and are only good for the date and time of this inspection.

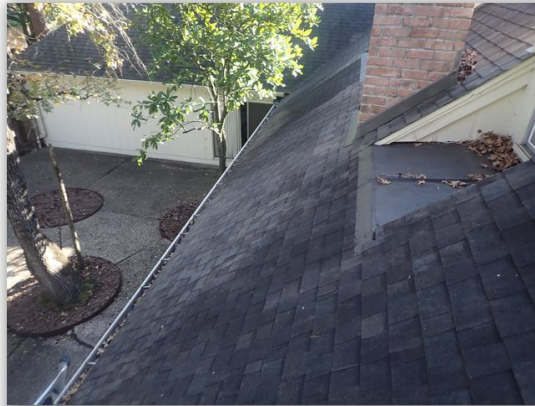
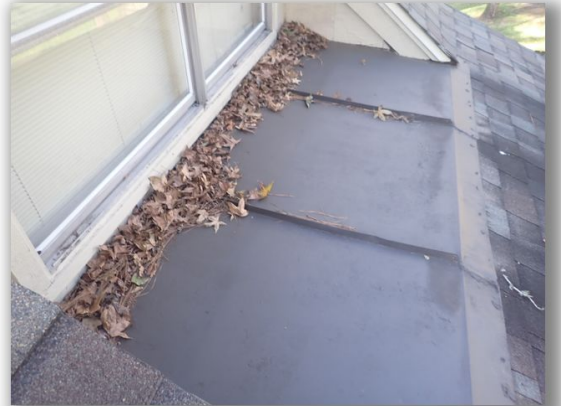
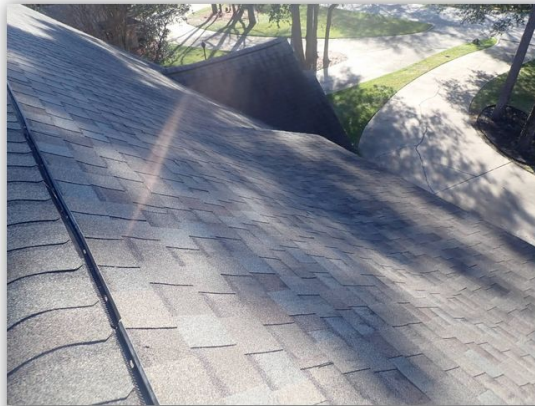
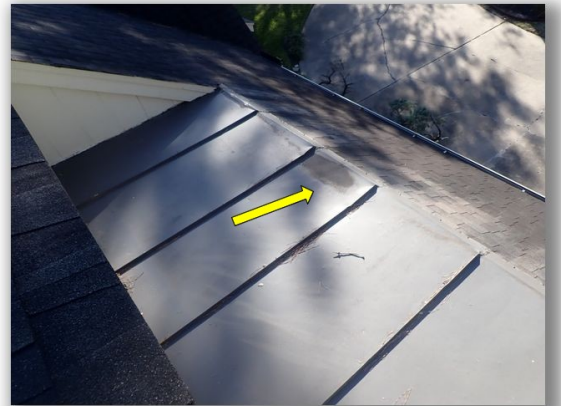
- The composition roofing material has experienced granular loss in various locations throughout the roof.
- One or more of the shingles were observed to be lifting on the west side of the roof structure.
- There is visible evidence of standing water on the metal roof

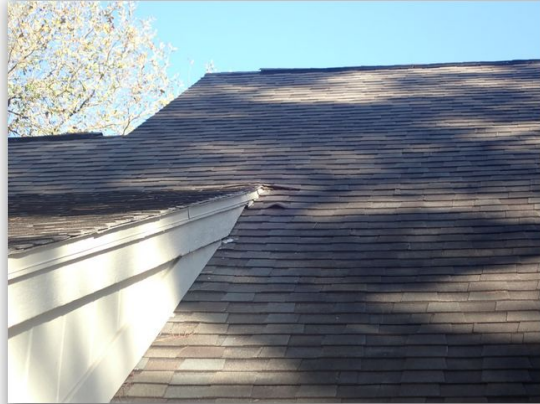
### Flashing Details

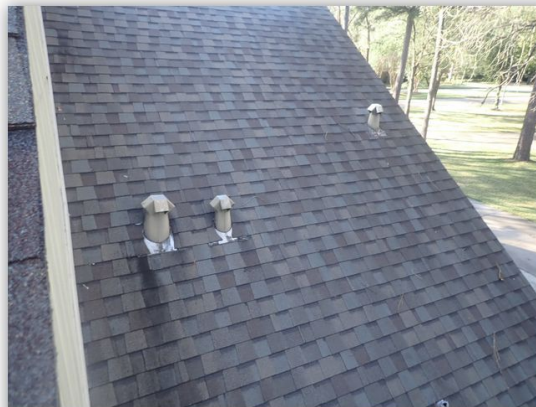
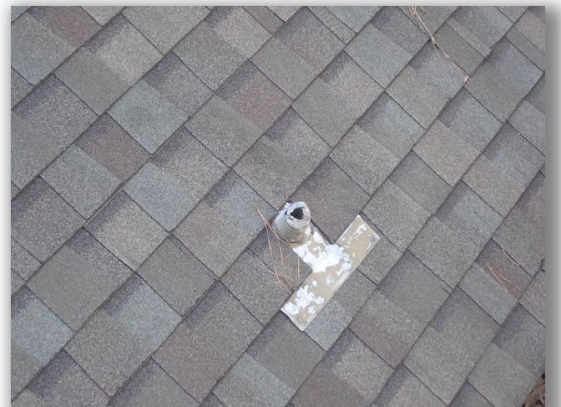
**Note:** Due to the limited nature of a general home inspection, it is possible that additional deficiencies will be discovered by a licensed technician. It is recommended to have the system serviced prior to the expiration of any option/warranty period.

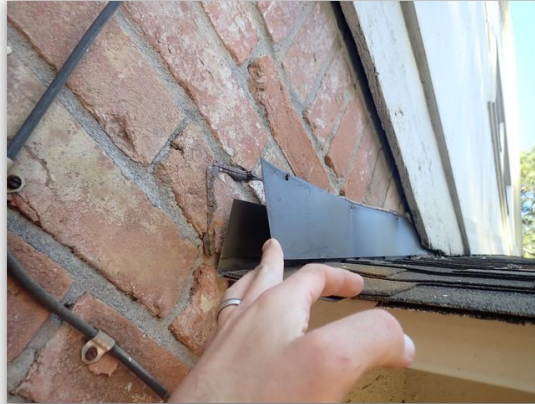
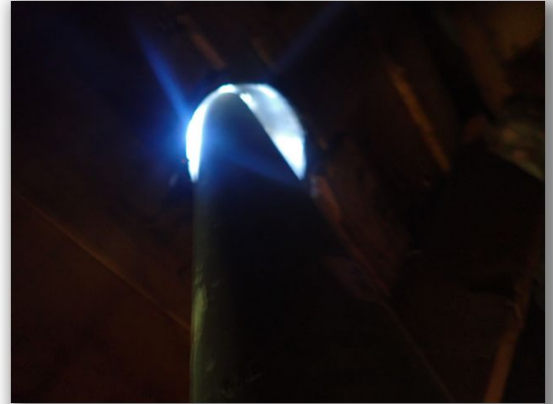
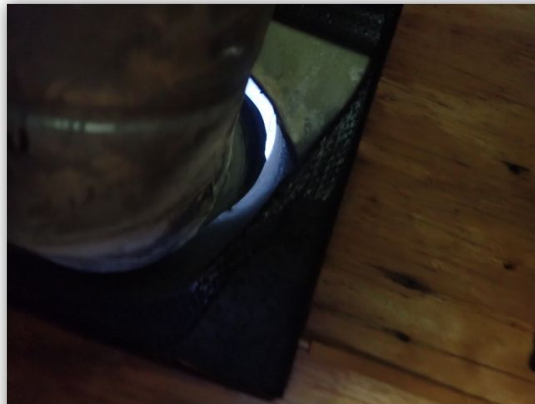
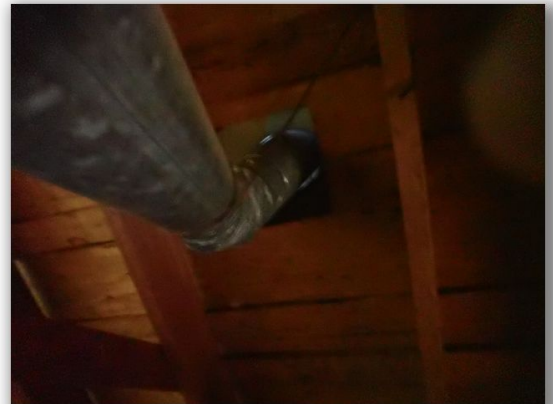
**Notice:** Life expectancy of the roofing material is not covered by this property inspection report. If any concerns exist about the roof covering life expectancy or potential for future problems, a roofing specialist should be consulted. The Inspector cannot offer an opinion or warranty as to whether the roof has leaked in the past, leaks now, or may be subject to future leaks, either expressed or implied.

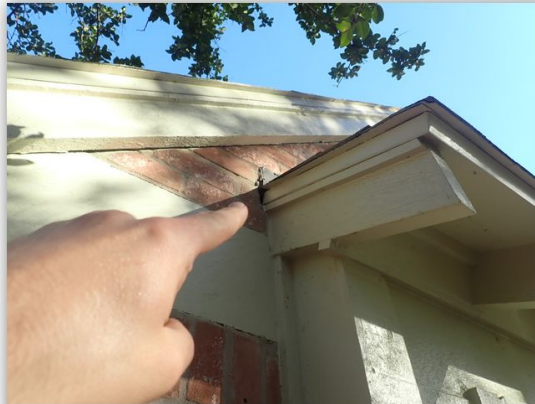
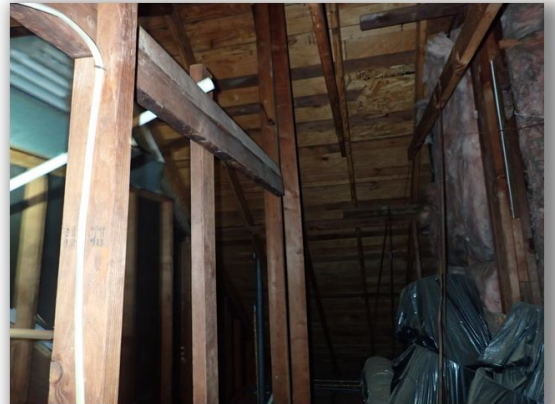
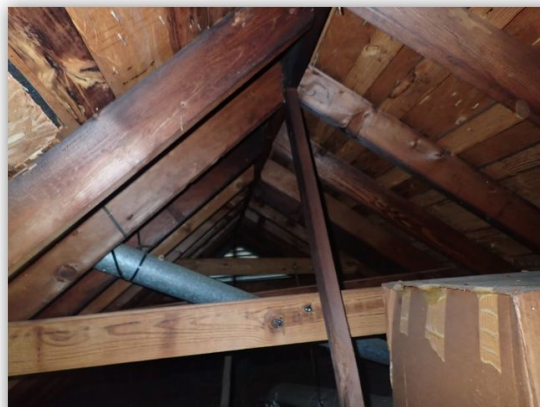
### Attic Ventilation

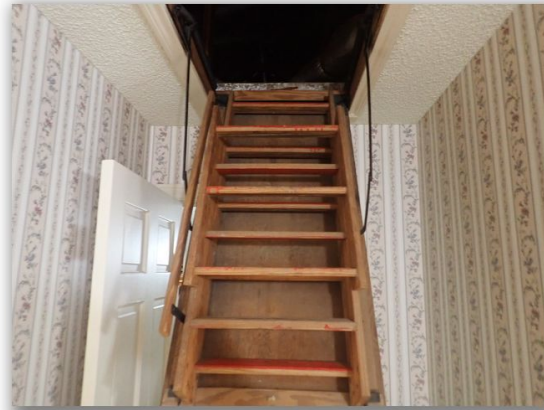
**Note:** The hatch door is not insulated at this time. This is an "As Built" condition that does not meet current energy standards. It is recommended to insulate the hatch door / opening after taking possession / ownership of the property.

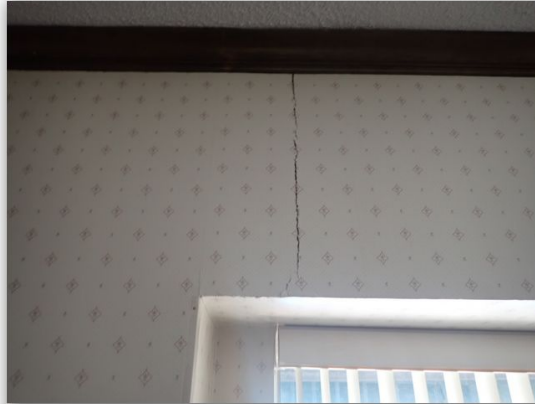
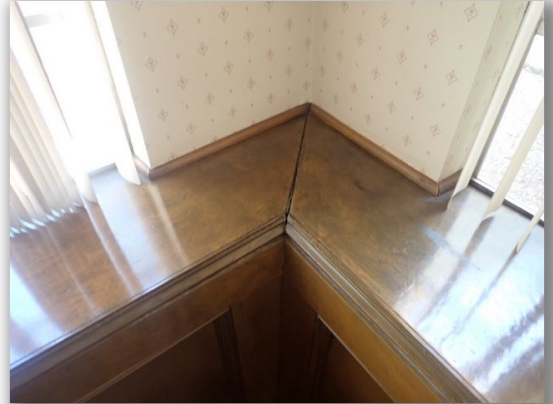
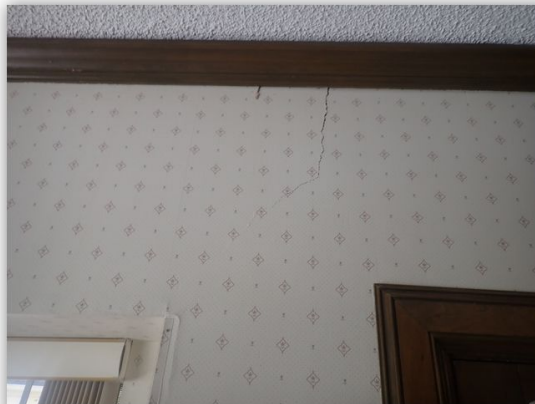
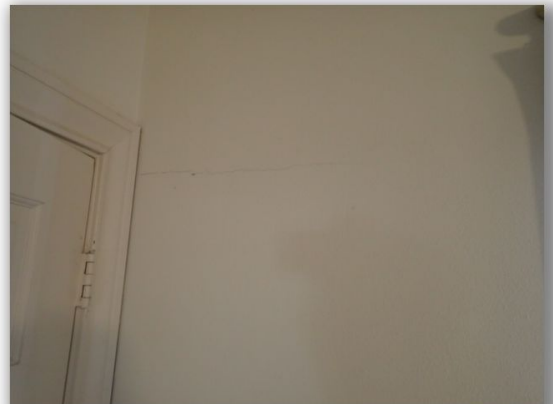
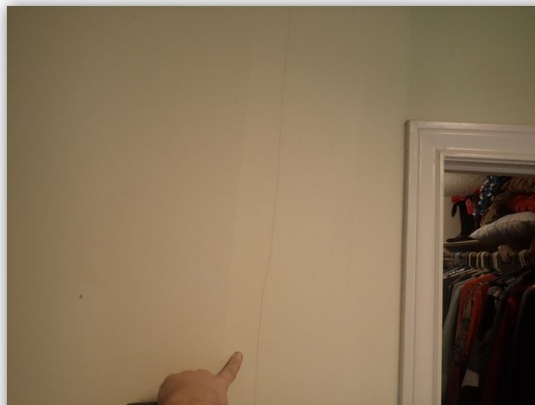
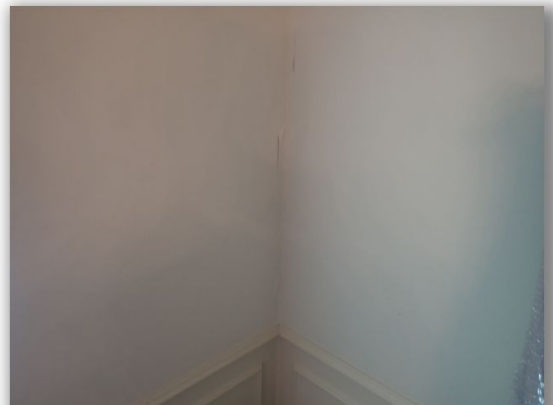
**Note:** Nail heads were observed to be pushing through the interior finish in one or more locations.

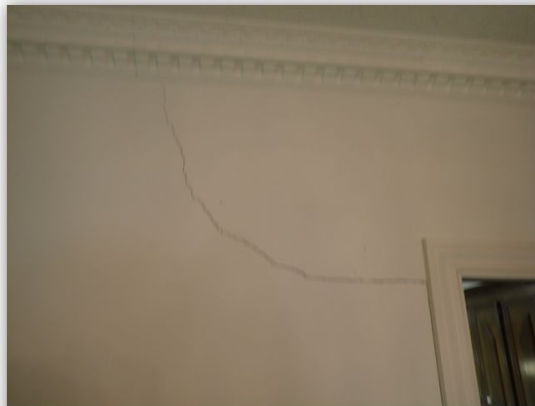
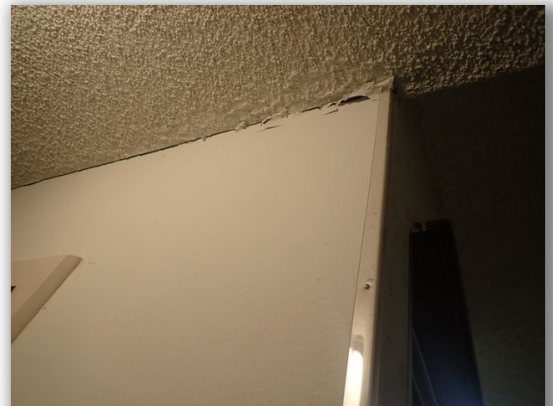
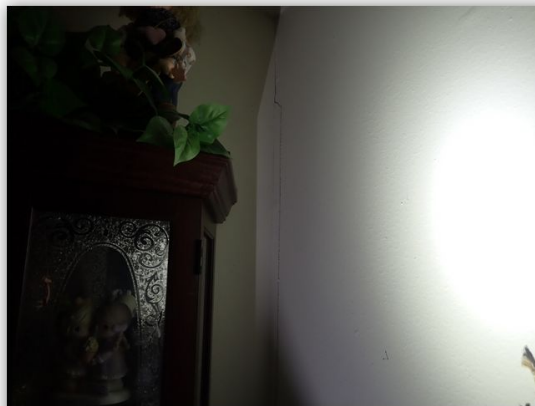
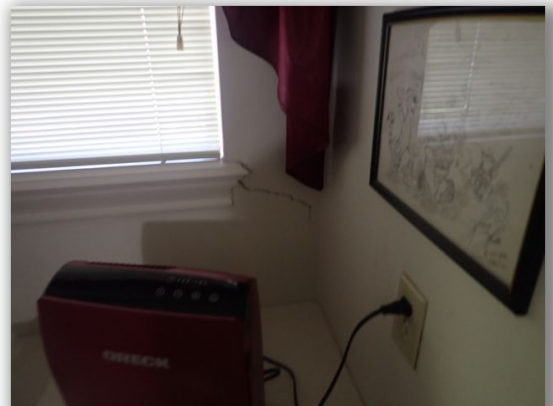
#### Cabinets & Cabinet Surfaces

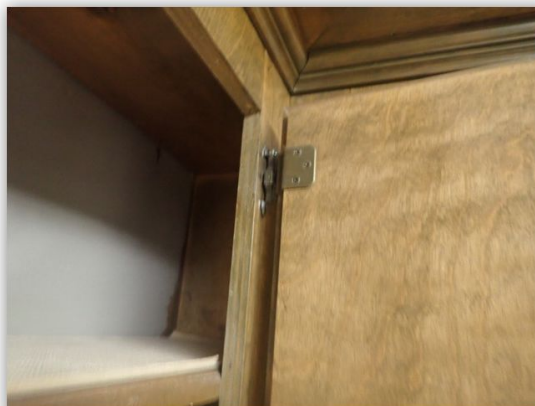
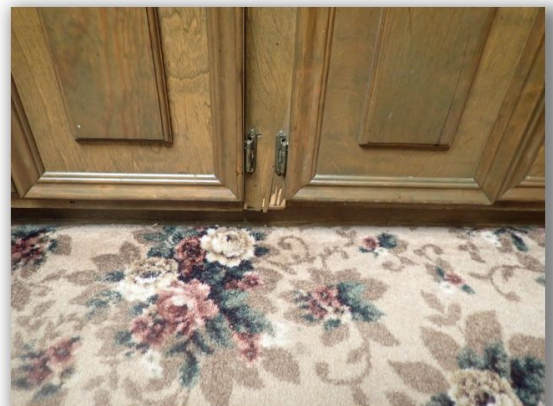
#### Exterior Walls & Surfaces

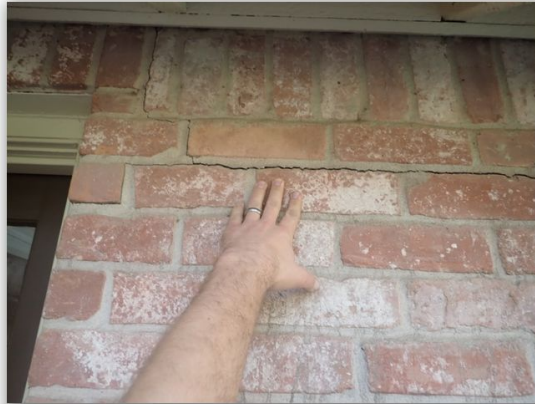
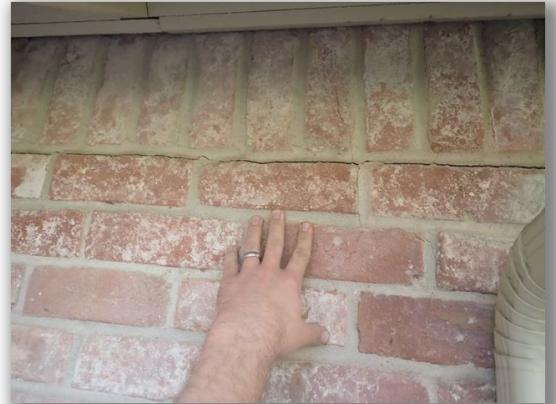
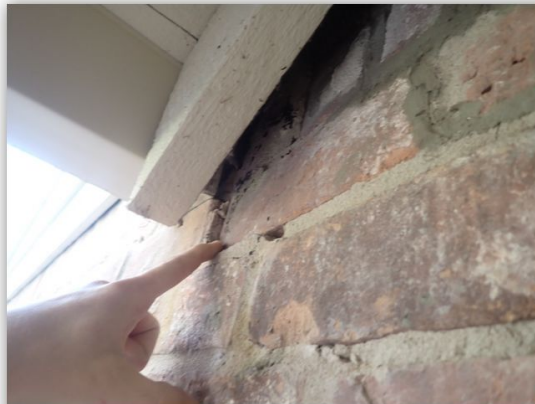
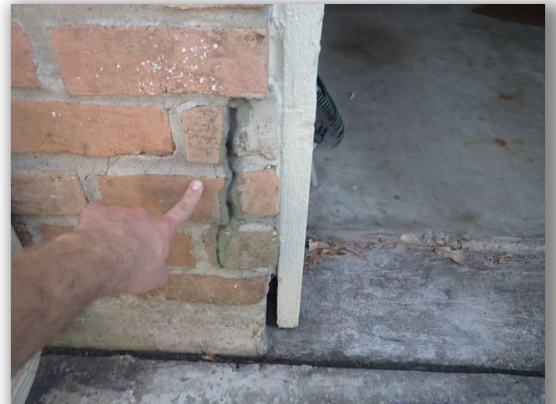
**Note:** Previous repairs to the exterior masonry mortar / grout was observed on the north side, west side of the structure.

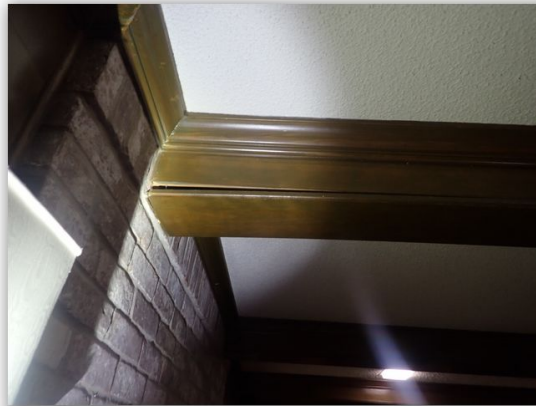
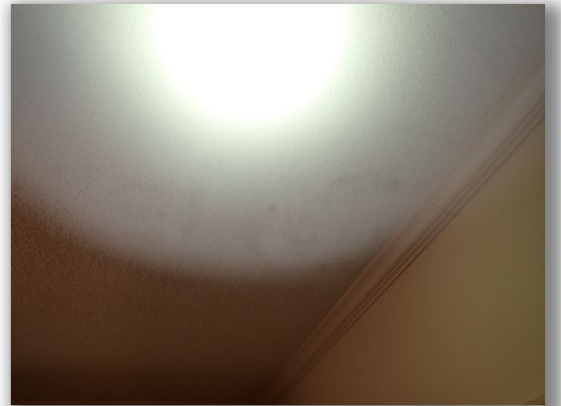
**Note:** There is evidence of painting and patching to the interior finish and prior interior finish repairs. This condition could limit the Inspectors visual observations and ability to render accurate opinions as to the performance of the structure.

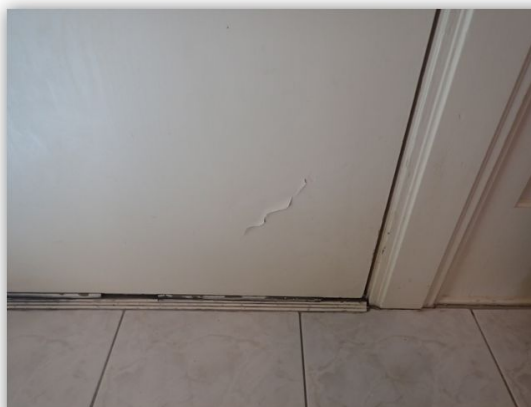
#### Overhead Garage Door

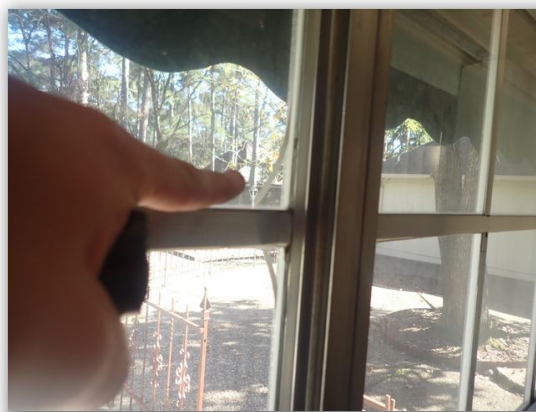
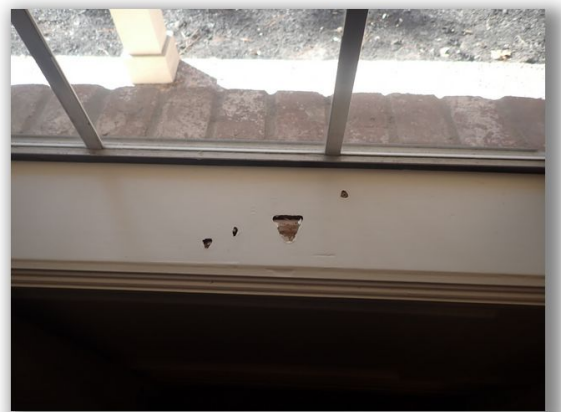
**Additional Notice from the Inspector:** It is the opinion of this inspector that although this component may be functioning as intended or in need of minor repairs, you should be aware that this is an older component and the future life expectancy cannot be determined. You can continue to use and service this component until replacement is necessary.

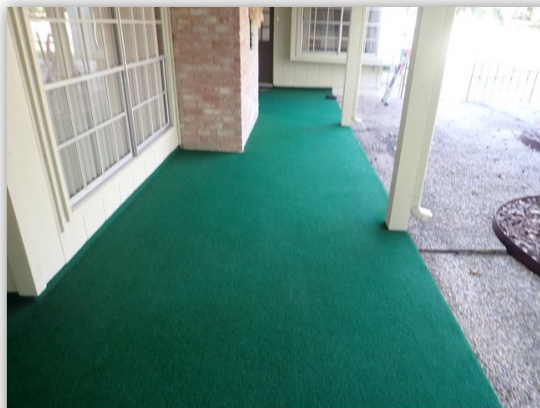
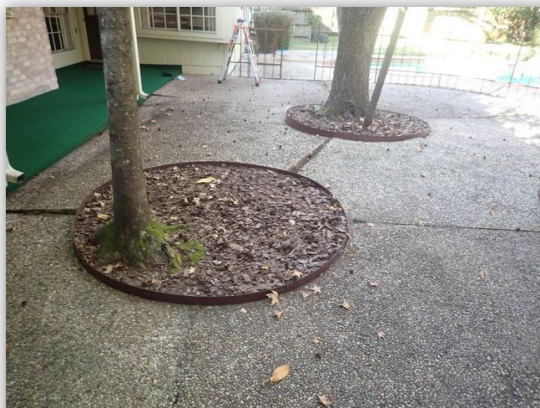
| I=Inspected | NI=Not Inspected | NP=Not Present | D=Deficient |
|---|---|---|---|
| I | NI | NP | D |

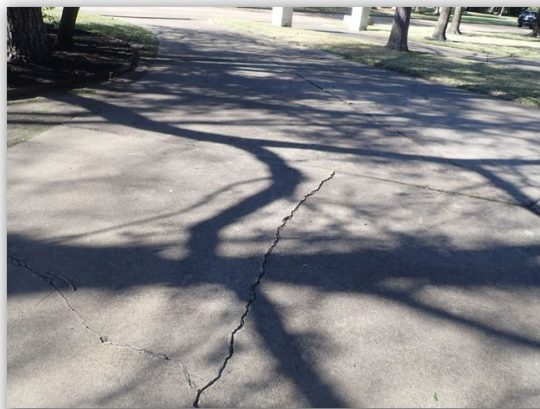
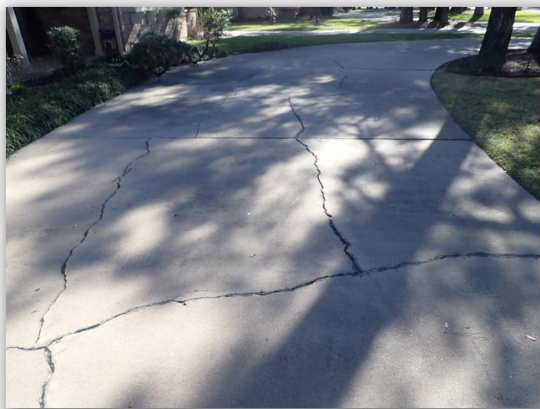
- Minor cracks and/or deficiencies were observed in the driveway.
- Larger than typical cracks and/or deficiencies were observed in the driveway.

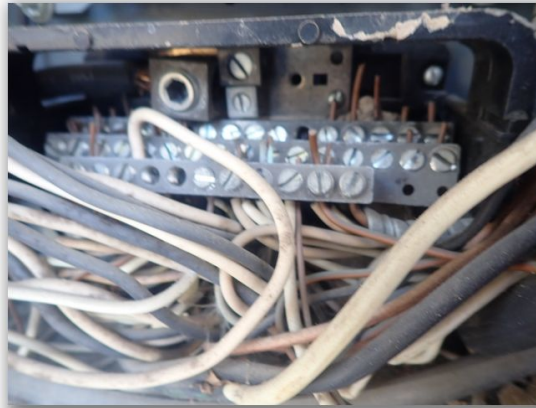
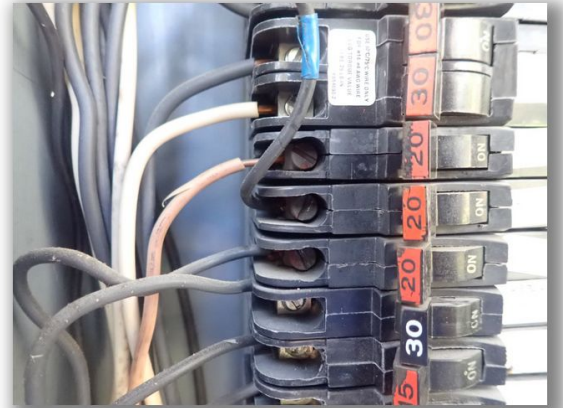
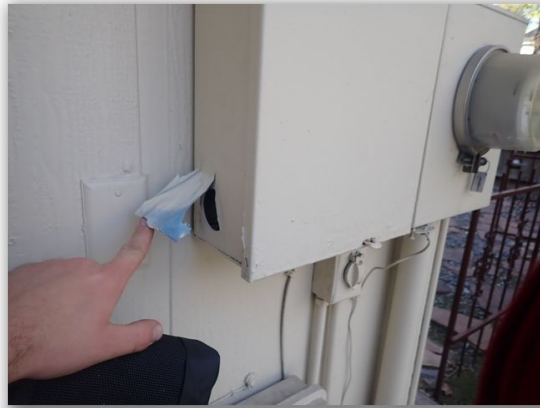
#### Arc-Fault Circuit Interrupter Protection (AFCI)

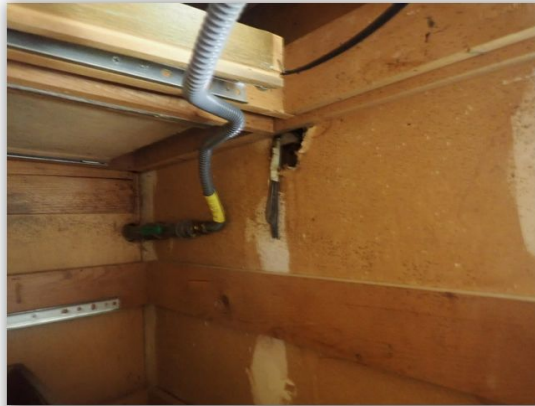
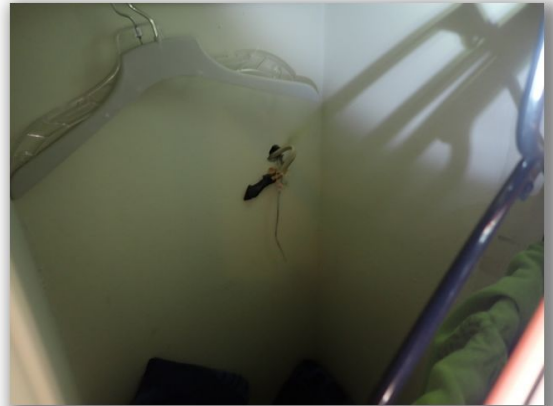
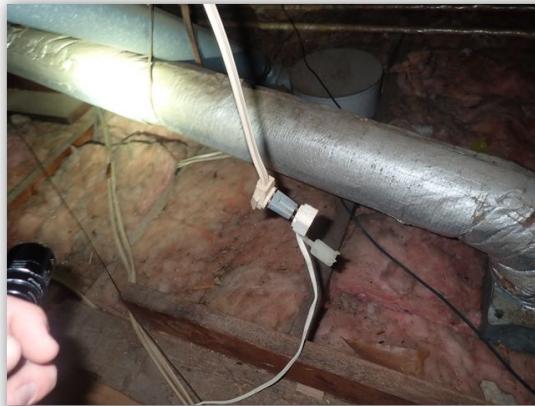
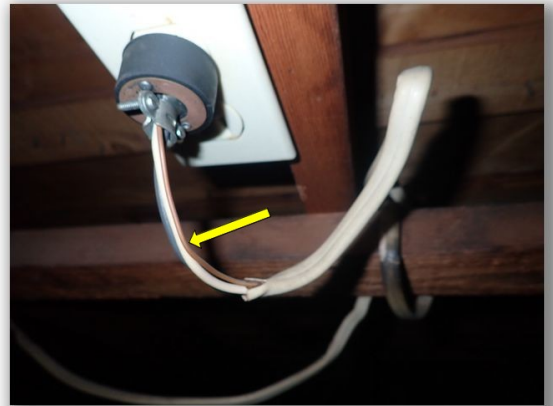
#### Grounding / Bonding

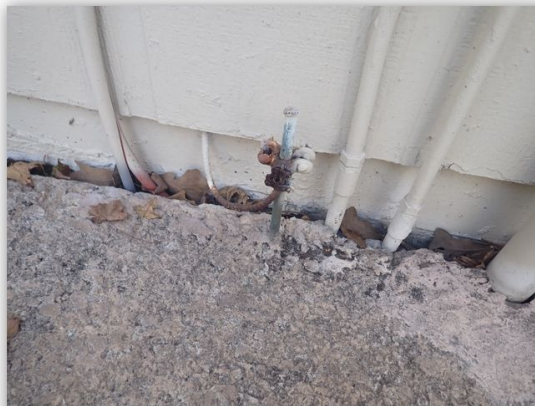
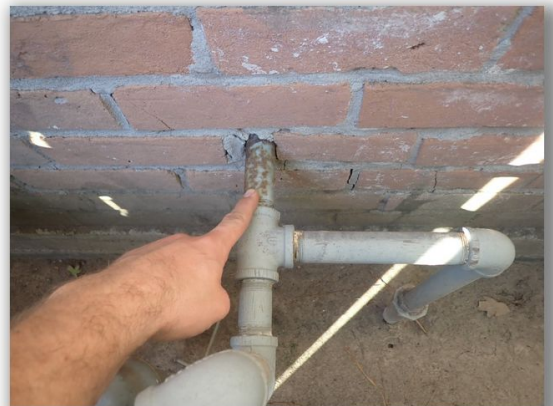
- I was unable to locate the electrical bond connection for the gas piping back to the grounding electrode system. All bond connections should be accessible for inspection, repair or replacement. This condition should be further investigated and corrected if necessary.

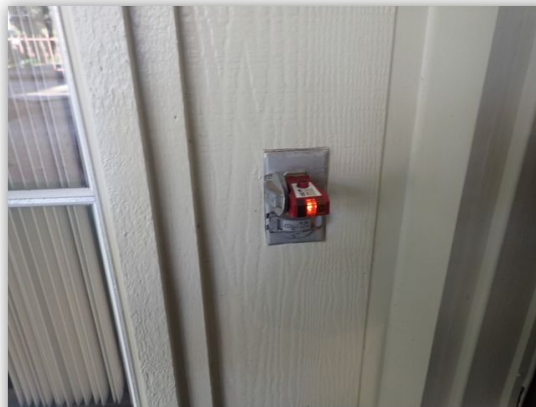
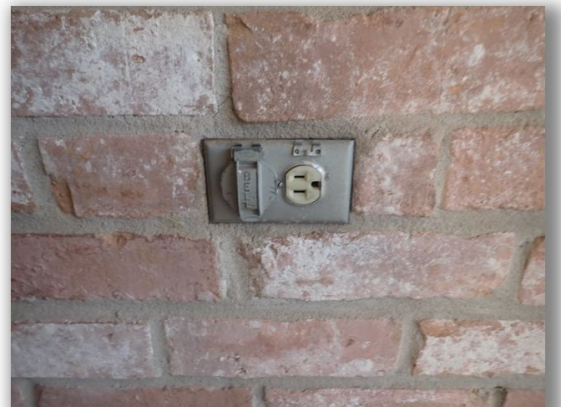
### Arc-Fault Circuit Interrupter Protection (AFCI)

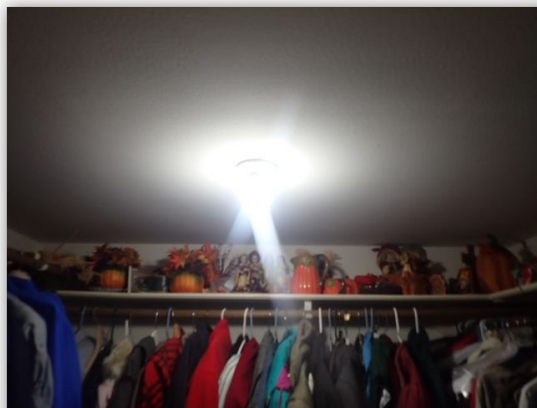
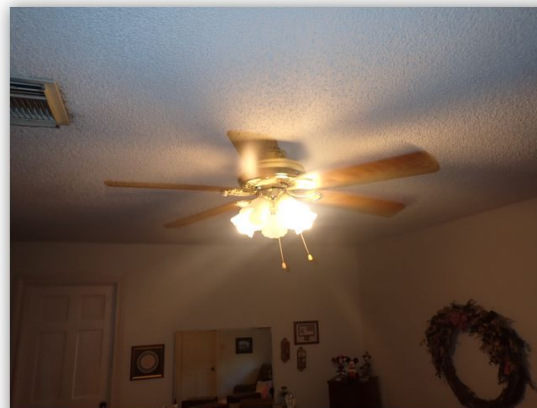
- The ceiling fan is not balanced properly and wobbles when operated in the upstairs side middle bedroom.

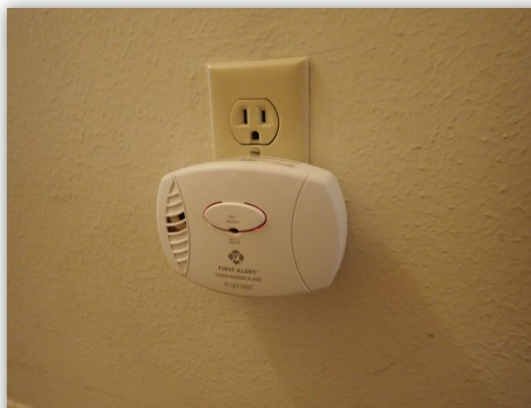
#### Doorbell / Chime

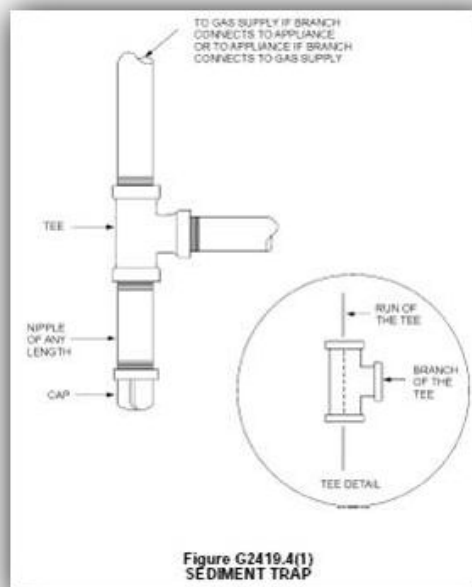
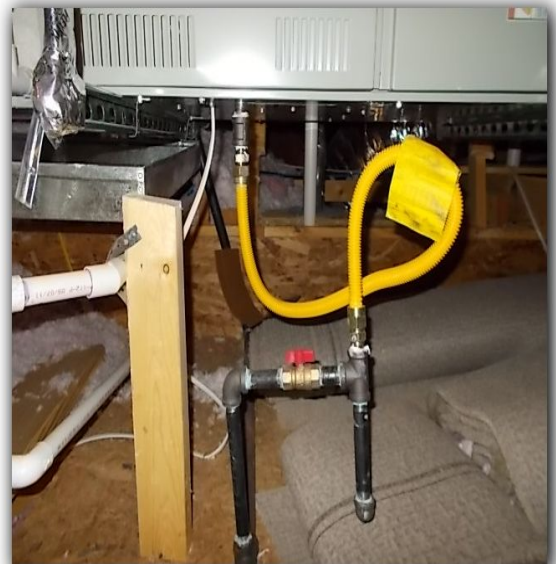
Samples of correct sediment trap installation.

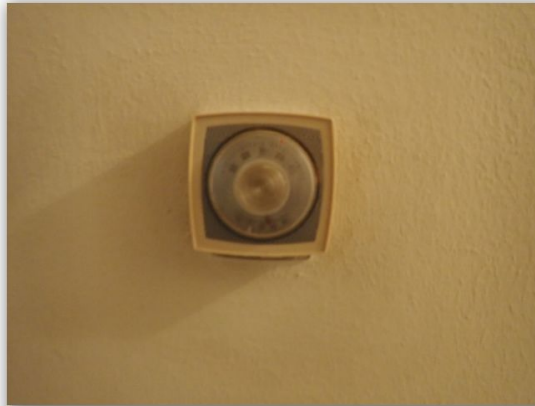
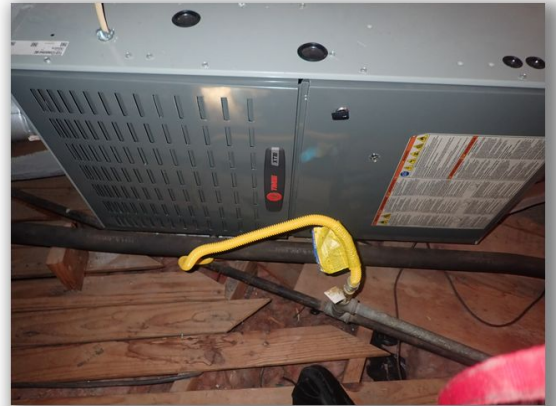
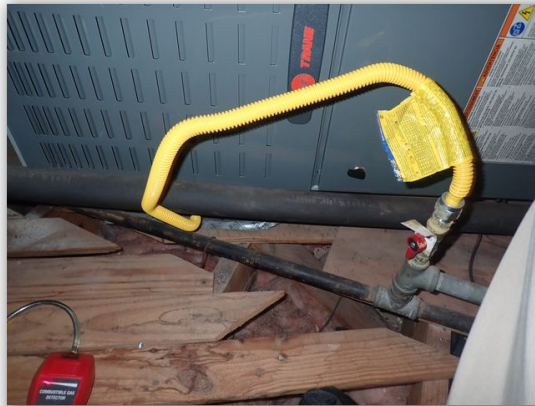
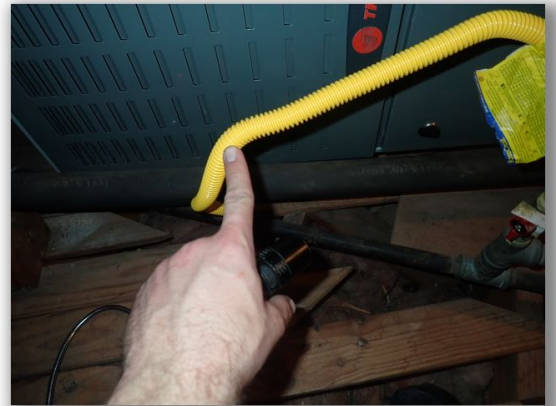
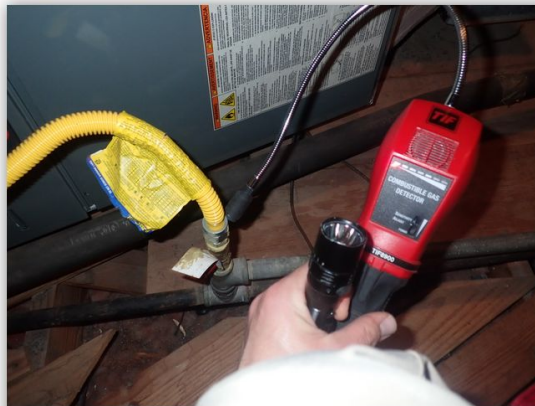
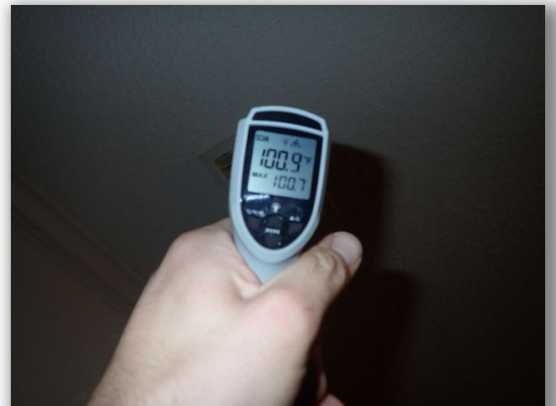
**Downstairs Central Heating System – Energy Source: Gas**  
**Brand Name: Unable To Determine**

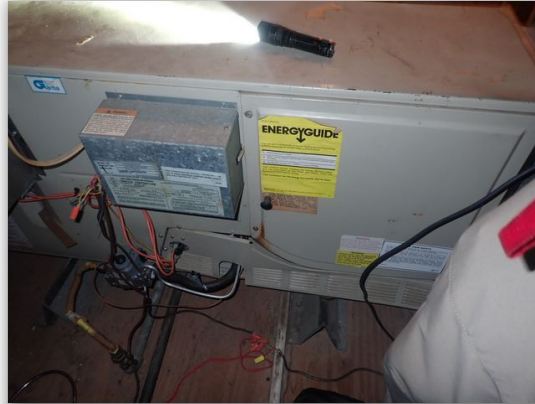
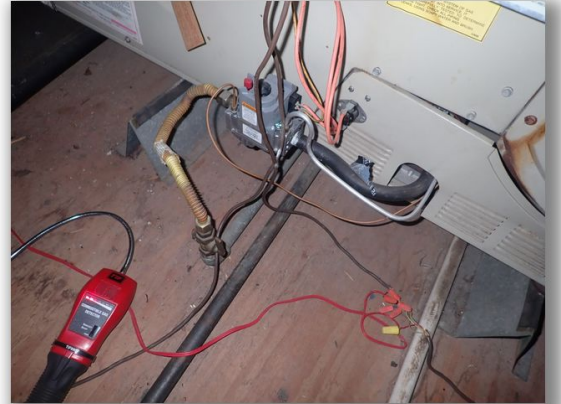
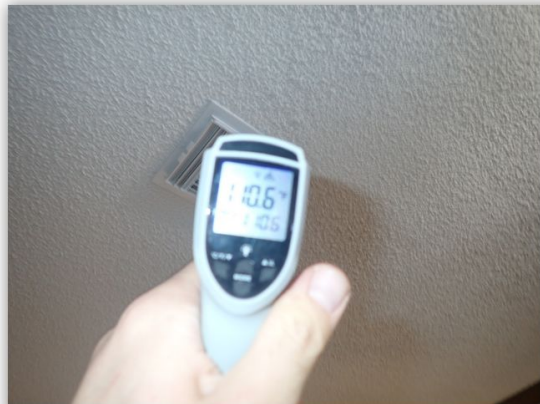
**Upstairs Central Heating System** – Energy Source: Gas  
Brand Name: Trane

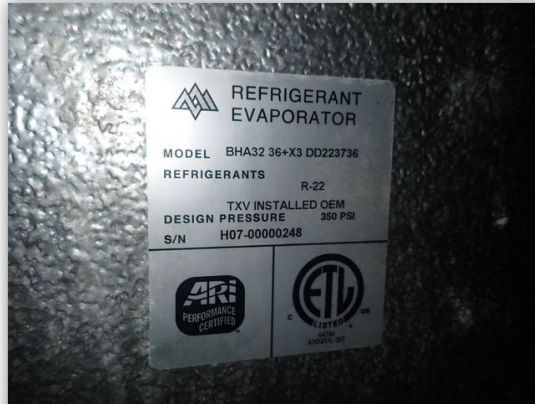
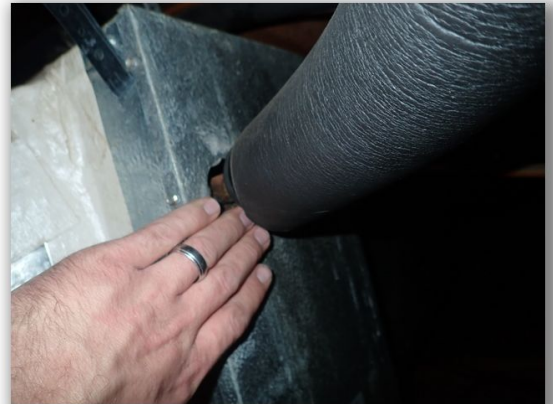
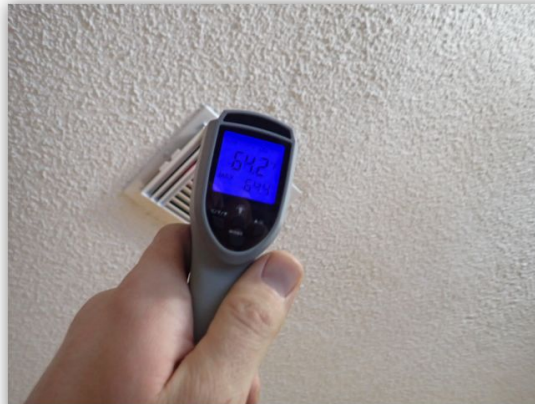
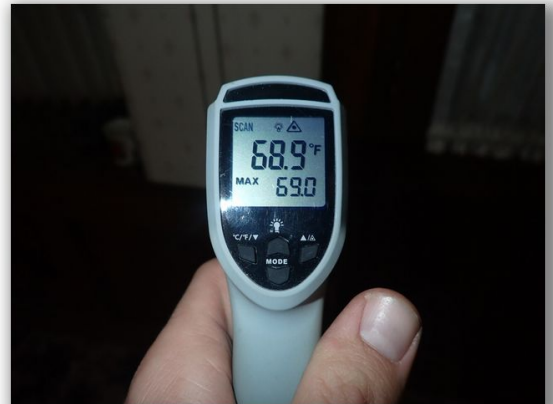
#### Downstairs Central Cooling System

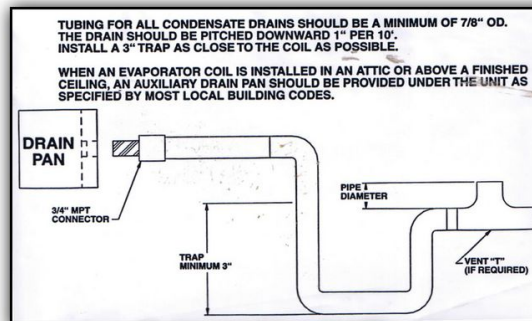
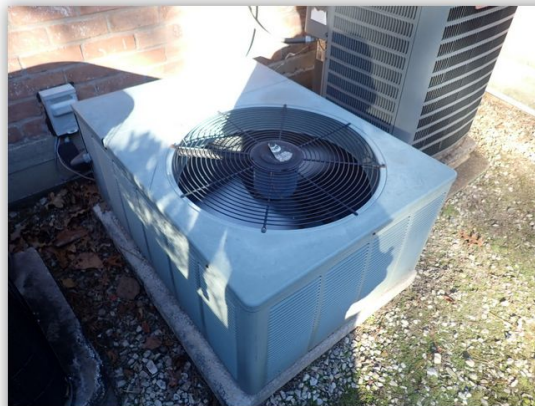
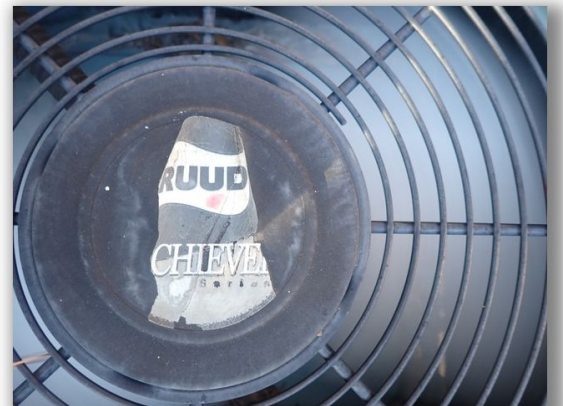
**Note:** Due to the limited nature of a general home inspection, it is possible that additional deficiencies will be discovered by a licensed technician. It is recommended to have the system serviced prior to the expiration of any option/warranty period.

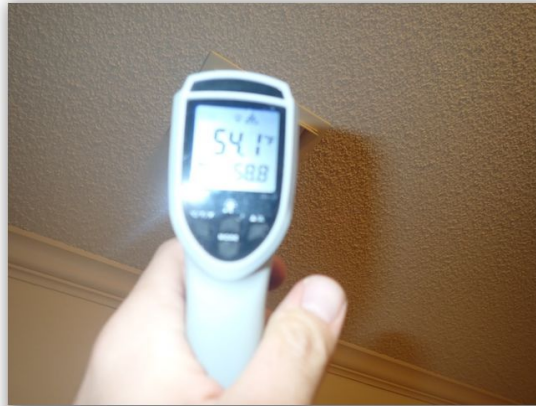
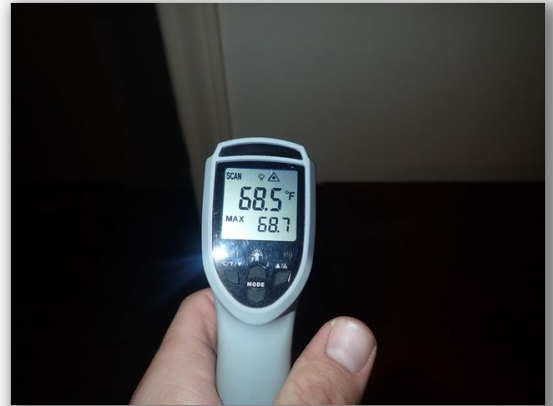
#### Upstairs Central Cooling System

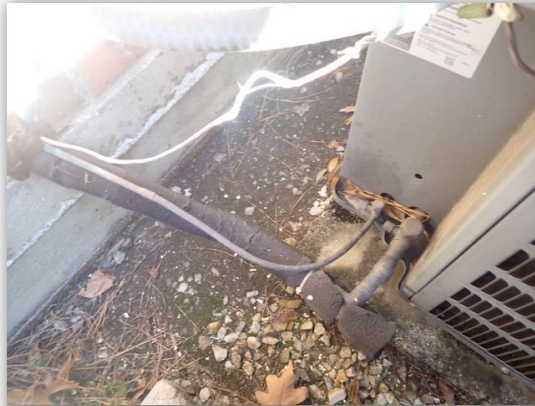
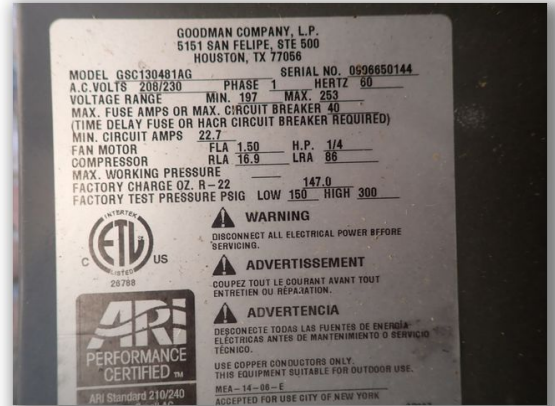
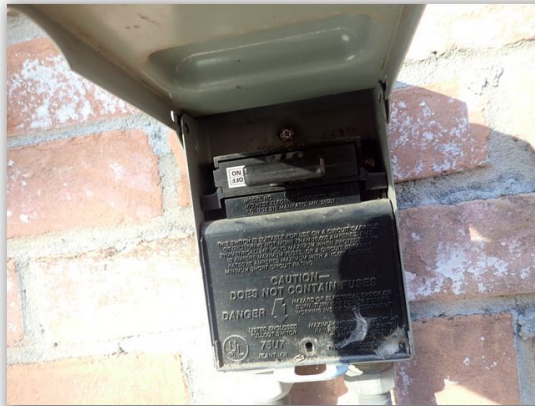
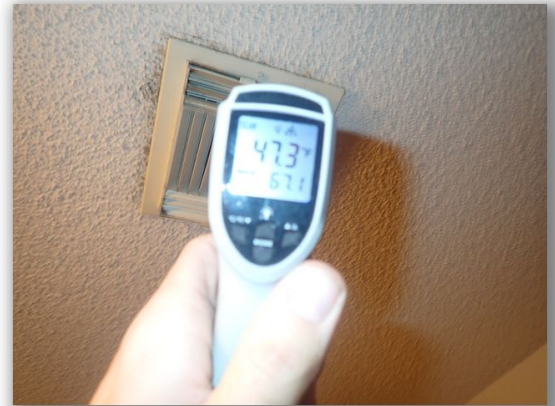
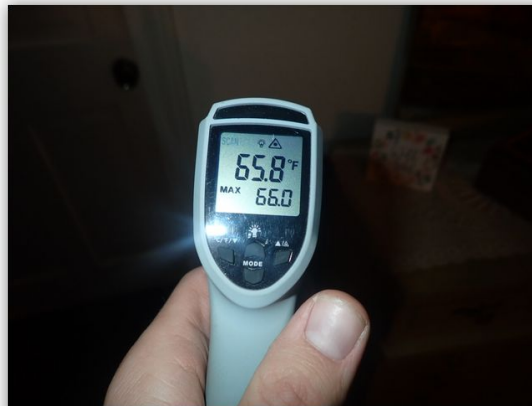
**Notice:** Temperature differential readings (Delta-T) are an accepted industry standard of practice for testing the proper operation of the cooling system. Our company policy normal acceptable range is considered approximately **between 15 to 20 degrees °F** total difference (Delta-T) measured between the return air and supply air within close proximity of the related coils of the system being evaluated. Conditions such as but not limited to; excessive humidity, high or low outdoor temperatures or restricted airflow may indicate abnormal operation even through the equipment is functioning basically as designed and occasionally may indicate normal operation in spite of an equipment malfunction. **The inspector will not be able to anticipate future events, conditions or changes in performance of any component or**

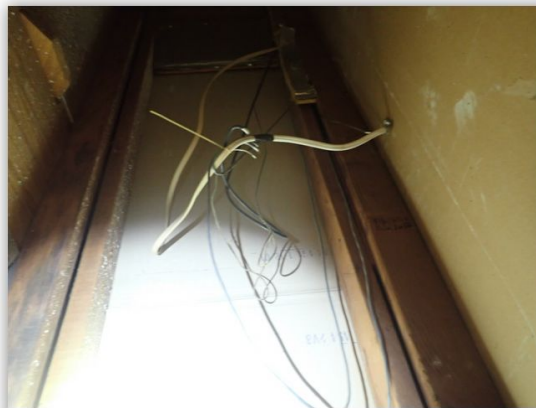
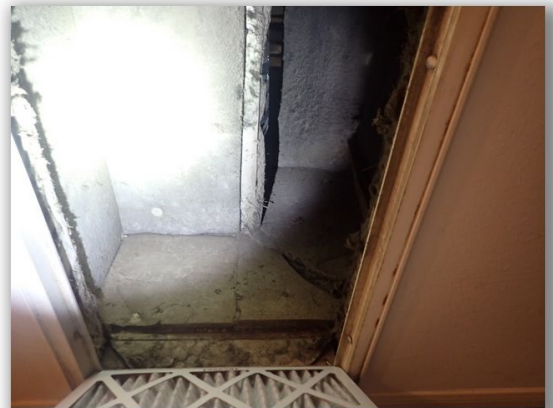
| I=Inspected | NI=Not Inspected | NP=Not Present | D=Deficient |

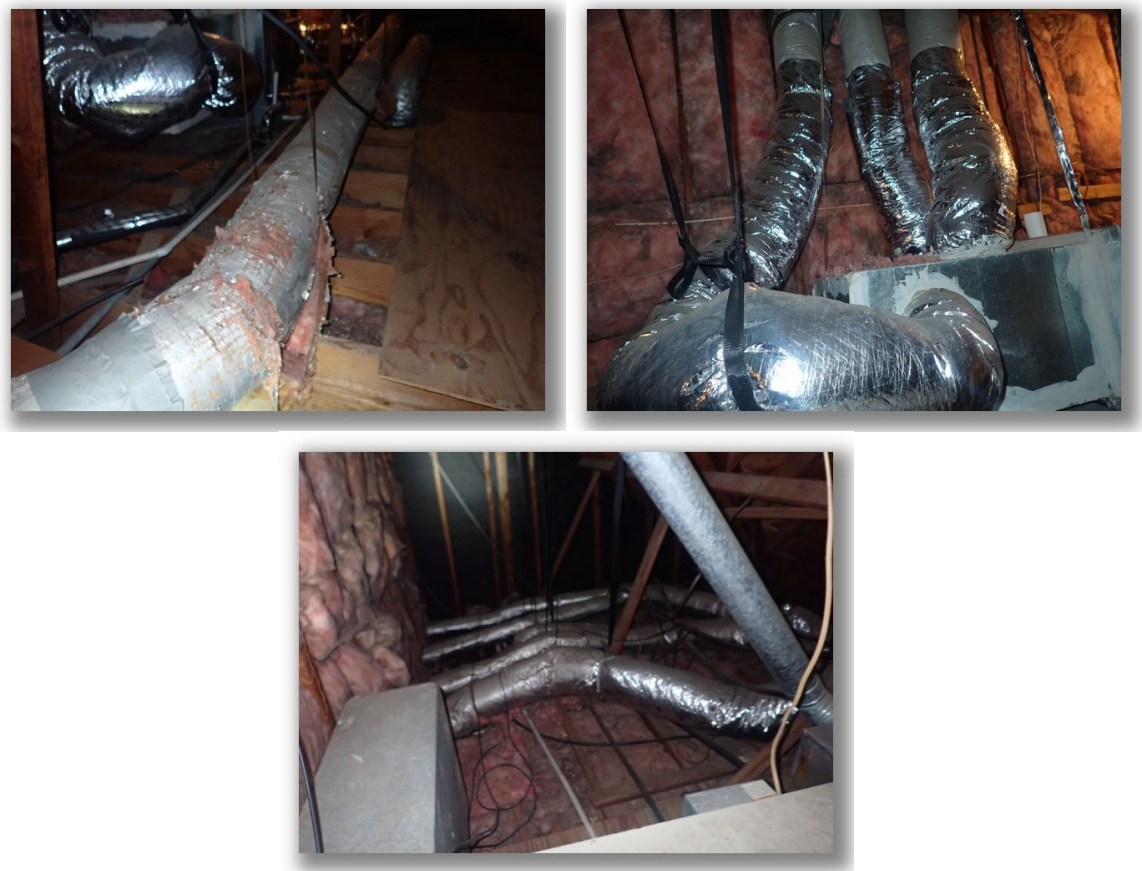
| I=Inspected | NI=Not Inspected | NP=Not Present | D=Deficient |
|---|---|---|---|
| I | NI | NP | D |

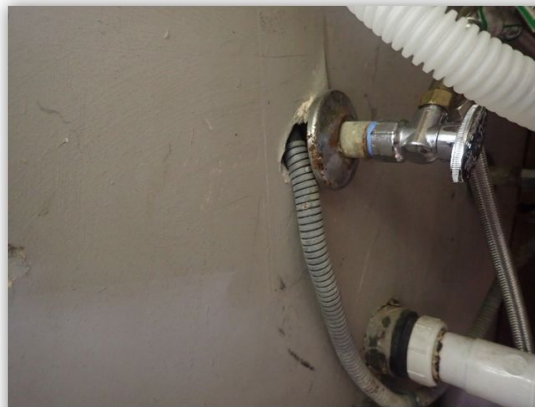
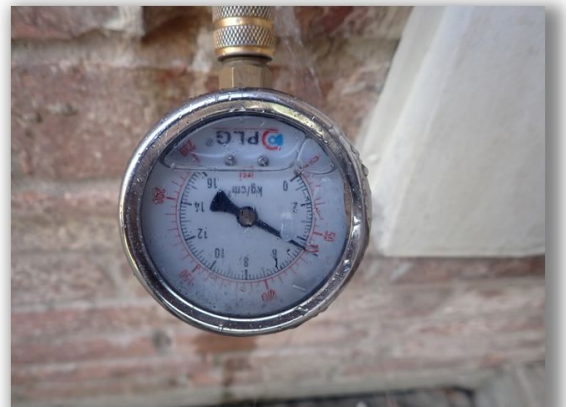
**Note:** Due to the limited nature of a general home inspection, it is possible that additional deficiencies will be discovered by a licensed technician. It is recommended to have the system serviced prior to the expiration of any option/warranty period.

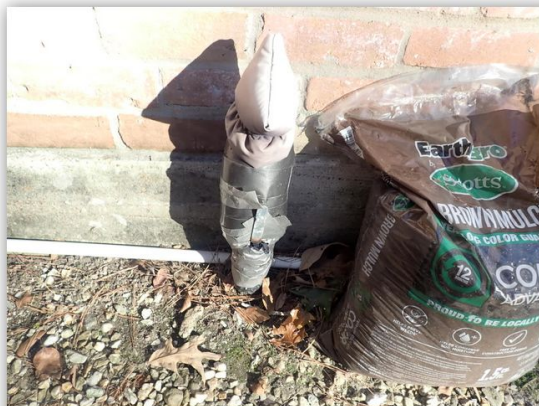
#### Exterior Faucets/Fixtures
