713-730-3151

[www.a-actionhouston.com](http://www.a-actionhouston.com)

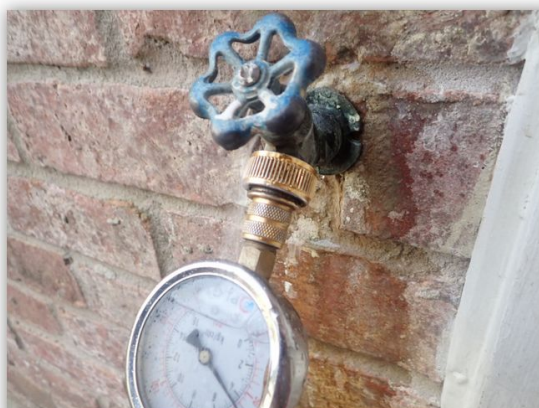
#### Laundry Connections

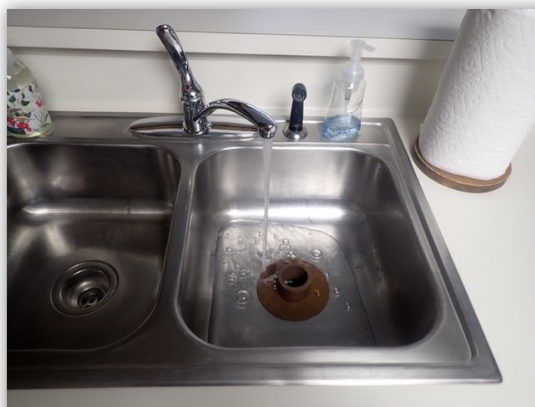
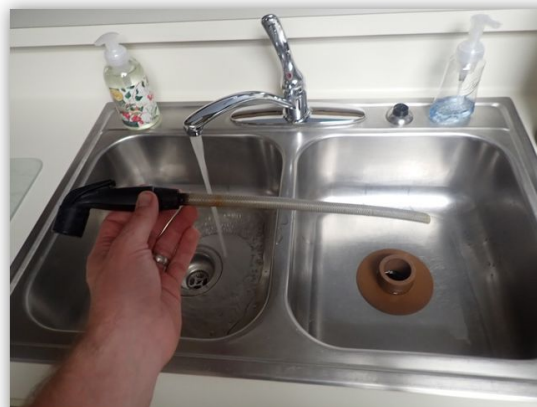
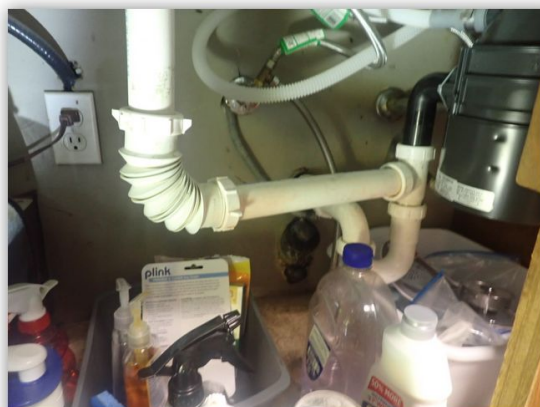
- The drain line is made of corrugated material. It is recommended to use smooth wall/PVC type material to prevent blockage.
- The sprayer head appears to be inoperative.

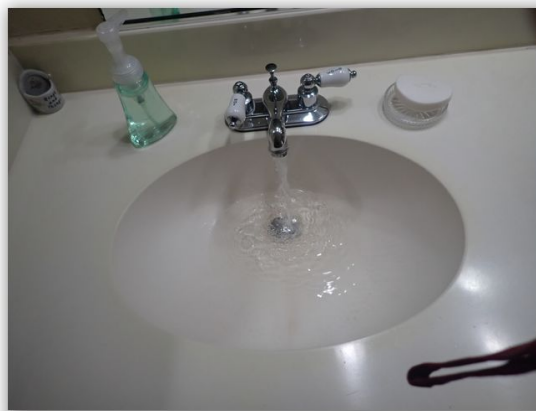
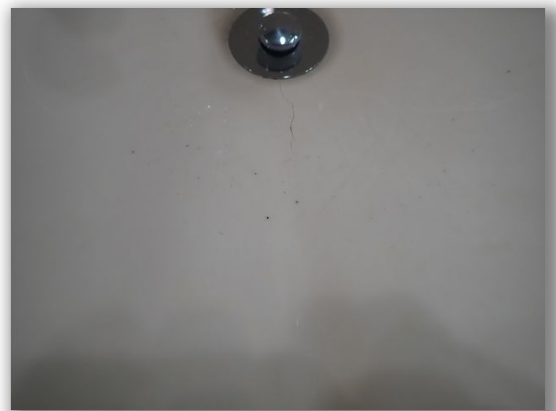
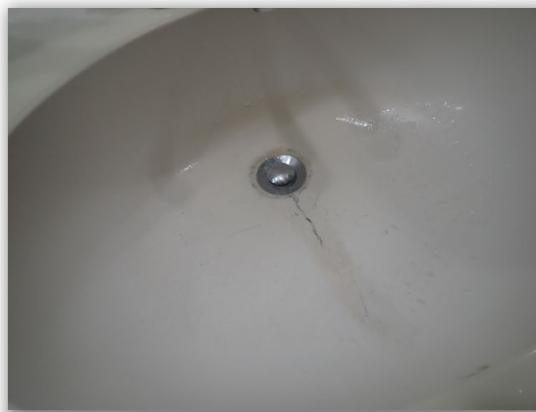
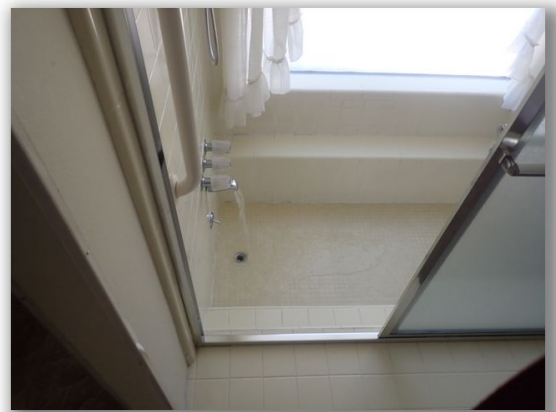
- The floor around the toilet is discolored indicating the toilet is or has leaked near the drain. Recommend further evaluation.

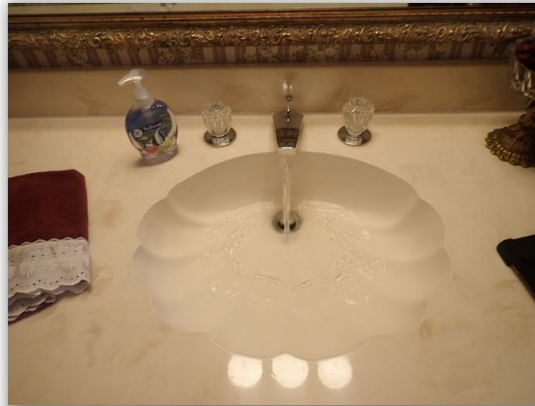
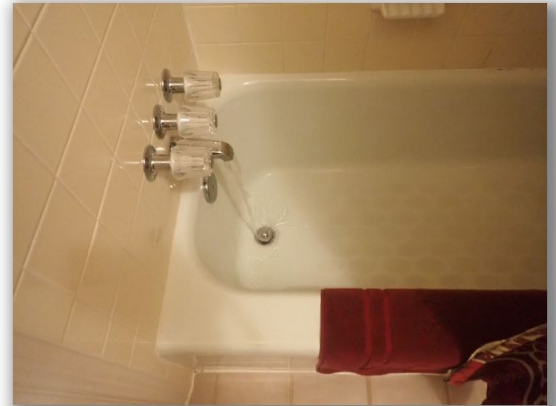
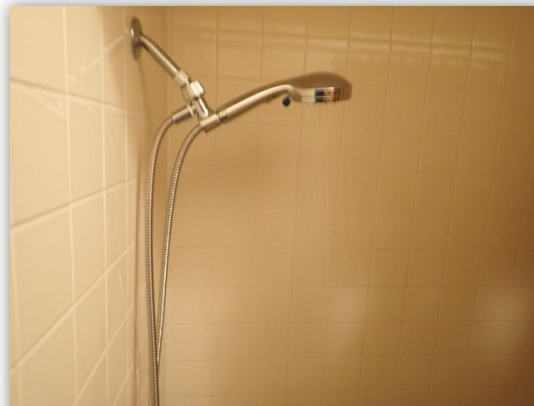
### **Laundry Sink**

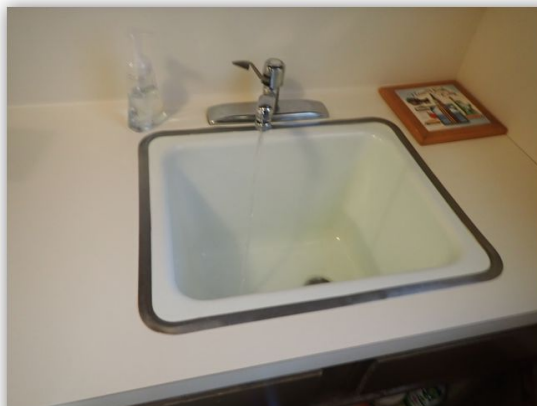
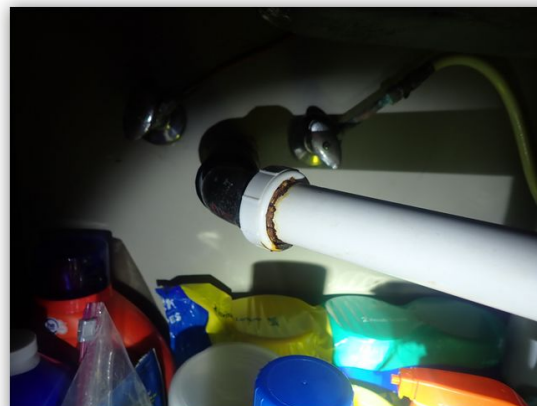
**Bath Between Rooms – “Jack & Jill Bath”**

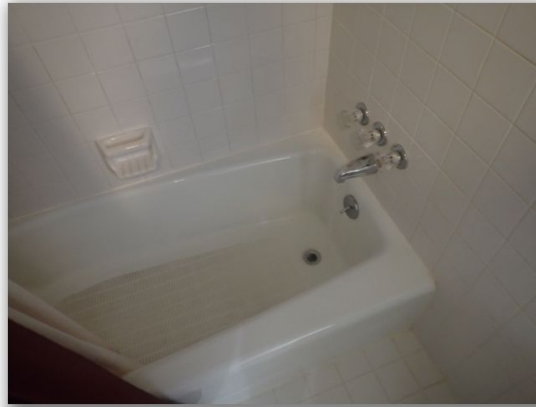
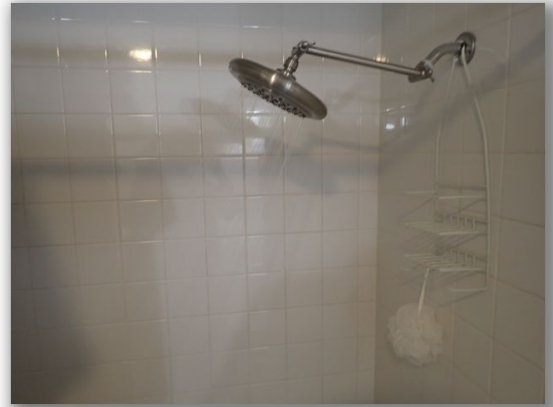
**Notice:** The Inspector has attempted to discover and report conditions requiring further evaluation or repair. However; determining the condition of any component that is not visible and/or accessible, such as plumbing components that are buried, beneath the foundation, located within construction voids or otherwise concealed, and reporting any deficiency that does not appear or become evident during our limited cursory and visual survey is outside the scope of this inspection. **The inspector will not be able to anticipate future events, conditions or changes in performance of any component or system due to changes in use or occupancy. The inspector makes no guarantee or warranty, express or implied, as to future performance of any item, system or component.**

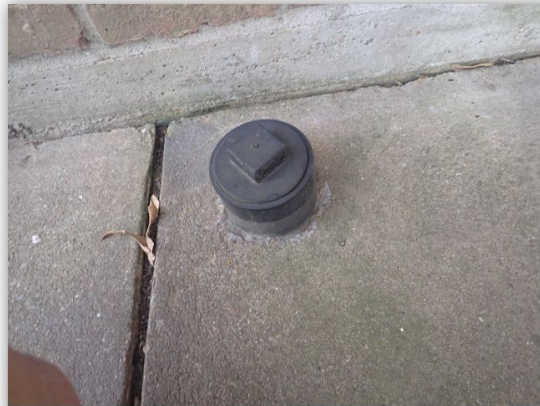
**Notice:** Reporting the condition of drains, wastes and vent piping that is not completely visible and/or accessible or; reporting any defect or deficiency that requires extended use of the system to develop or does not become evident during our limited cursory and visual survey is outside the scope of the inspection. This is a limited cursory and visual survey of the accessible general conditions and circumstances present at the time of this inspection. Opinions are based on general observations made

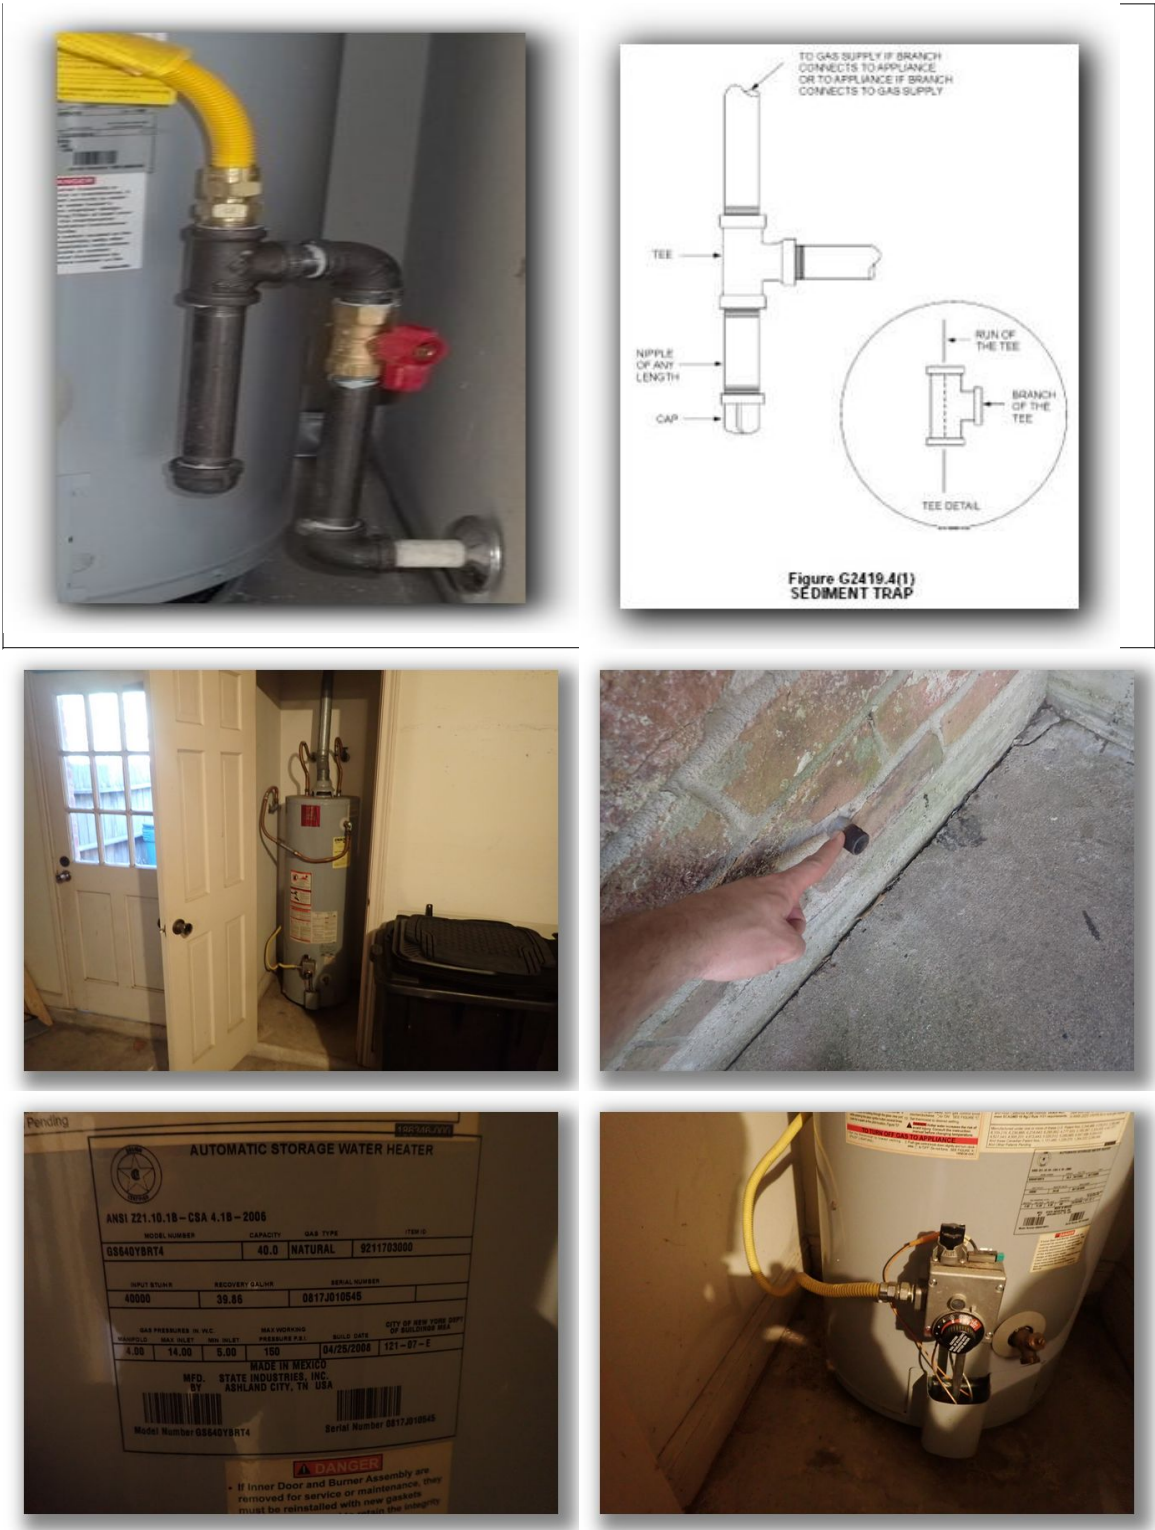
| I=Inspected | NI=Not Inspected | NP=Not Present | D=Deficient |
|---|---|---|---|
| I | NI | NP | D |

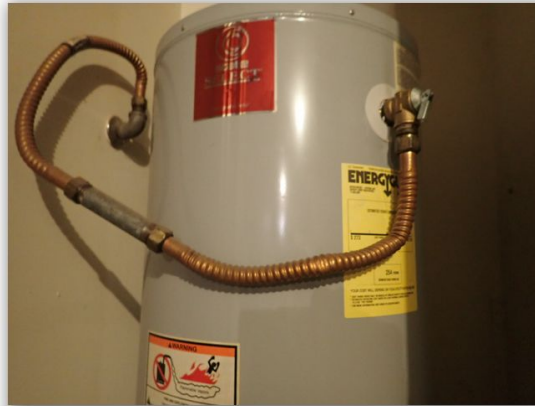
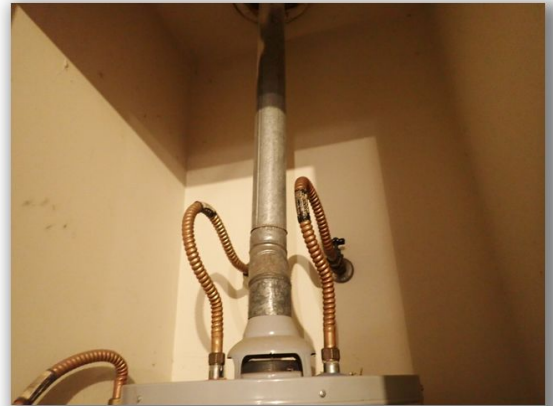
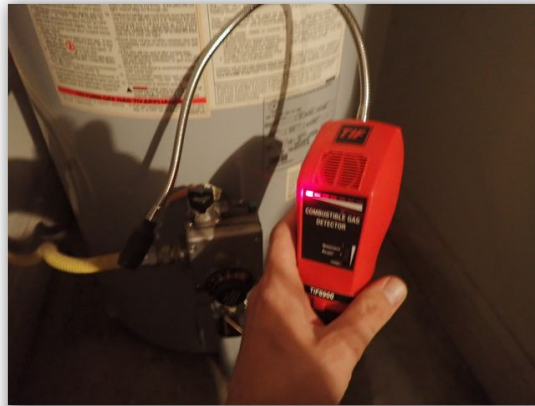
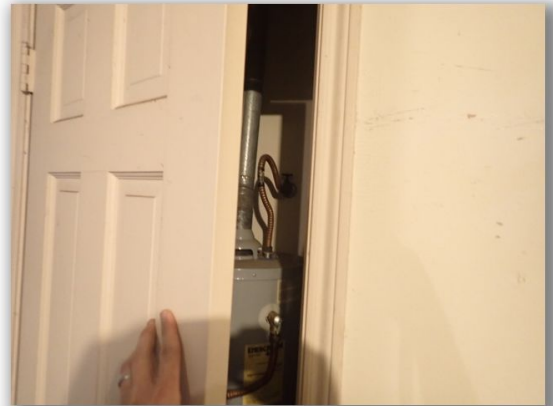
**Water Heater** – Energy Source: **Gas**

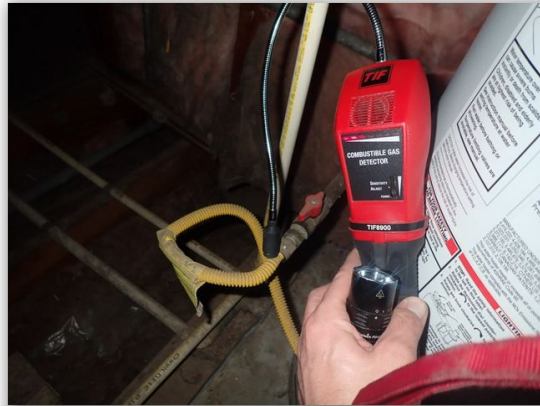
| <input type="checkbox"/> | <input checked="" type="checkbox"/> | <input checked="" type="checkbox"/> | <input type="checkbox"/> |

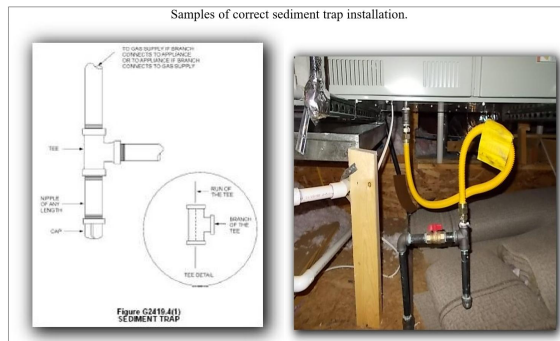
Samples of correct sediment trap installation.

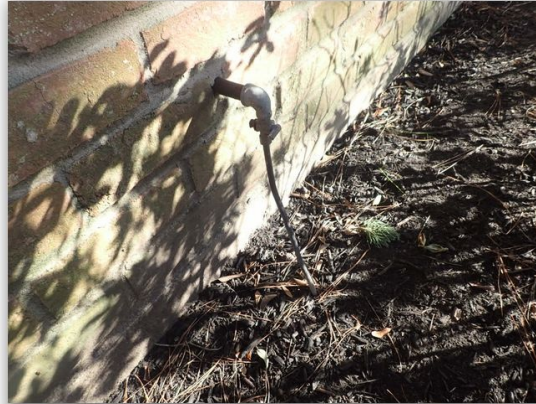
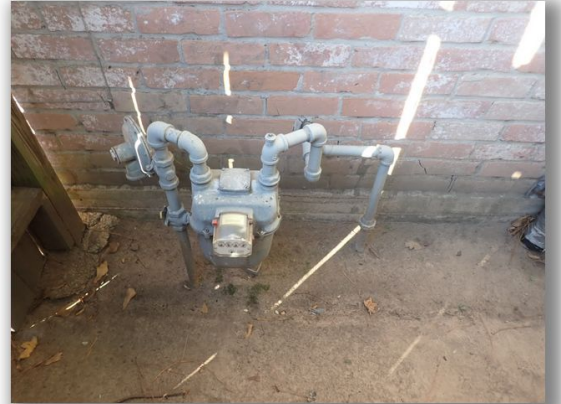
**Notice:** The Inspector will use a combustible gas leak detector on accessible gas lines, joints, unions and connectors and report visible deficiencies found at the time and date of the inspection. The inspector inspects the gas lines from the point they enter the structure and will complete the inspection without digging, damaging property, permanent construction or building finish. When performing the inspection, the inspector will keep in consideration the age of the system and normal wear and tear from ordinary use when rendering opinions.

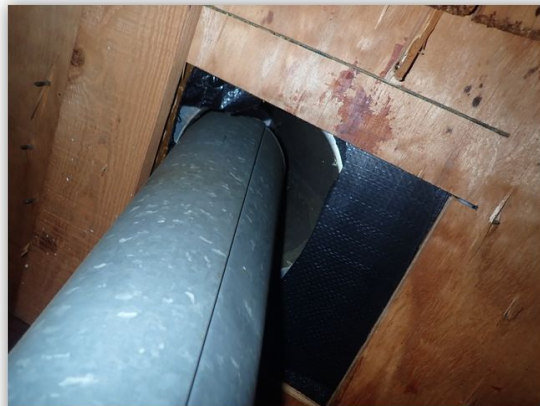
- The ducting to one of the mechanical exhaust fans was observed to be separated in the attic area.

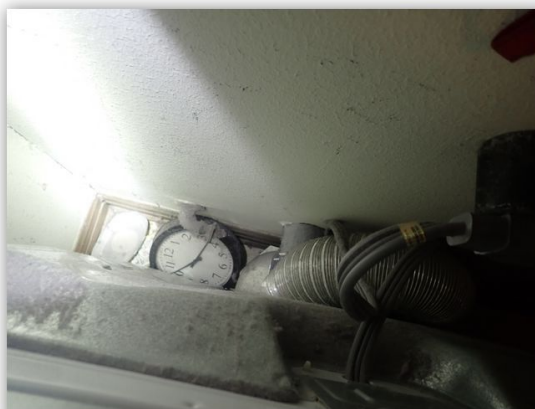
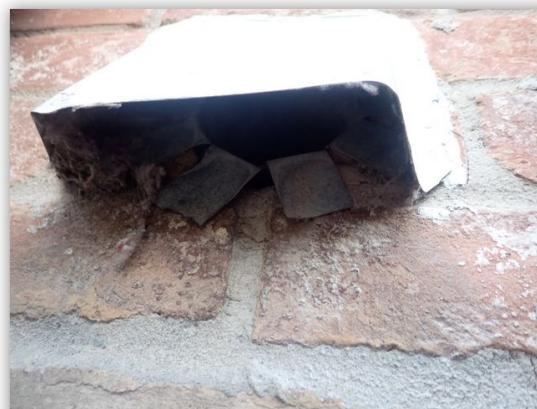
- The dryer duct termination is not equipped with a backdraft damper. This condition does not meet current installation standards and should be corrected as necessary.

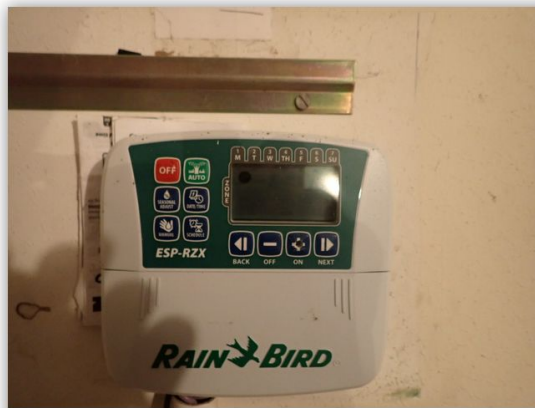
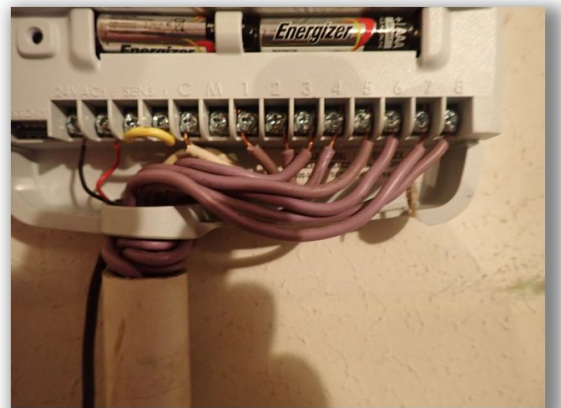
| I=Inspected | NI=Not Inspected | NP=Not Present | D=Deficient |

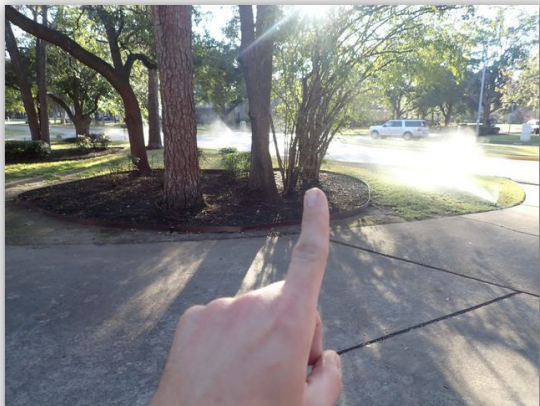
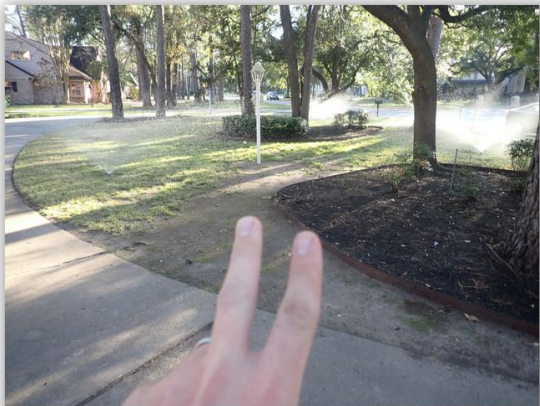
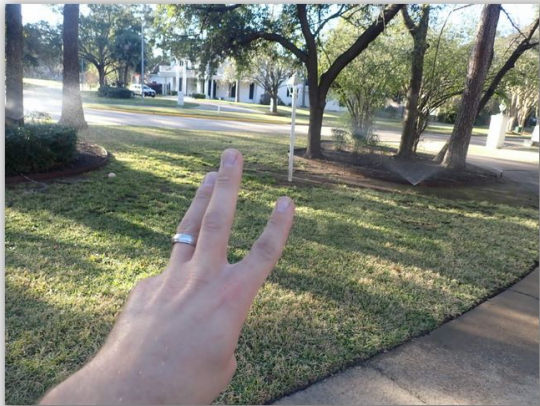
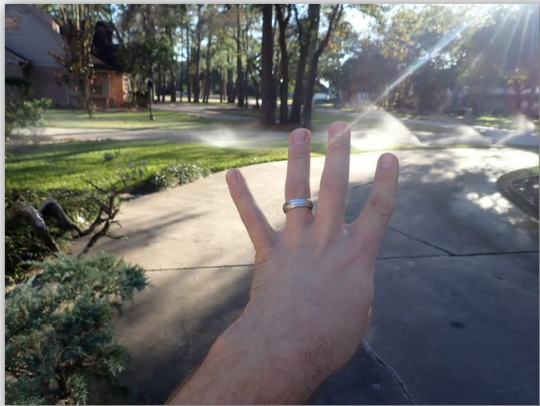
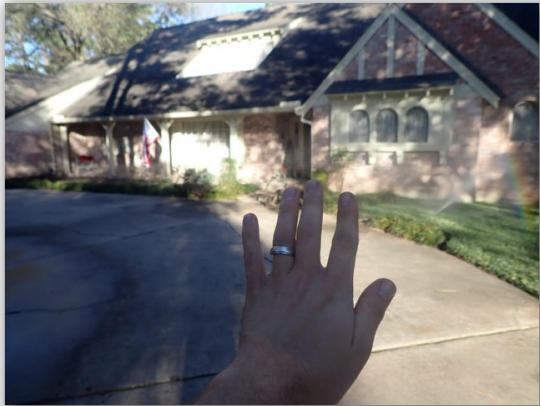
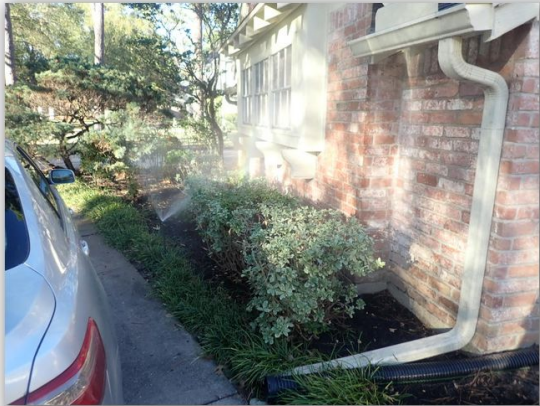
| I=Inspected | NI=Not Inspected | NP=Not Present | D=Deficient |
|---|---|---|---|
| I | NI | NP | D |

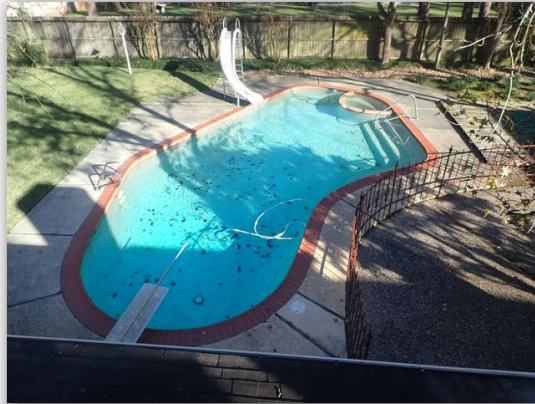
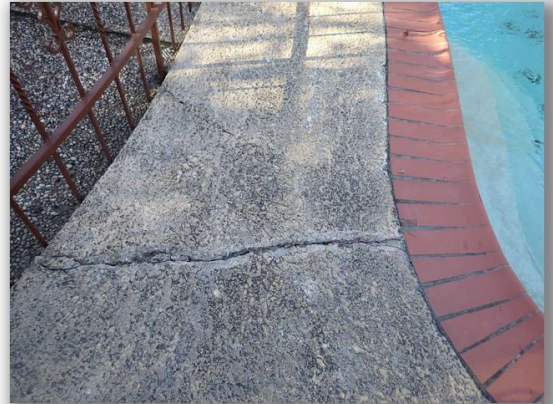
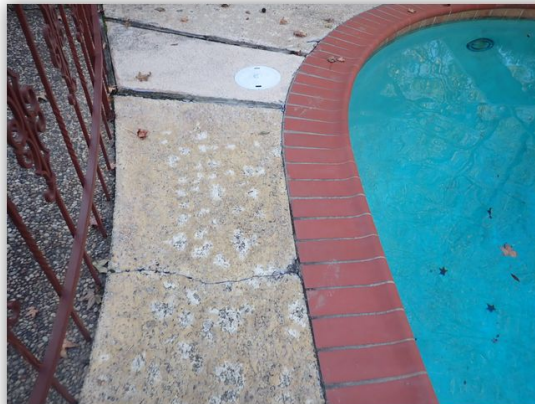
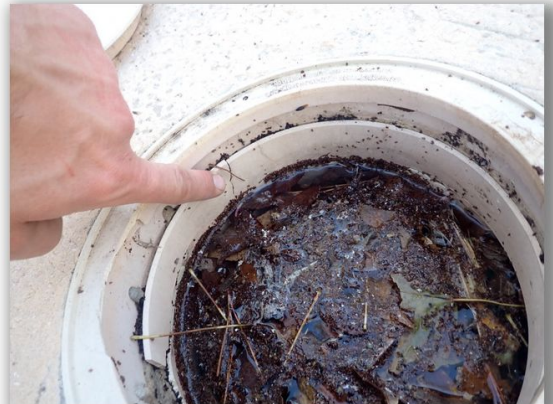
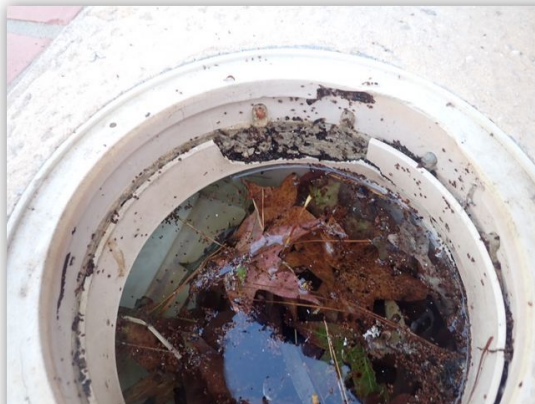
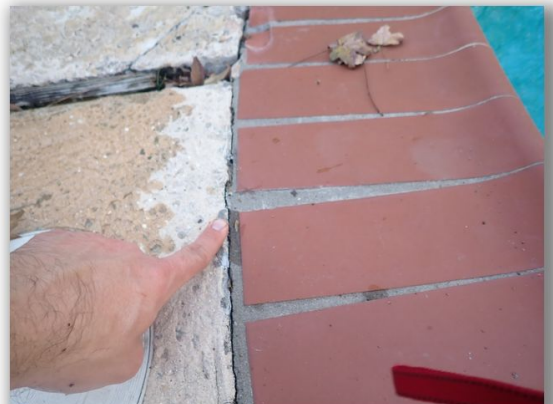
| I=Inspected | NI=Not Inspected | NP=Not Present | D=Deficient |

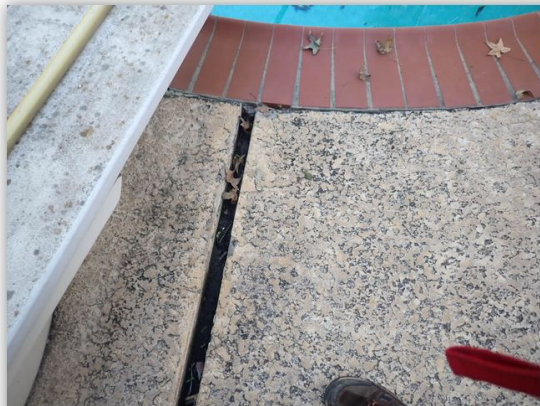
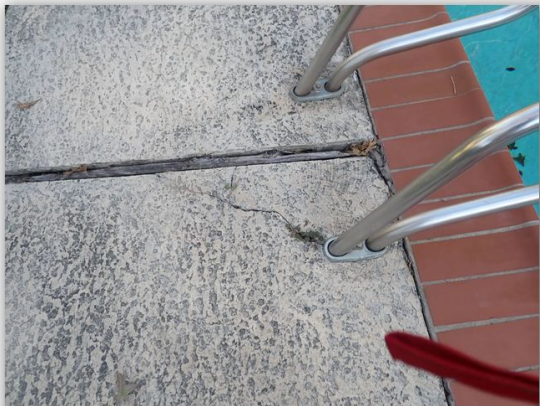
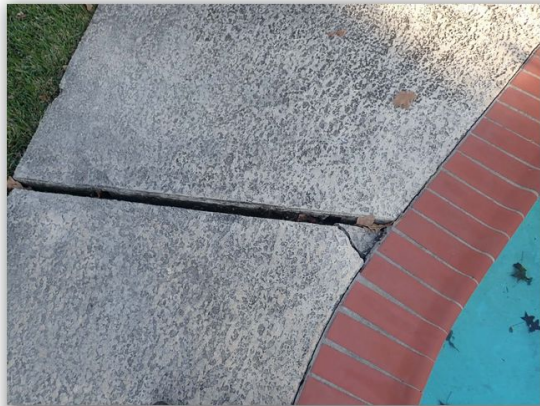
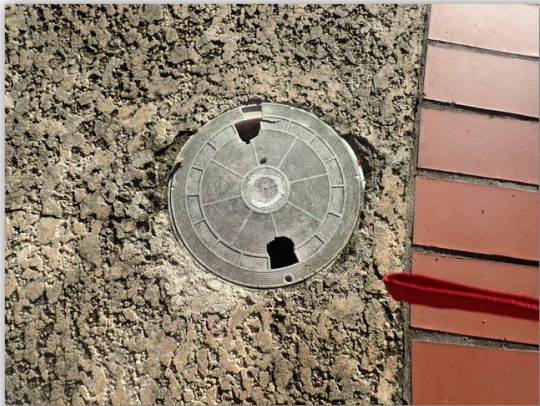
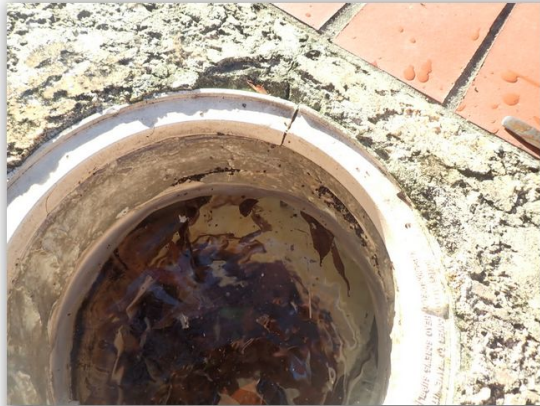
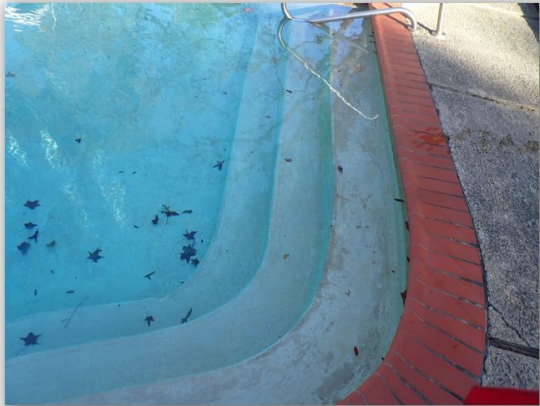
| I=Inspected | NI=Not Inspected | NP=Not Present | D=Deficient |
|---|---|---|---|
| I | NI | NP | D |

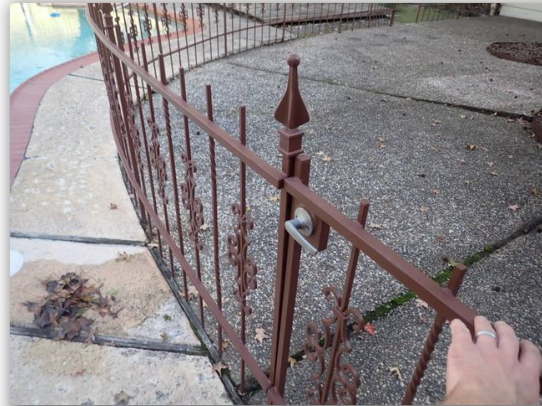
**Notice:** Based on what we were able to observe and our experience with swimming pool, spa and hot tub technology, we submit this inspection report based on the present condition, working under current use and habits of the current occupants of the residence. When performing the inspection, the inspector will keep in consideration the age of the system and normal wear and tear from ordinary use when rendering opinions. All of the pool or spa systems and associated components are inspected and operated in the manual / service settings only. Operating the pool components from indoor control panels or handheld remotes are outside the scope of this inspection.

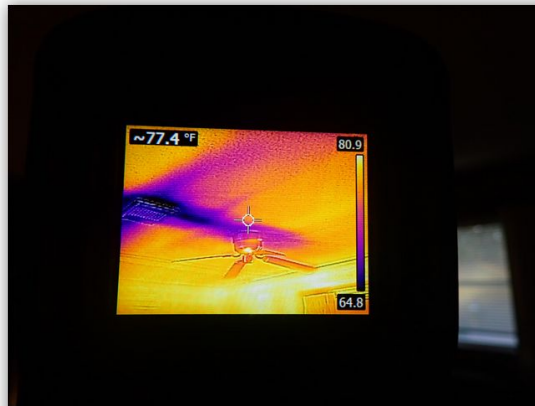
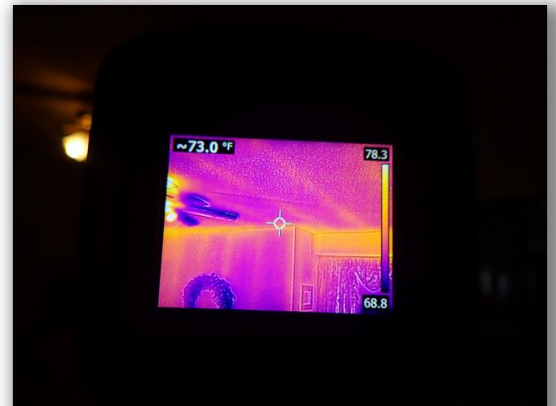
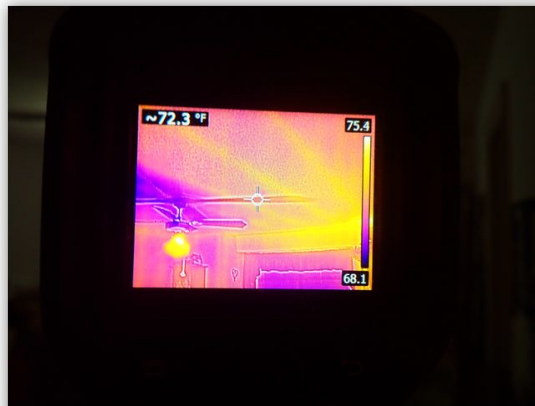
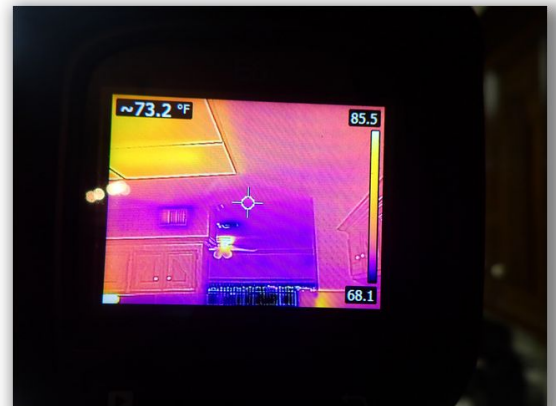
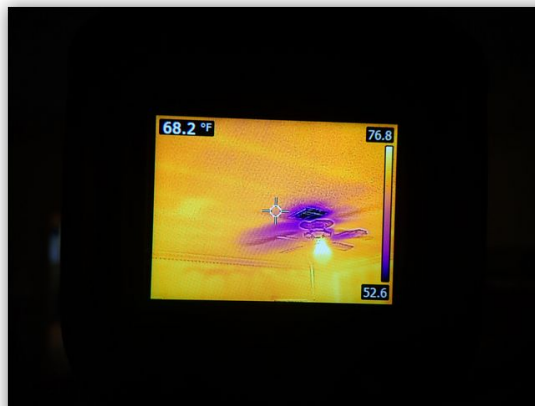
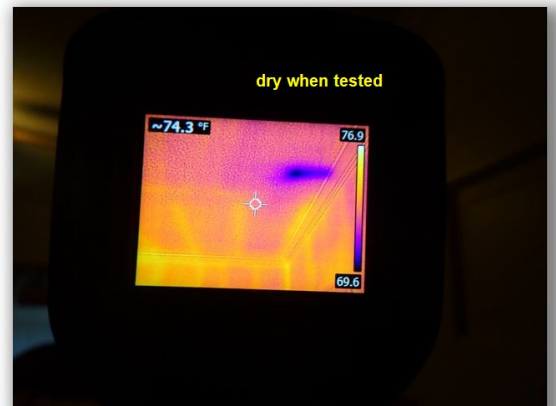
I=Inspected      NI=Not Inspected      NP=Not Present      D=Deficient

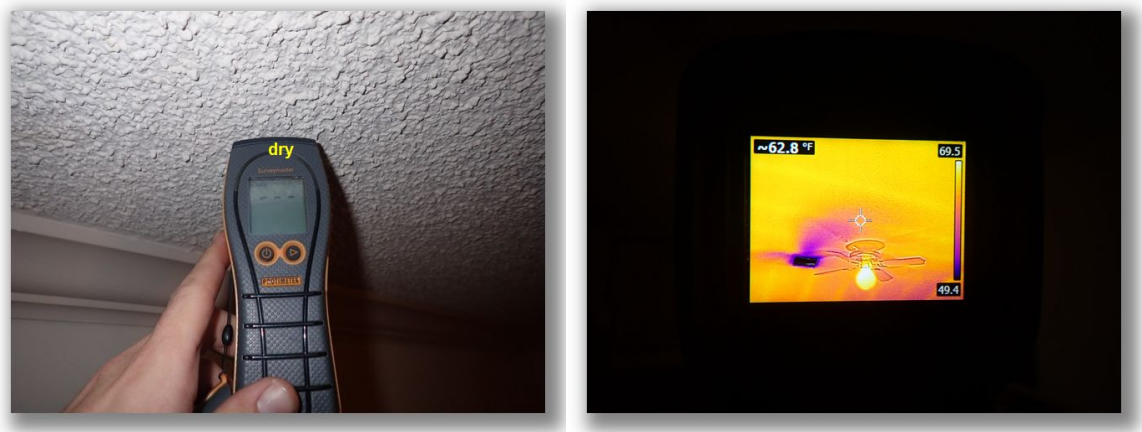
**INSPECTION AGREEMENT**  
**PLEASE READ THIS AGREEMENT CAREFULLY BEFORE SIGNING**

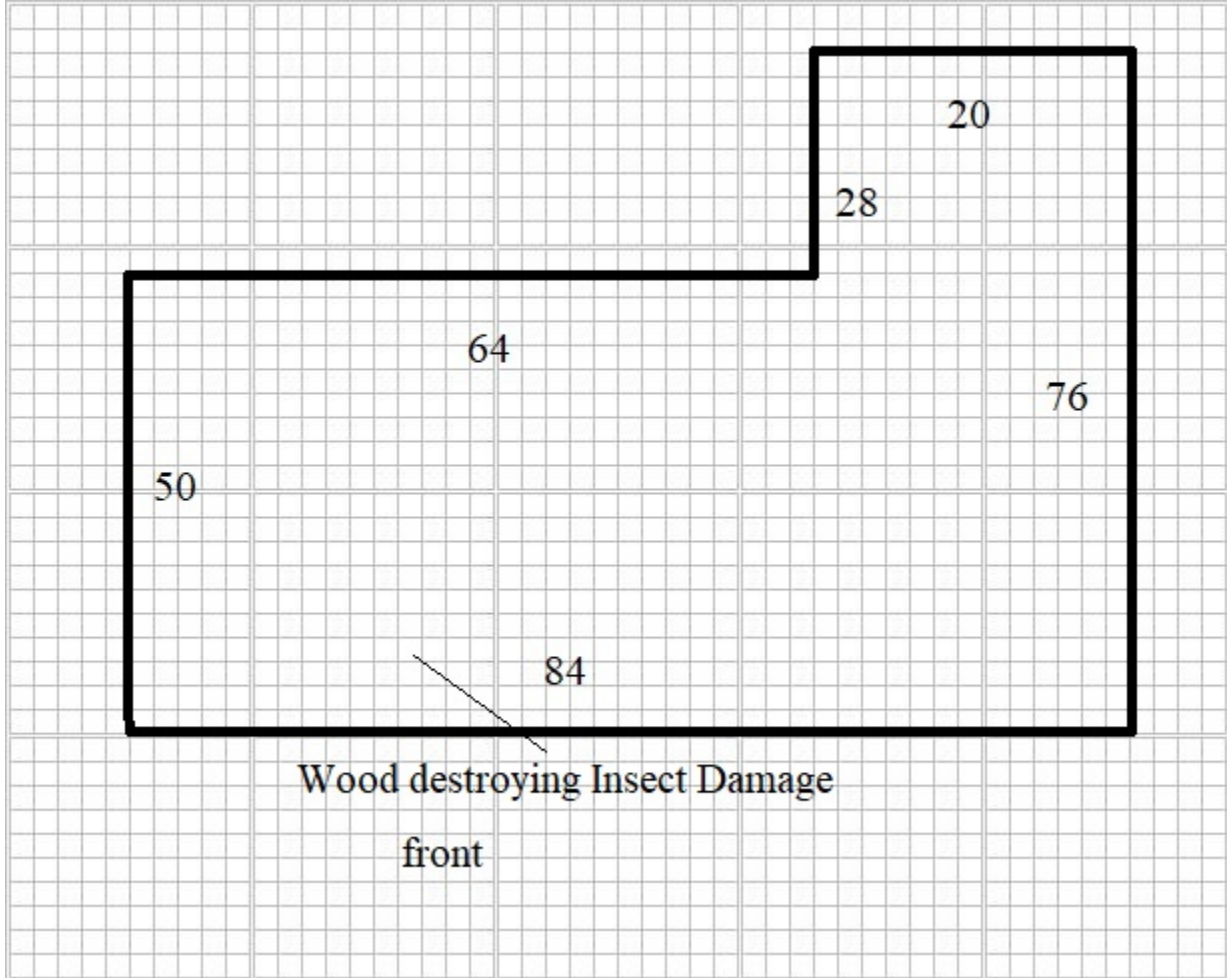
Additional Comments There is visible evidence of a previous Wood Destroying insect infestation at the time of this inspection without signs of previous treatment or records of previous treatment. Treatment is recommended at this time. See diagram for location(s).

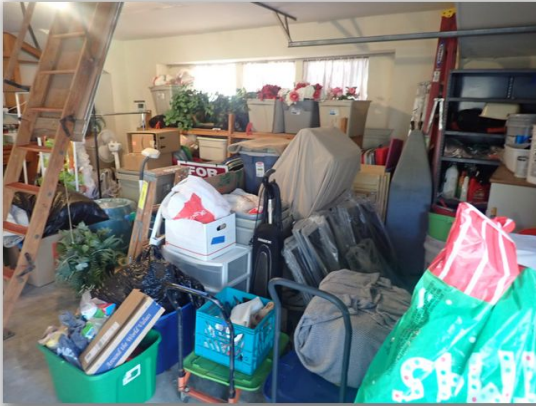
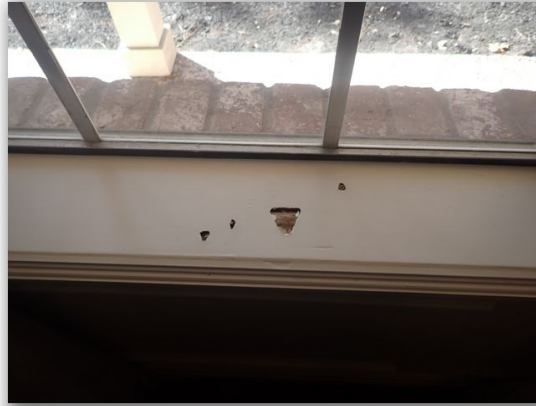
# TEXAS OFFICIAL WOOD DESTROYING INSECT REPORT
