713-730-3151

[www.a-actionhouston.com](http://www.a-actionhouston.com)

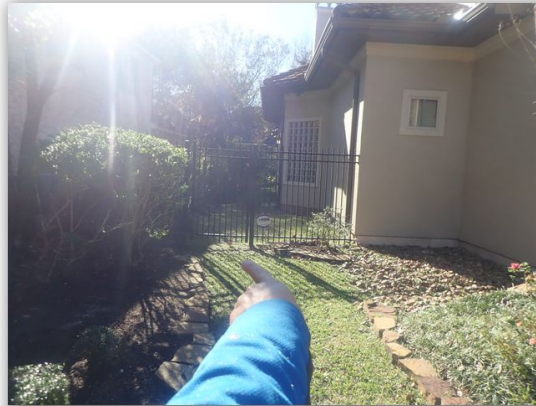
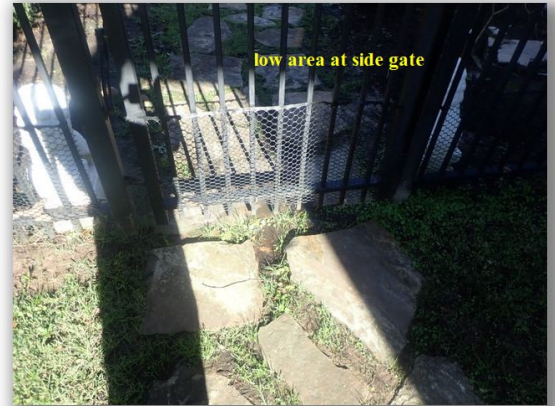
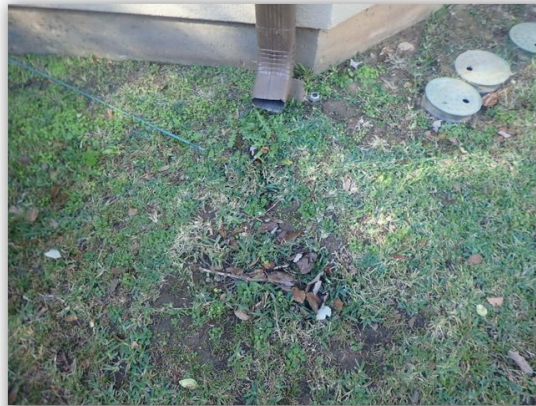
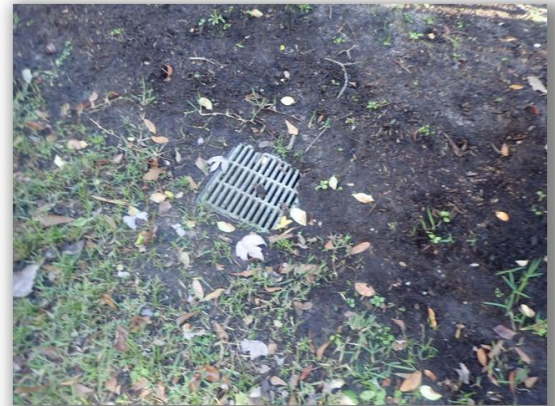
#### Gutter & Downspout System

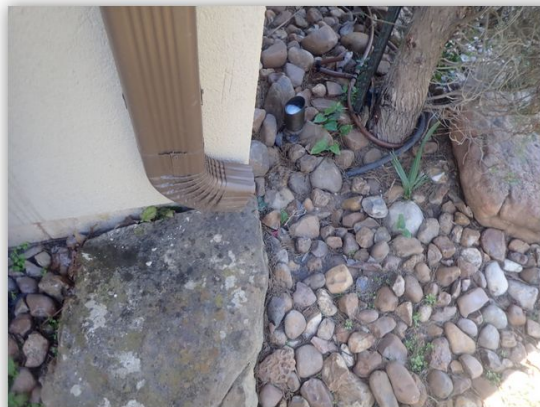
**Note:** The gutter downspouts should discharge water at least thirty-six inches (36") away from the foundation perimeter beam. Storm water should be encouraged to flow away from the structure at the points of discharge.

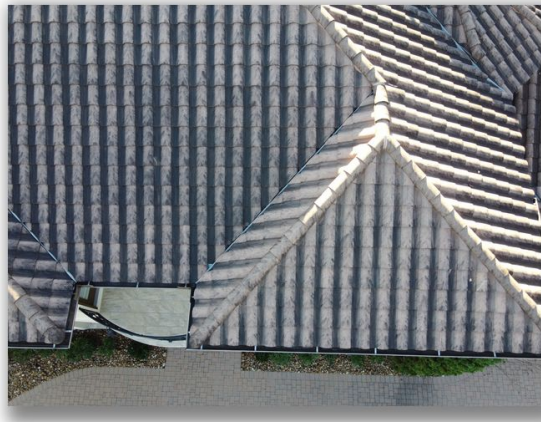
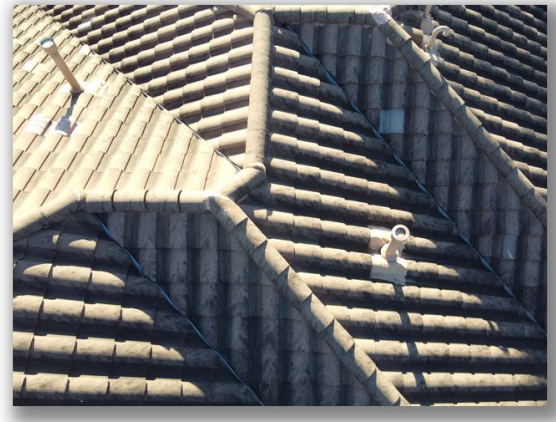
**Note:** The inspector inspected the roof with a drone due to the height and structure type. The drone will help identify major issues but cannot detect the smaller deficiencies that can be identified by walking the structure.

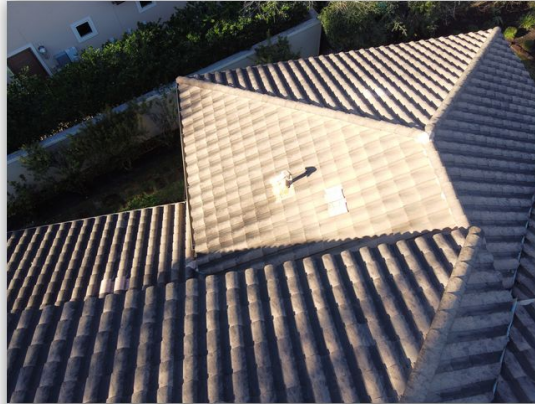
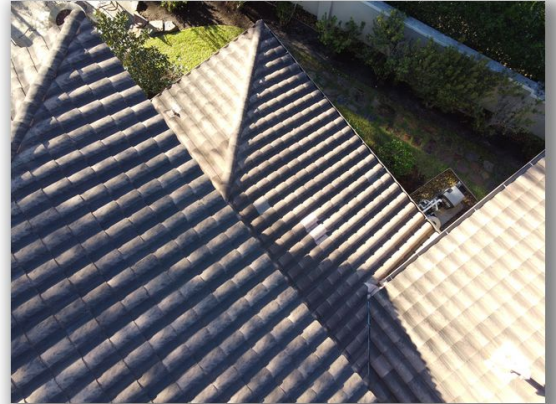
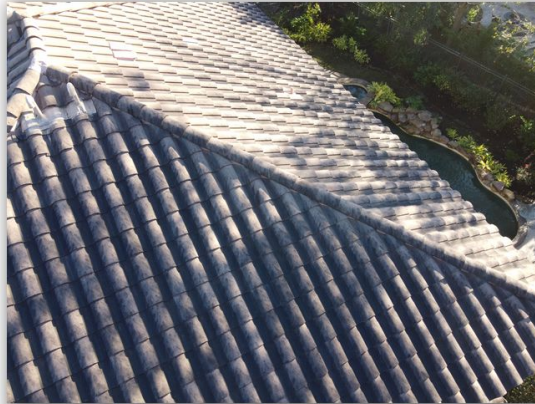
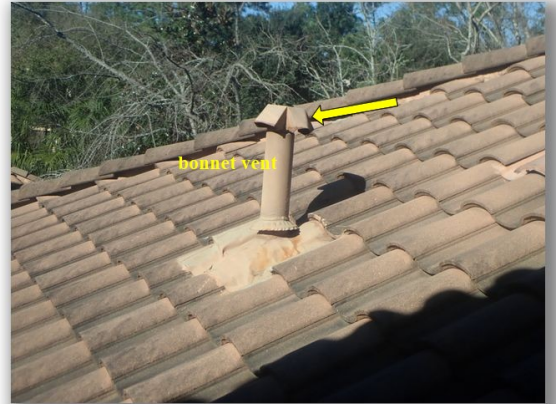
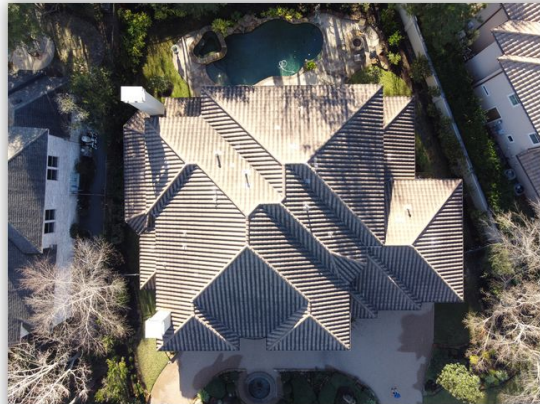
**Notice:** Life expectancy of the roofing material is not covered by this property inspection report. If any concerns exist about the roof covering life expectancy or potential for future problems, a roofing specialist should be consulted. The Inspector cannot offer an opinion or warranty as to whether the roof has leaked in the past, leaks now, or may be subject to future leaks, either expressed or implied.

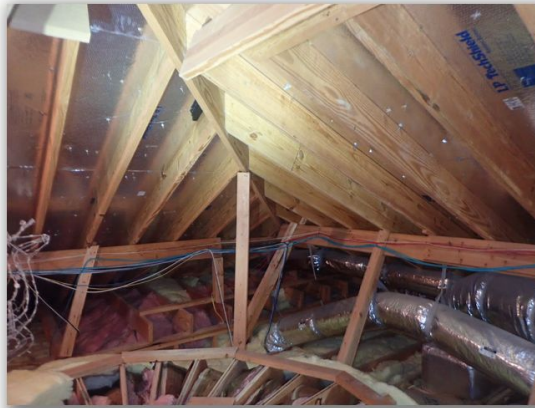
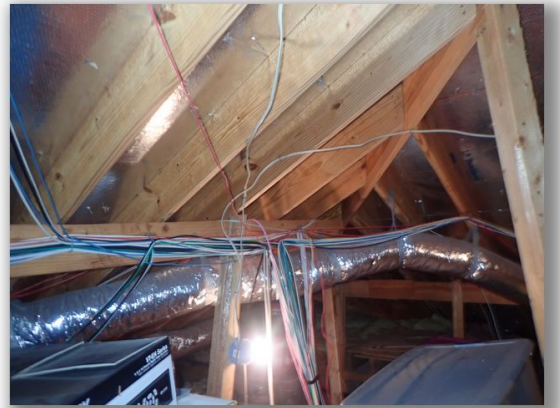
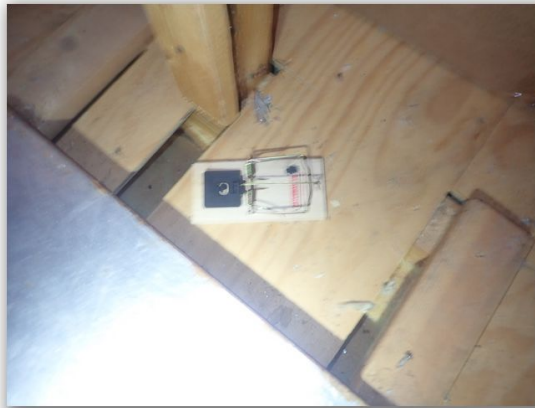
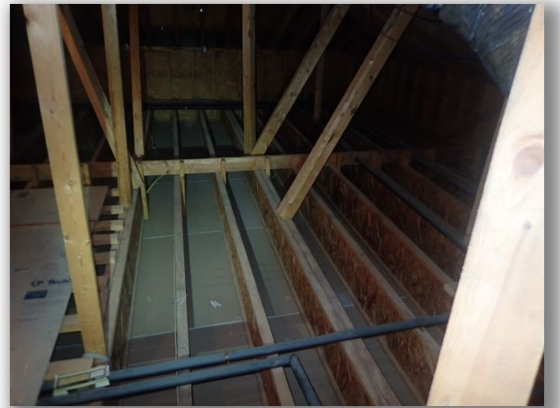
**Note:** Visible evidence of rodent activity was observed in the attic area. It is recommended to have a Certified Pest Control Operator further evaluate this condition and make corrections as necessary.

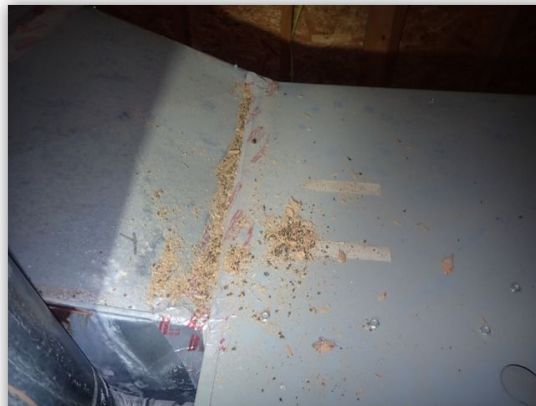
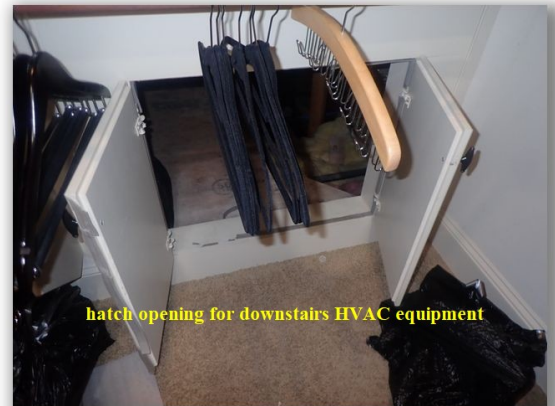
#### Attic Ventilation

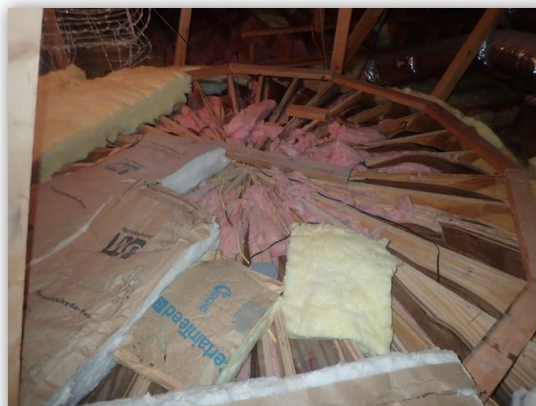
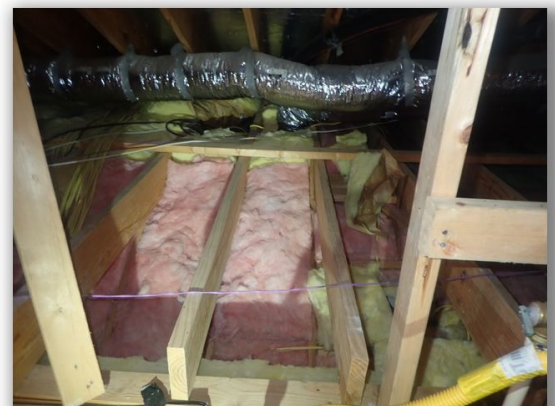
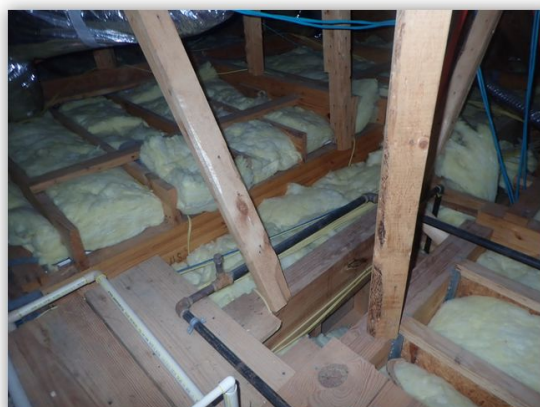
All components were found to be performing and in satisfactory condition on the day of the inspection.

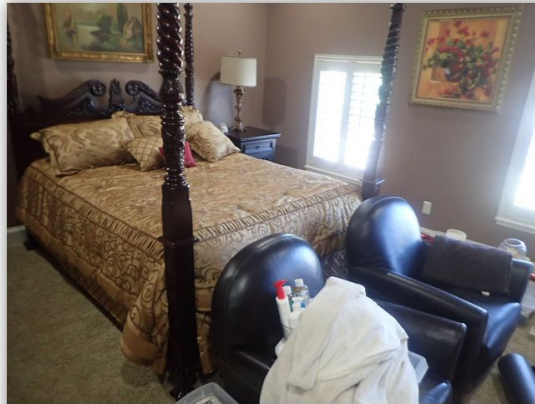
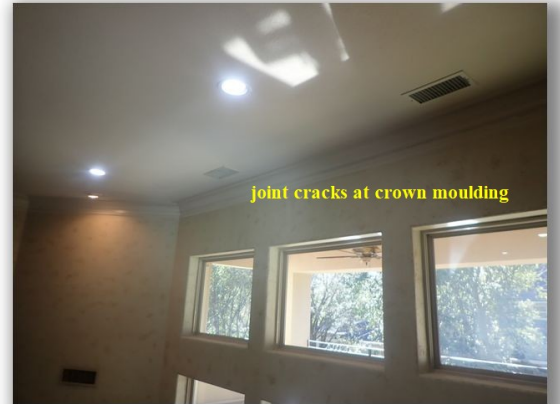
#### Stucco (Hard Coat or EIFS) Observation and Opinions

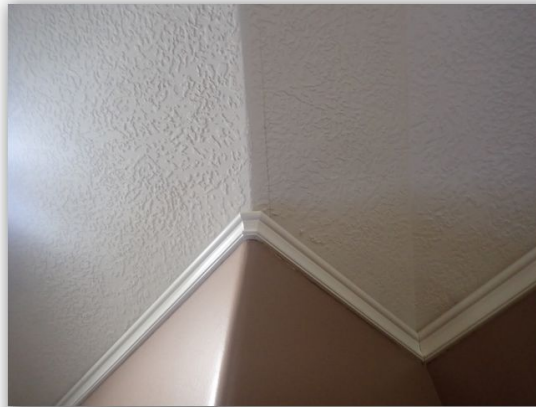
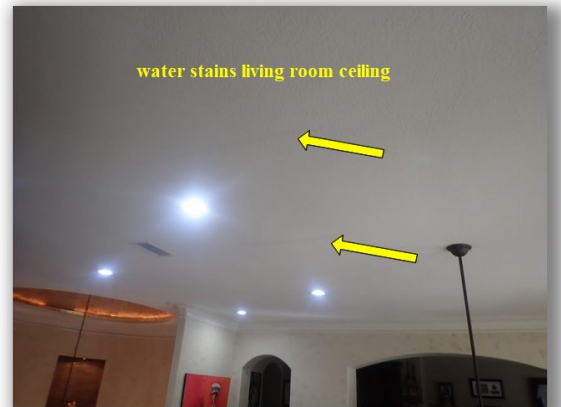
**Note:** Nail heads were observed to be pushing through the interior finish in one or more locations.

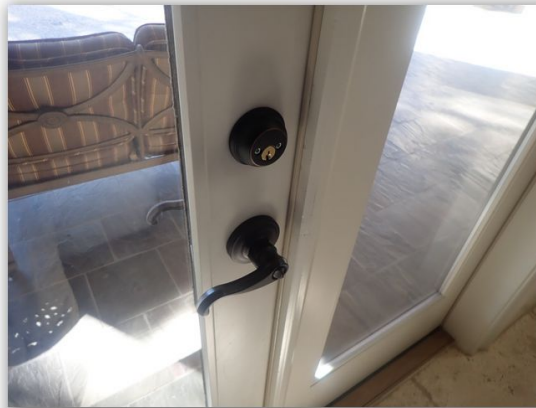
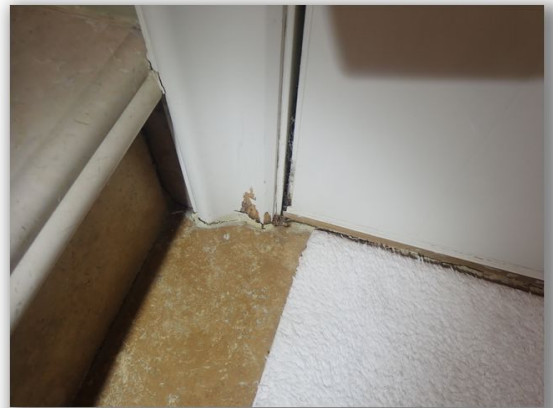
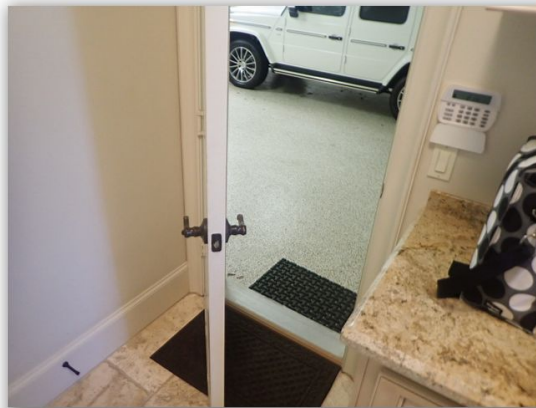
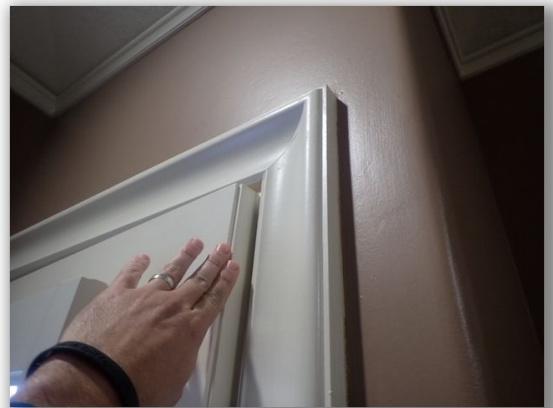
- Double cylinder locks were observed on one or more of the exterior exit (egress) doors. All exterior egress doors should be readily operable from the side from which egress is to be made without the use of a key or special knowledge or effort.
- Visible evidence of previous water intrusion was observed at and/or around the exterior primary bathroom, front balcony entry door(s). The cause and remedy should be investigated and corrected as necessary.
- The laundry room garage entry door self closing hinges are not functioning properly.
- The door is sticking to the balcony door.

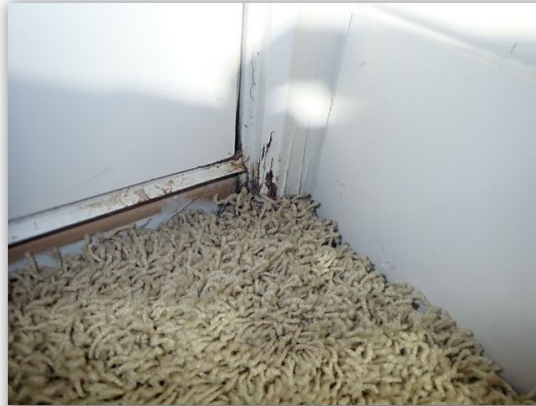
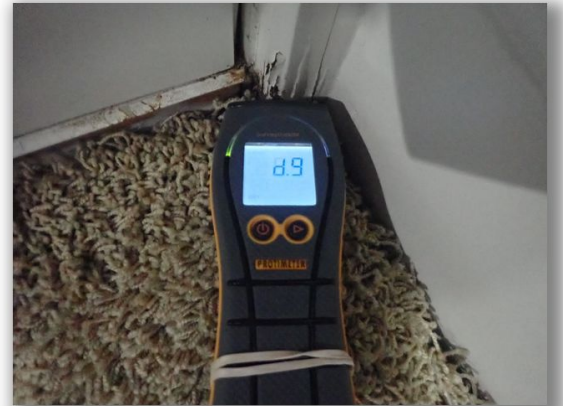
#### Overhead Garage Door

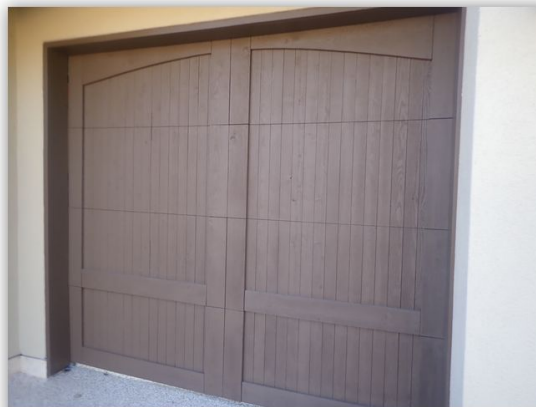
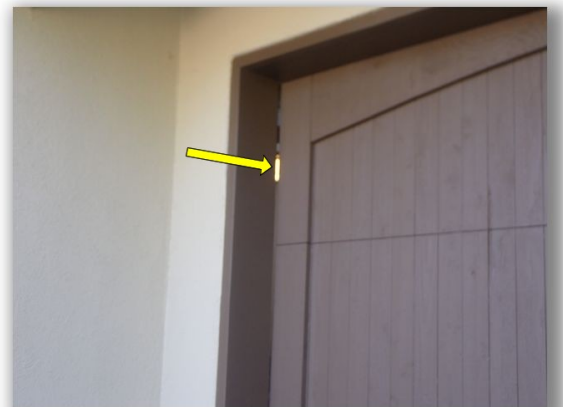
- Weather-stripping improvements are recommended for the garage exterior door(s).

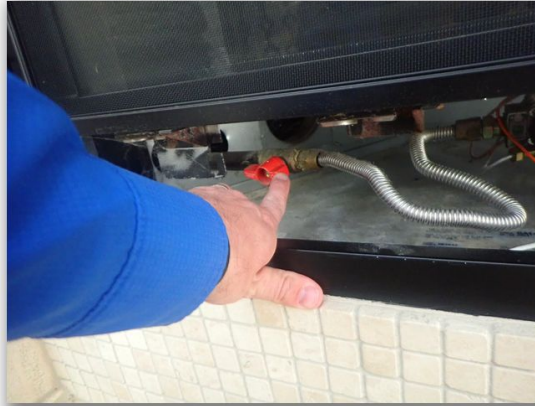
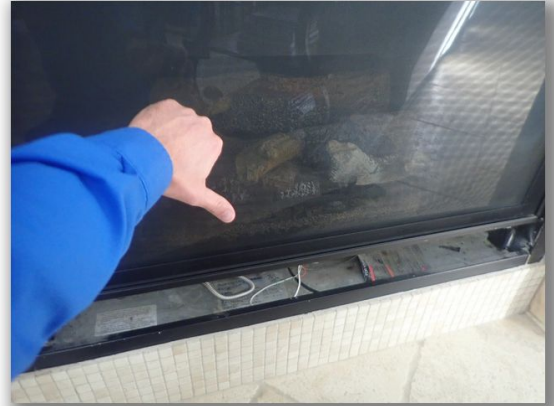
#### Primary Bedroom Fireplace / Chimney

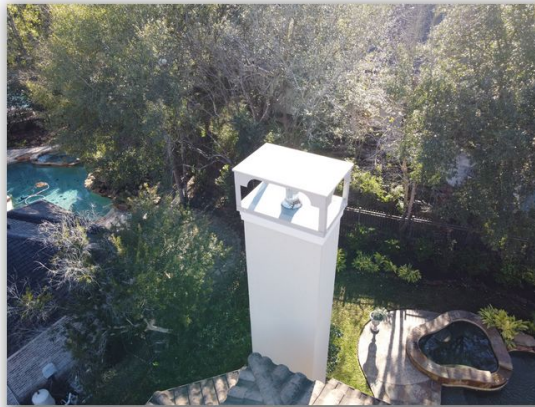
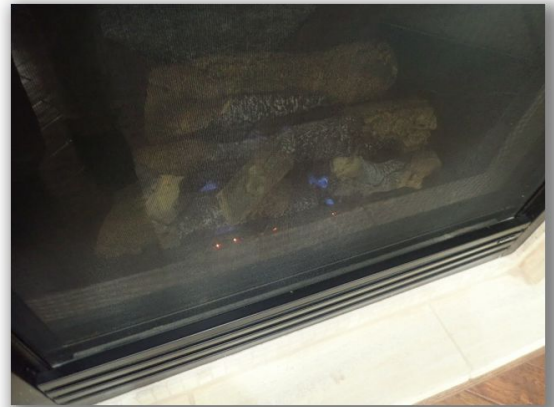
#### Study Area Fireplace / Chimney

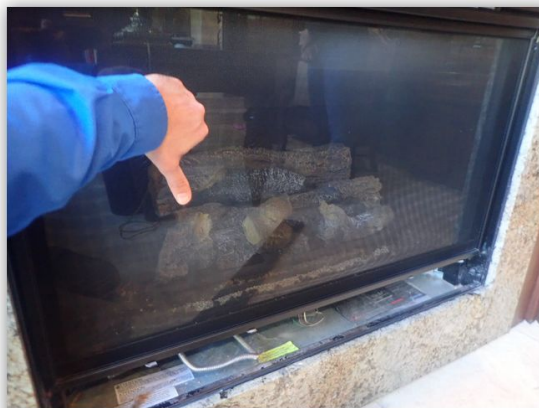
**Note:** Due to the limited nature of a general home inspection, it is possible that additional deficiencies will be discovered by a licensed technician. It is recommended to have the system serviced prior to the expiration of any option/warranty period.

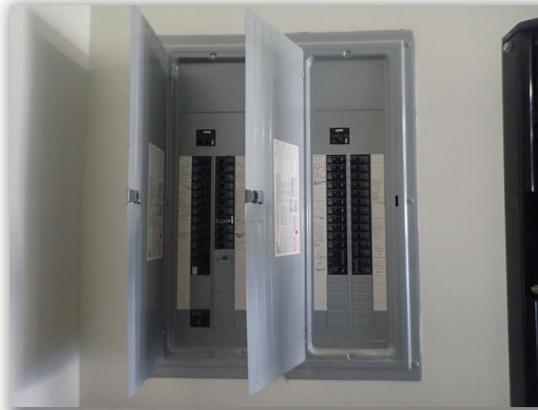
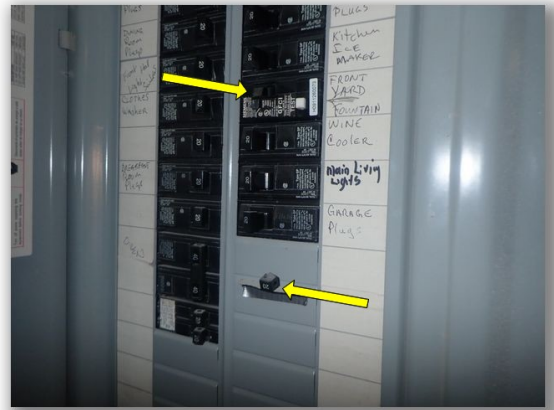
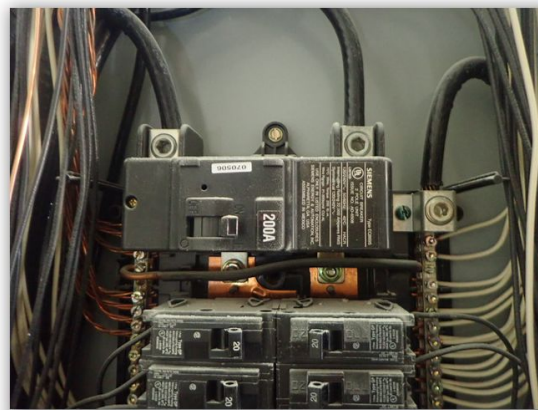
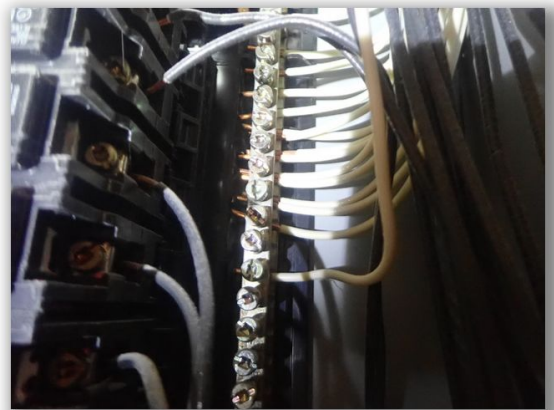
- The wires entering the electrical cabinet are not properly secured or protected from the sharp edges of the cabinet.
- One of the breaker switches / levers was observed to be damaged. It is recommended to replace the damaged breaker.

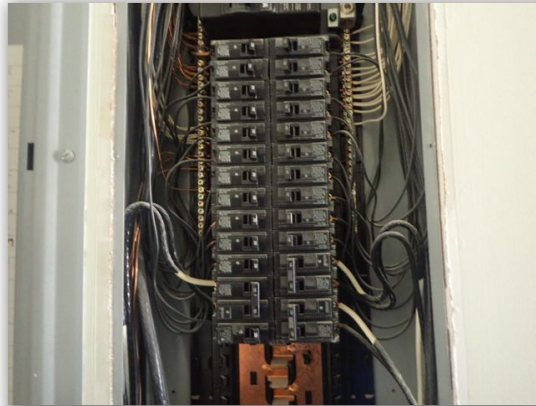
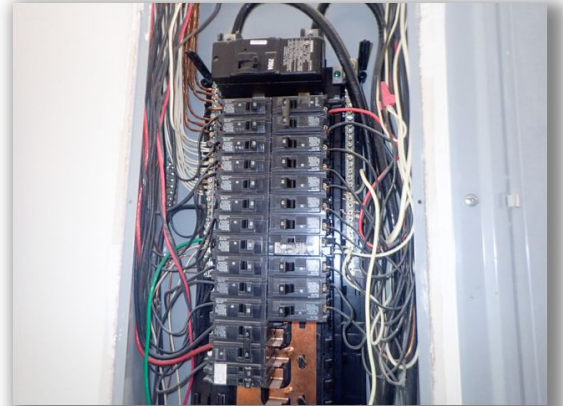
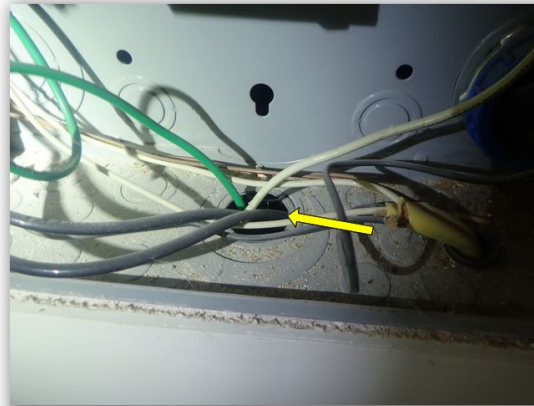
#### Arc-Fault Circuit Interrupter Protection (AFCI)

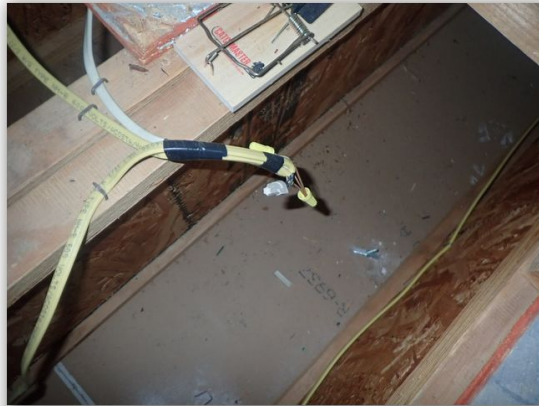
### Grounding / Bonding

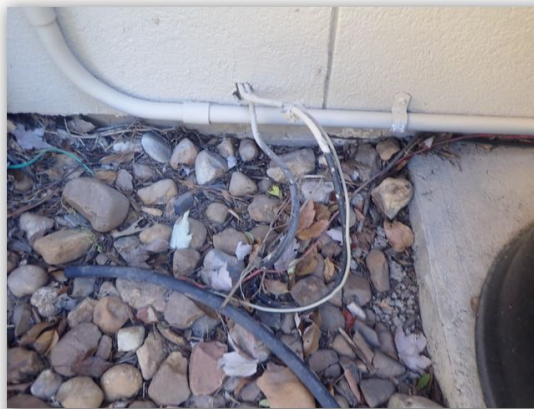
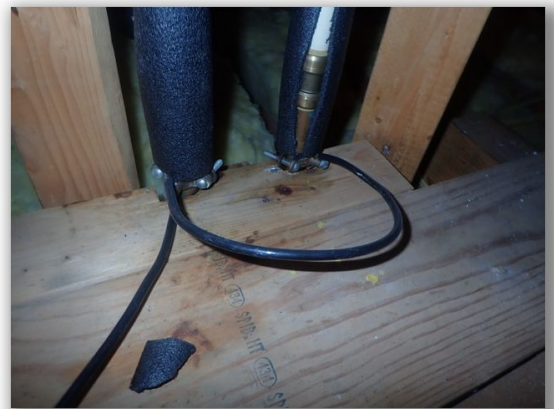
All components were found to be performing and in satisfactory condition on the day of the inspection.

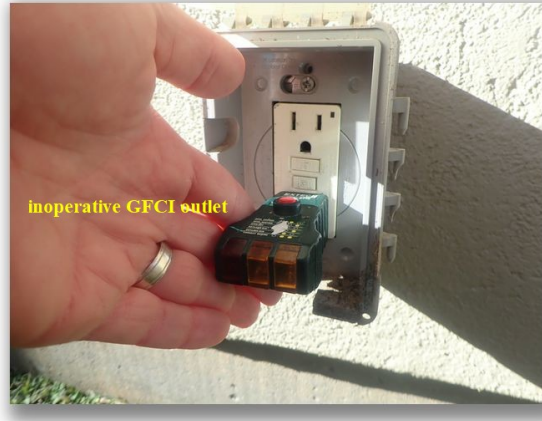
#### Arc-Fault Circuit Interrupter Protection (AFCI)

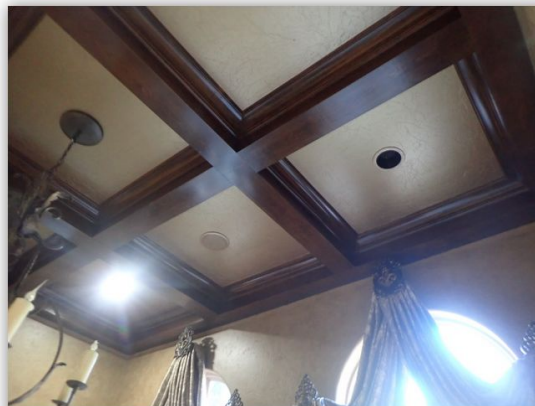
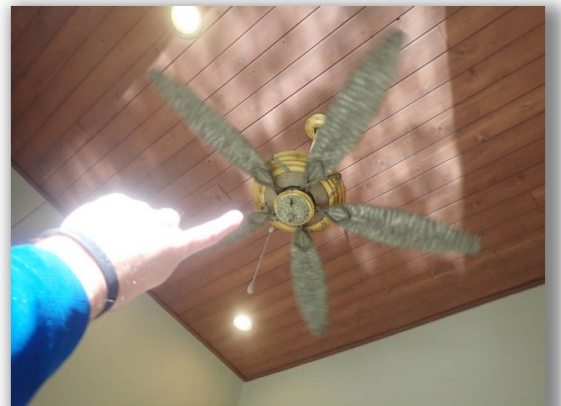
- One or more of the light fixtures appear to be inoperative in the dining room, upstairs bedroom hallway, back porch. This may be due to a bad bulb or some other unknown condition. This condition should be further evaluated and corrected as necessary.
- The ceiling fan is not balanced properly and wobbles when operated in the back porch.

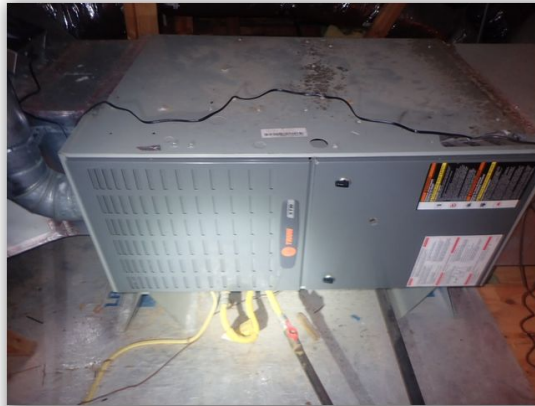
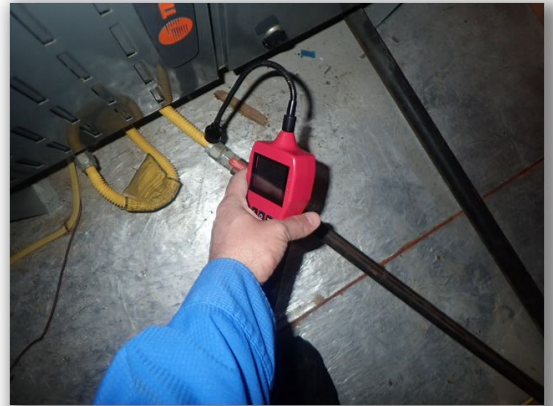
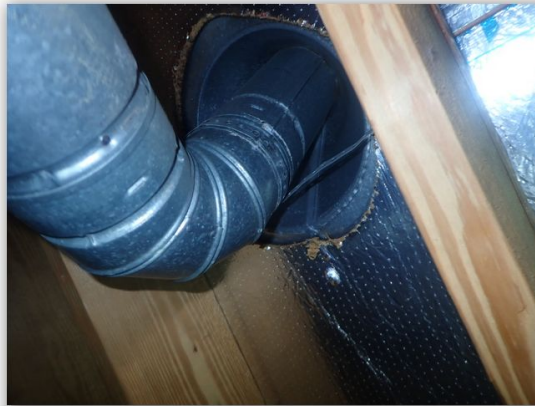
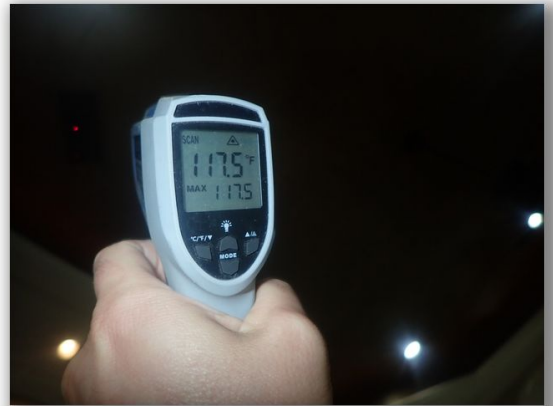
**Downstairs Central Heating System** – Energy Source: Gas

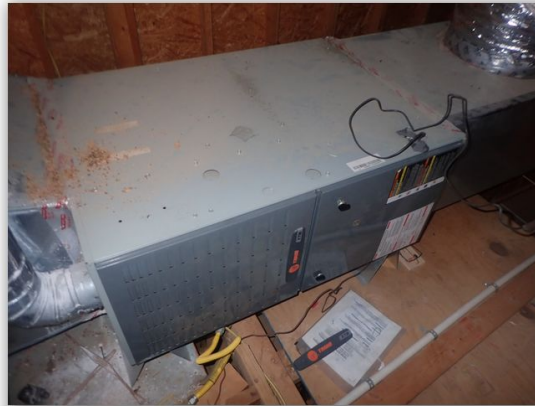
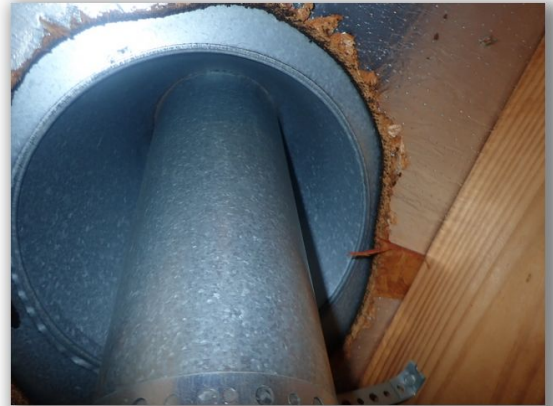
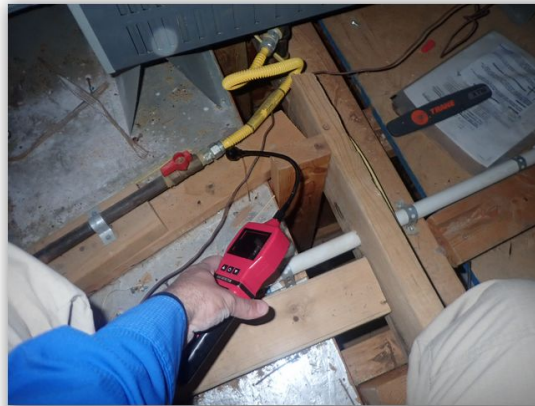
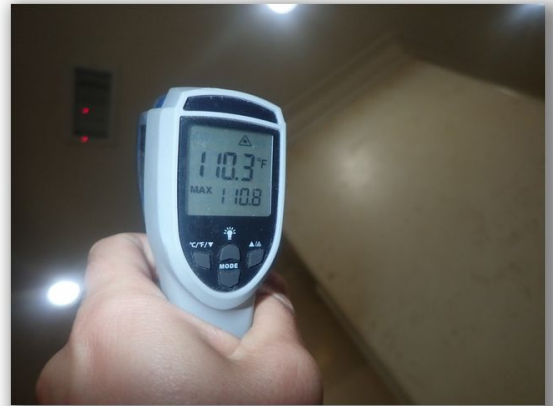
**Upstairs Central Heating System** – Energy Source: Gas  
Brand Name: Trane

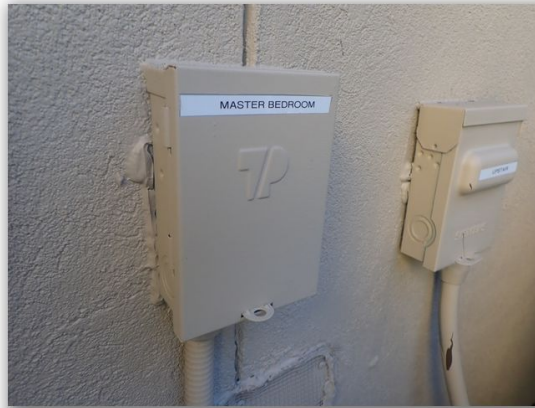
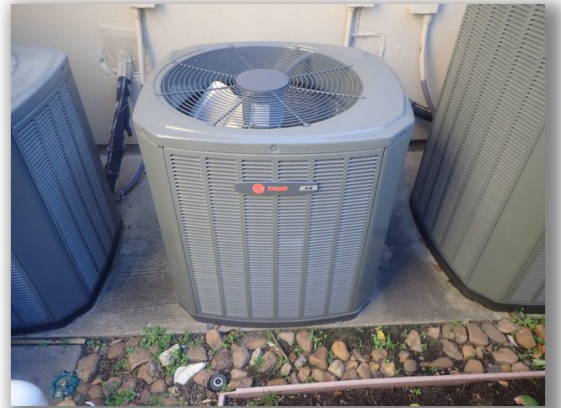
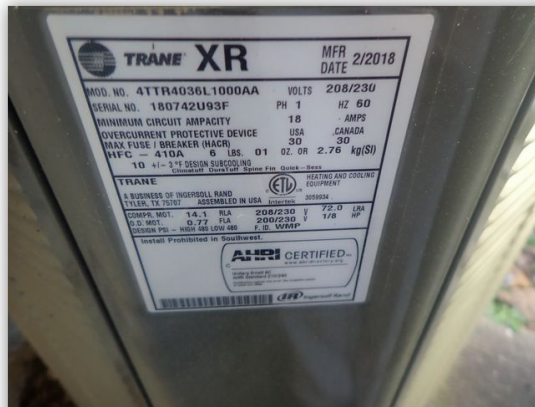
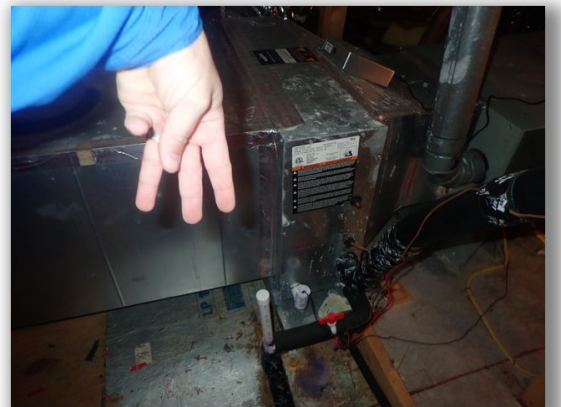
- The dirty air filter should be replaced.

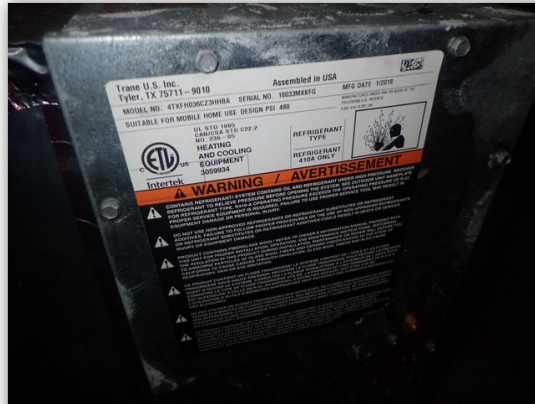
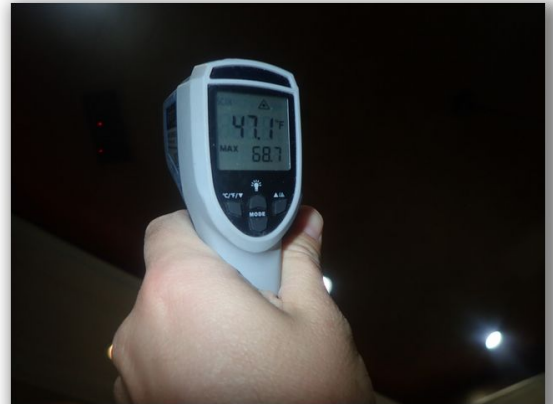
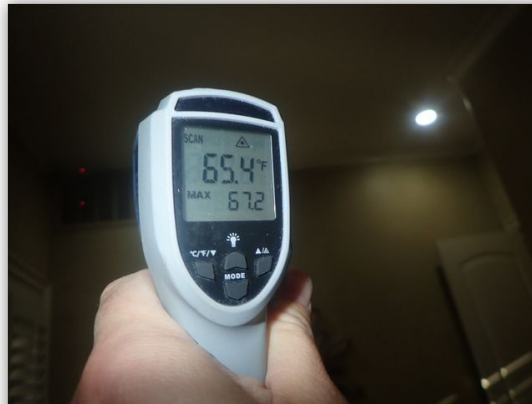
#### Downstairs Central Cooling System

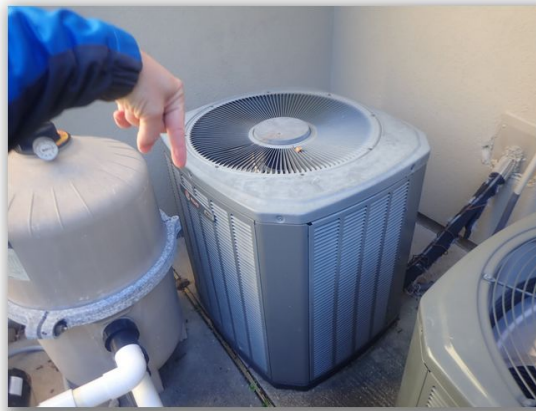
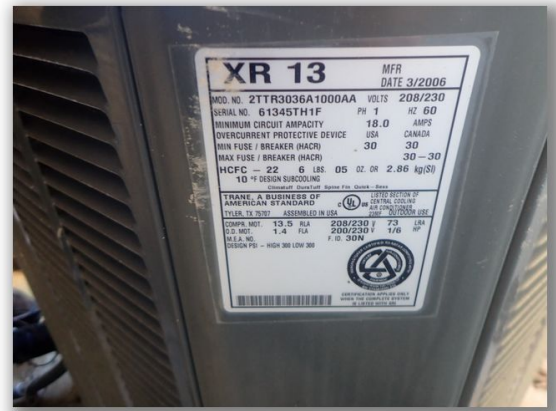
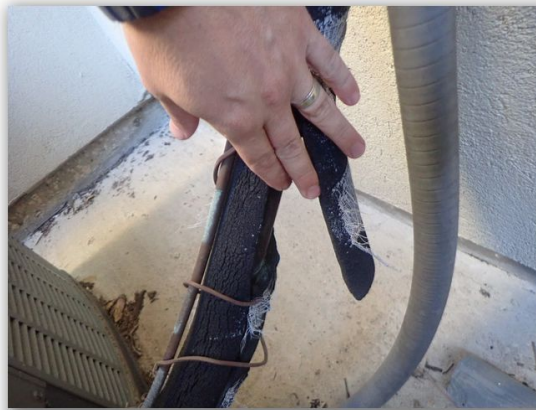
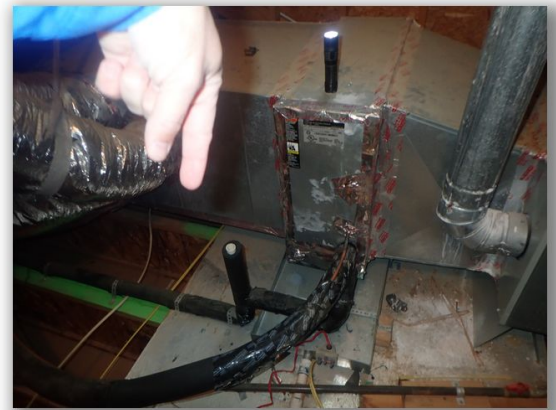
It would be wise to budget for replacement of the older freon system and to make a conversion over to a newer type of freon system as soon as it is financially feasible.

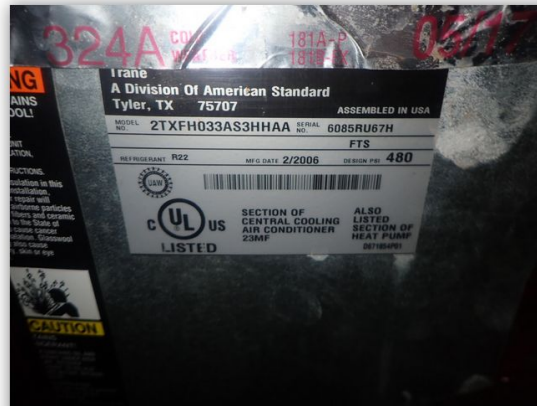
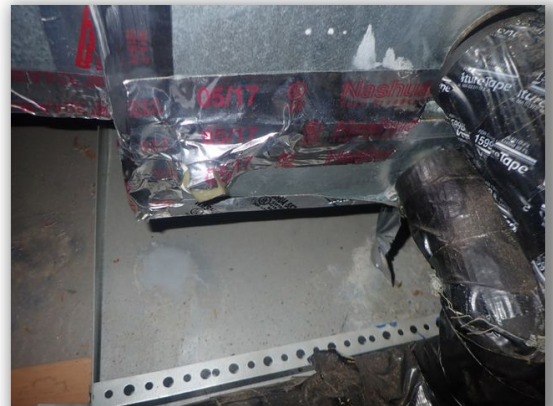
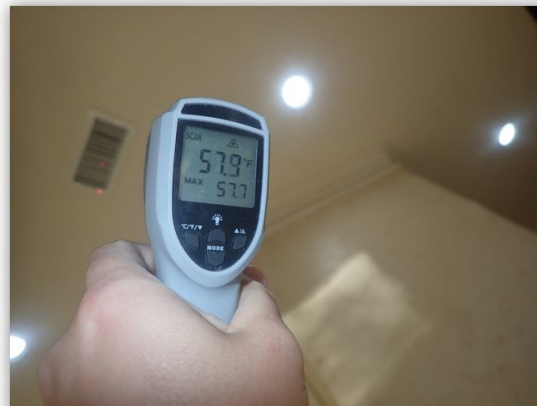
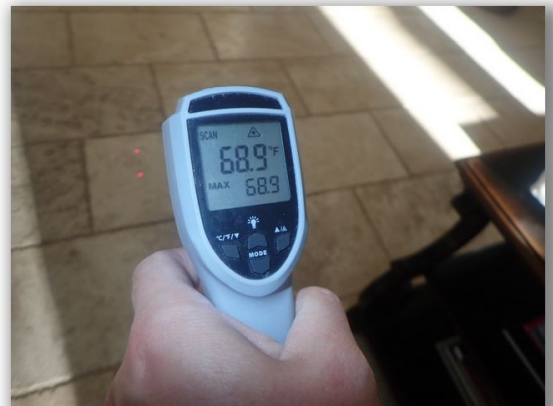
#### Upstairs Central Cooling System

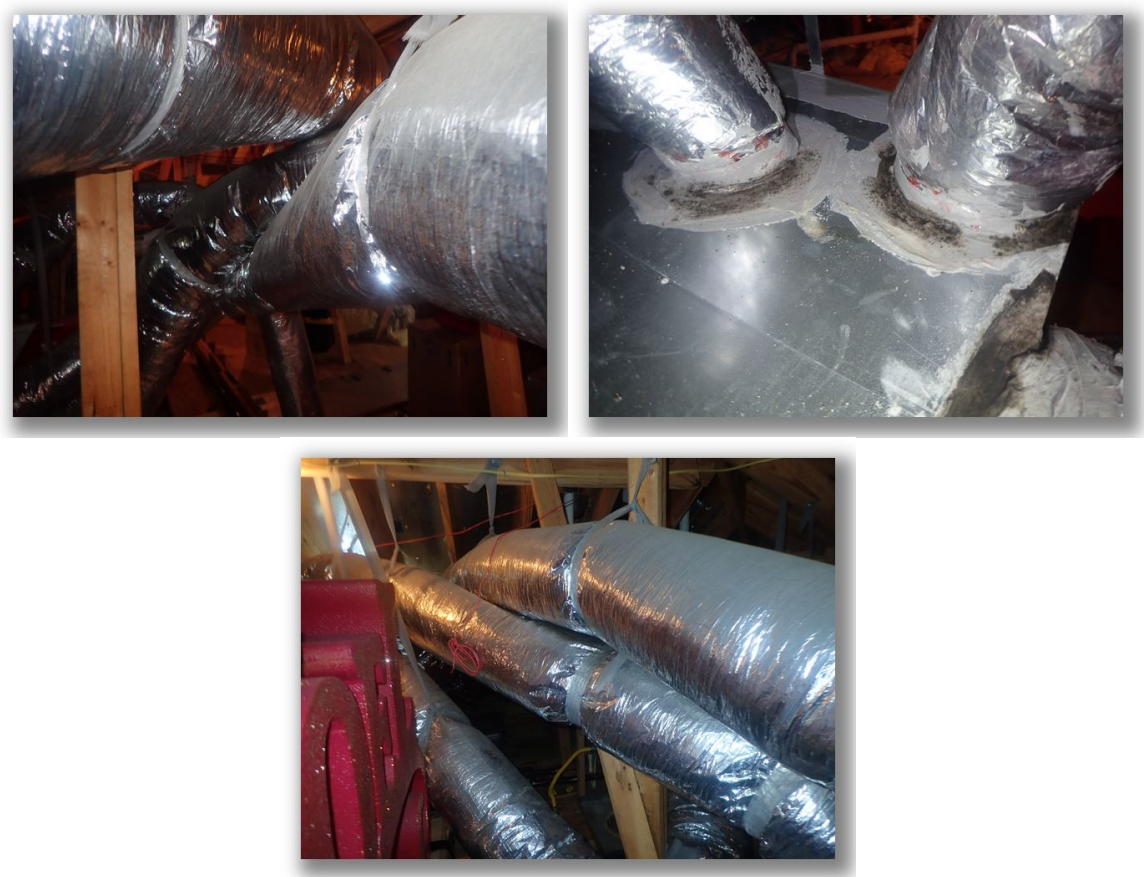
| I=Inspected | NI=Not Inspected | NP=Not Present | D=Deficient |
|---|---|---|---|
| I | NI | NP | D |

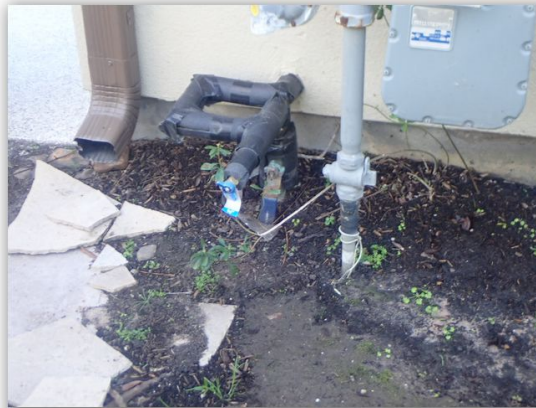
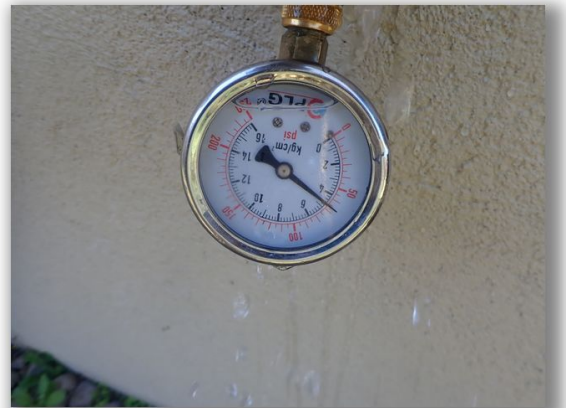
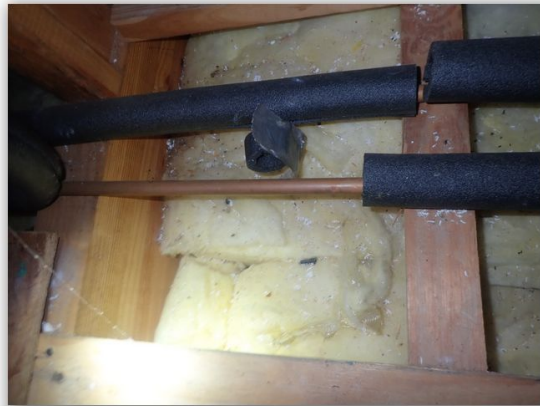
##### Exterior Faucets/Fixtures

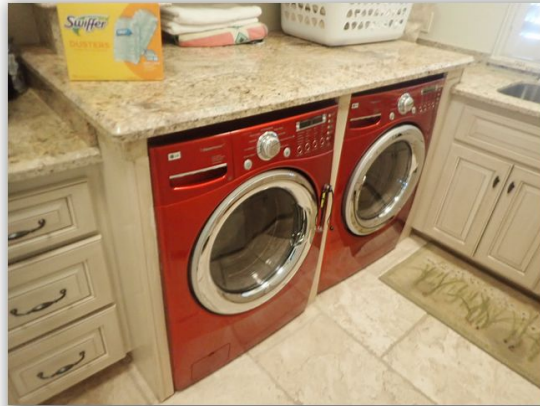
#### **Kitchen Sink**

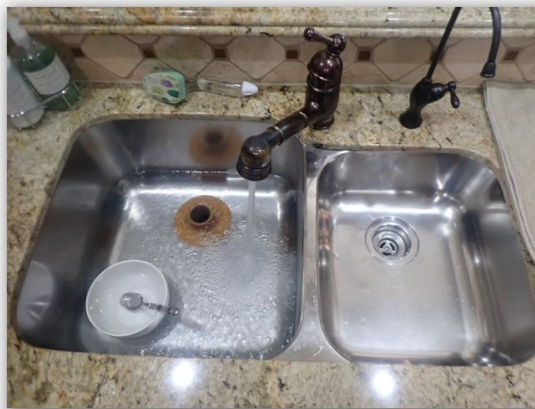
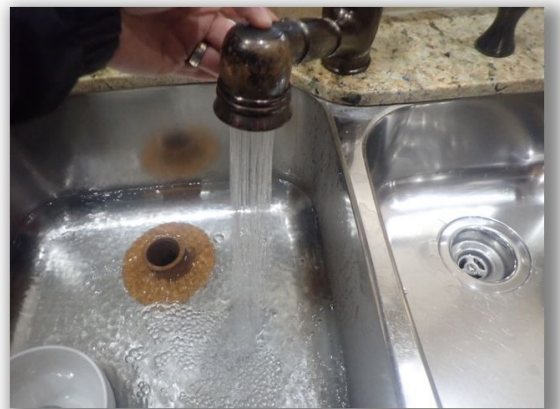
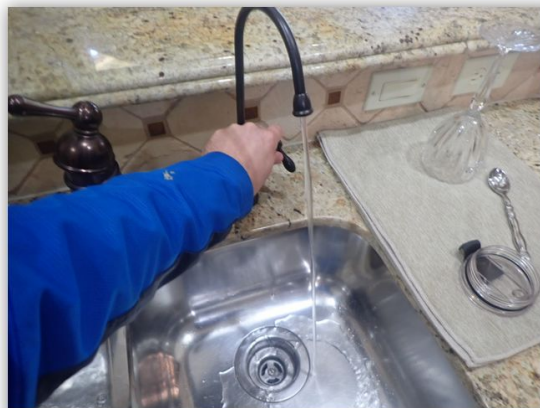
#### **Downstairs Wet Bar Sink**

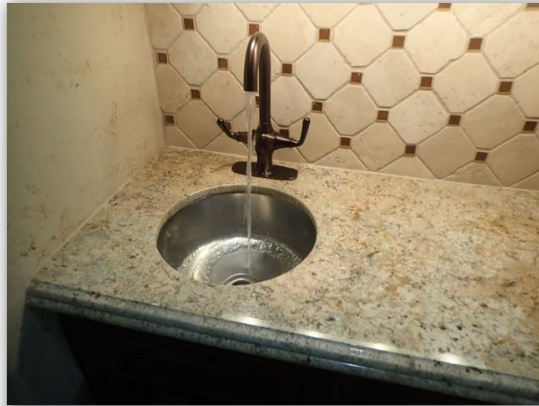
#### **Laundry Sink**

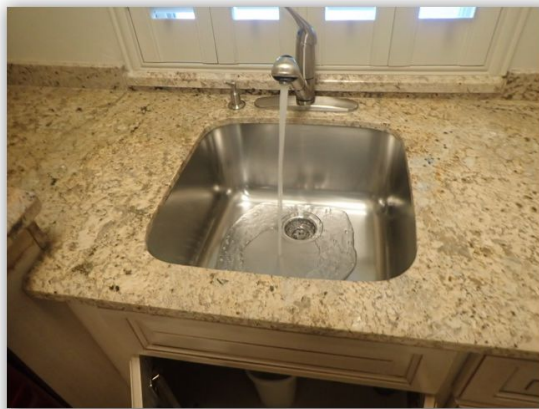
#### **Media Room Wet Bar Sink**

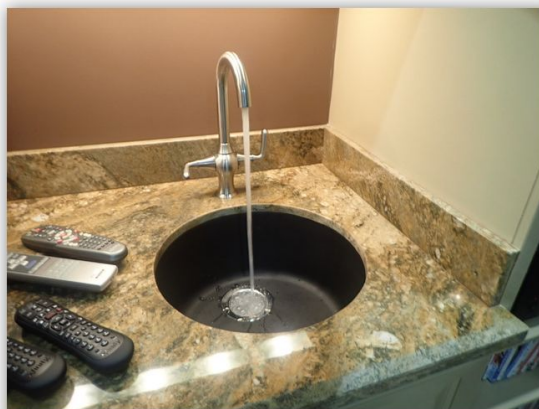
- The faucet assembly is loose.

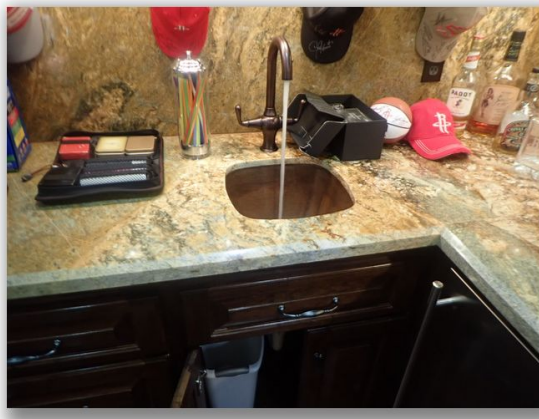
- The sink was observed to drain slowly, suggesting that an obstruction may exist.

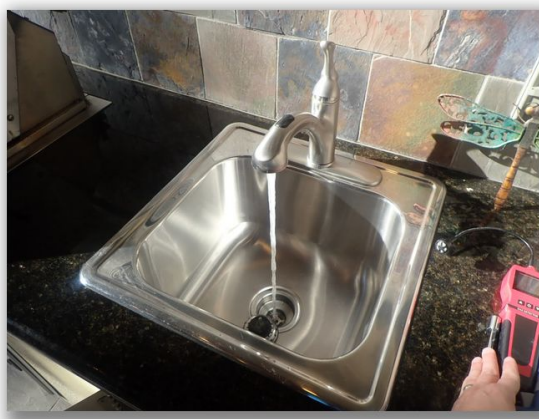
**Primary Bathroom**

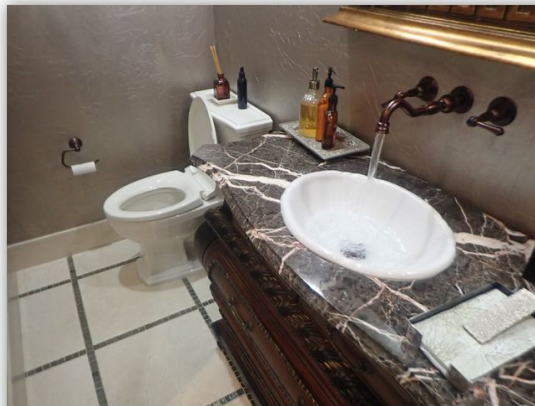
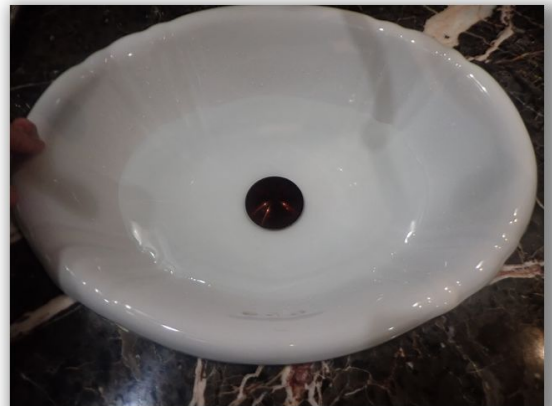
**Bath Between Rooms – “Jack & Jill Bath”**

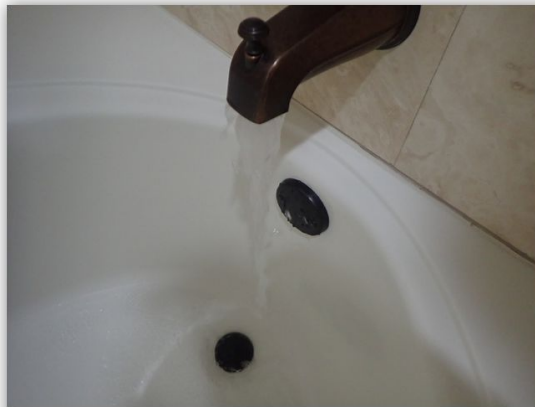
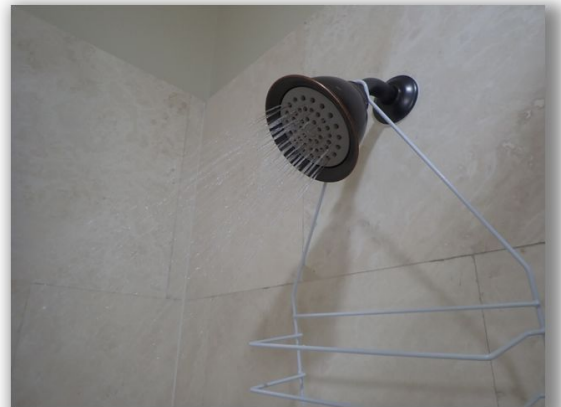
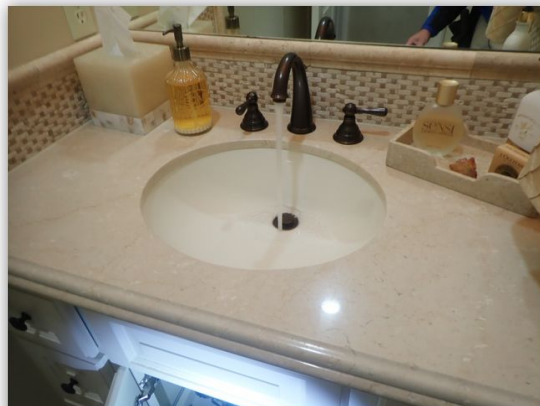
- Cracked, deteriorated and/or missing bathtub enclosure grout and/or caulking should be repaired or replaced as necessary.
- The bathtub shower head diverter is not functioning properly.
