713-730-3151

[www.a-actionhouston.com](http://www.a-actionhouston.com)

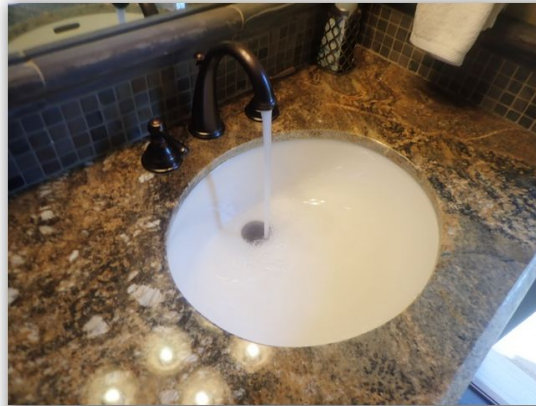
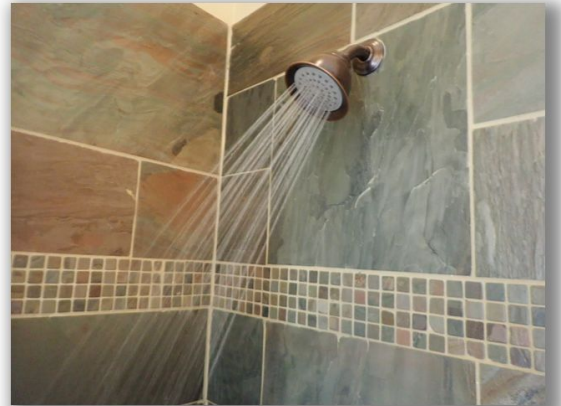
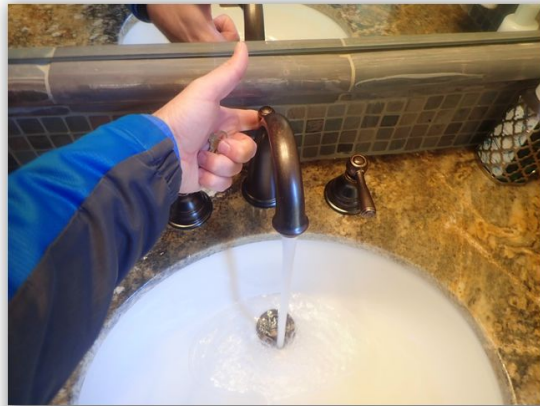
**Notice:** The Inspector has attempted to discover and report conditions requiring further evaluation or repair. However; determining the condition of any component that is not visible and/or accessible, such as plumbing components that are buried, beneath the foundation, located within construction voids or otherwise concealed, and reporting any deficiency that does not appear or become evident during our limited cursory and visual survey is outside the scope of this inspection. **The inspector will not be able to anticipate future events, conditions or changes in performance of any component or system due to changes in use or occupancy. The inspector makes no guarantee or warranty, express or implied, as to future performance of any item, system or component.**

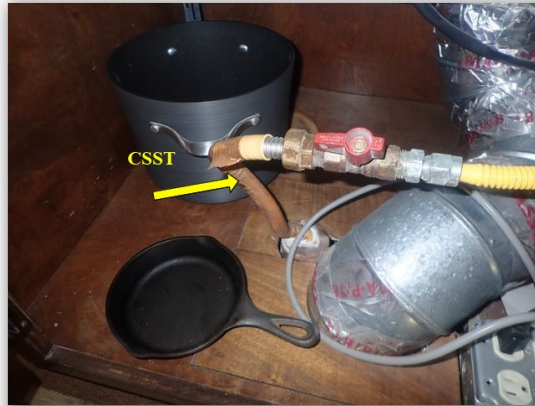
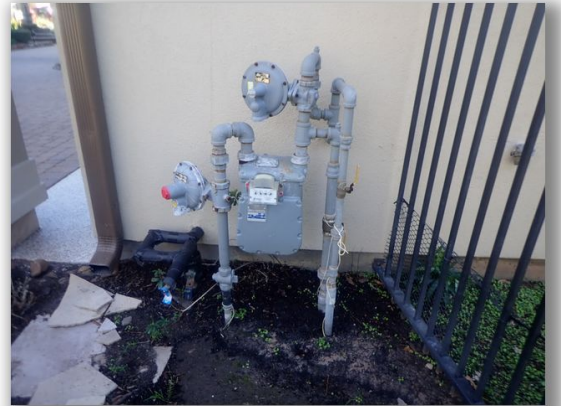
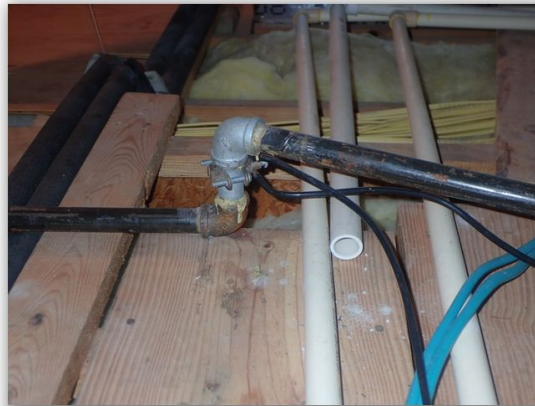
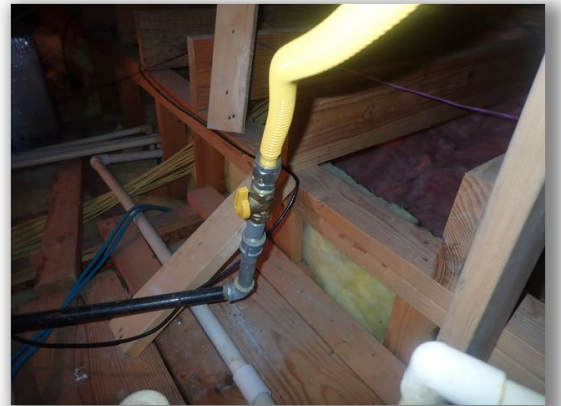
**Notice:** The Inspector will use a combustible gas leak detector on accessible gas lines, joints, unions and connectors and report visible deficiencies found at the time and date of the inspection. The inspector inspects the gas lines from the point they enter the structure and will complete the inspection without digging, damaging property, permanent construction or building finish. When performing the inspection, the inspector will keep in consideration the age of the system and normal wear and tear from ordinary use when rendering opinions.

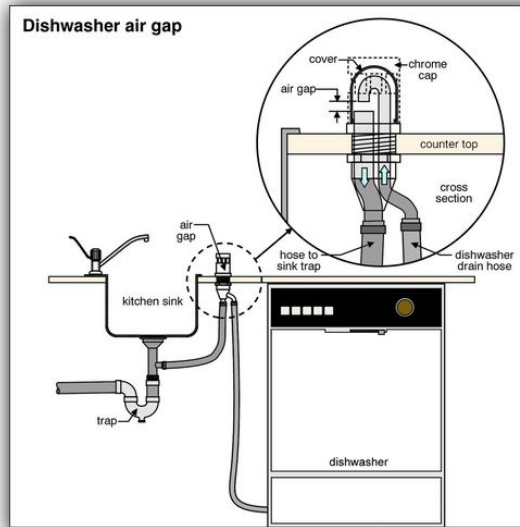
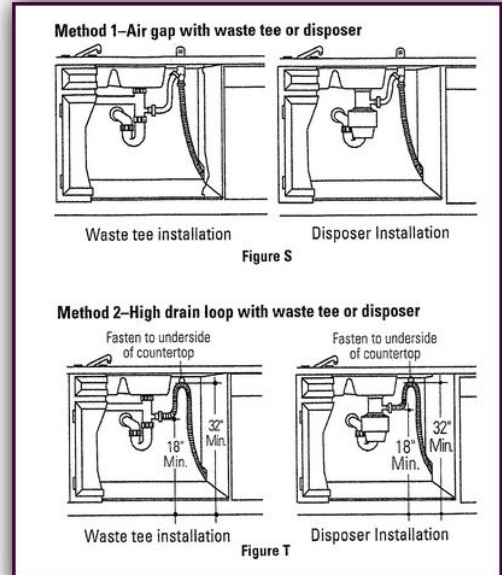
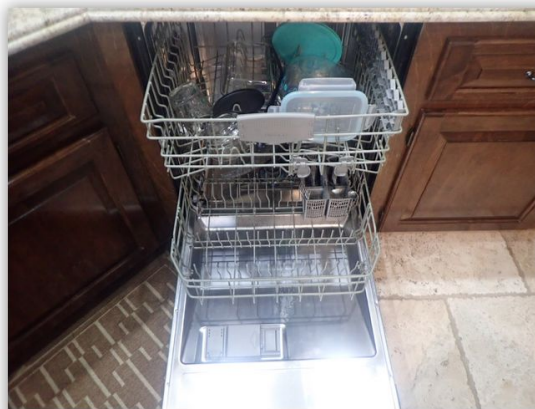
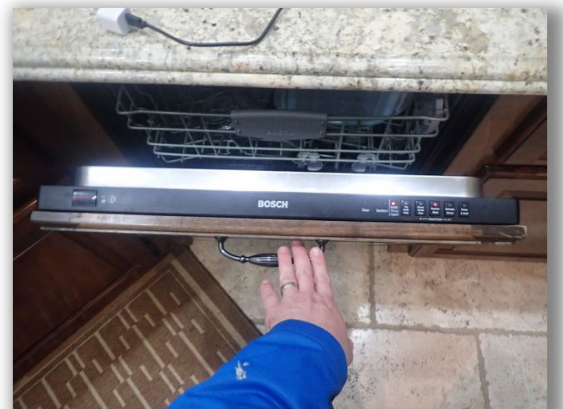
- The dishwasher drain hose is not properly installed to prevent back flow or anti-siphoning. It is recommended that an air gap device or high drain loop be installed in the drain line.

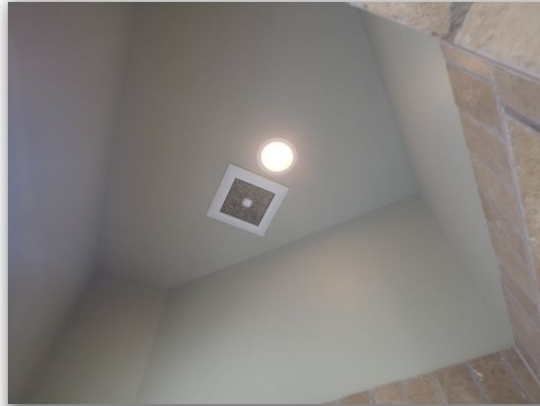
- The mechanical exhaust vent fan was unusually dirty in the primary bathroom.
- One or more of the mechanical exhaust vent systems was observed to be terminating to the soffit / eave area. This is an "AS Built" condition that does not meet current manufacturers or mechanical installation standards.

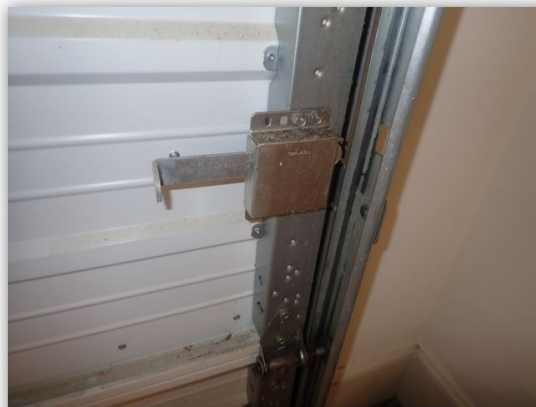
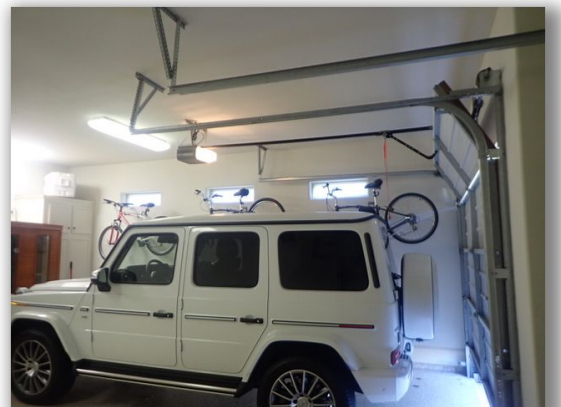
**Additional Notice from the Inspector:** It is the opinion of this inspector that although this component may be functioning as intended or in need of minor repairs, you should be aware that this is an older component and the future life expectancy cannot be determined. You can continue to use and service this component until replacement is necessary.

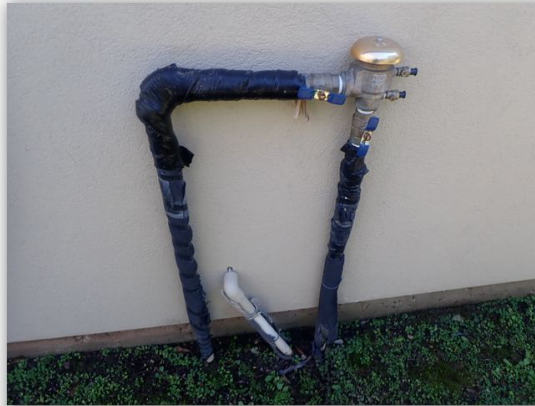
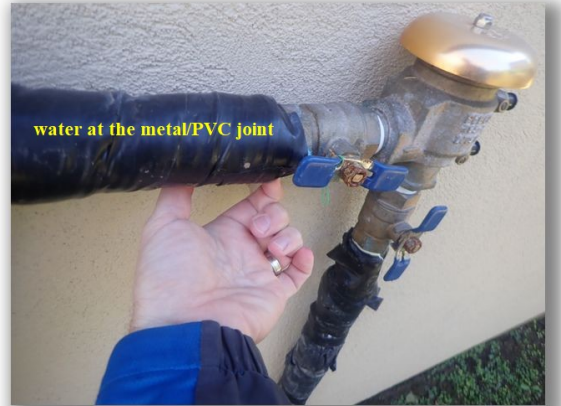
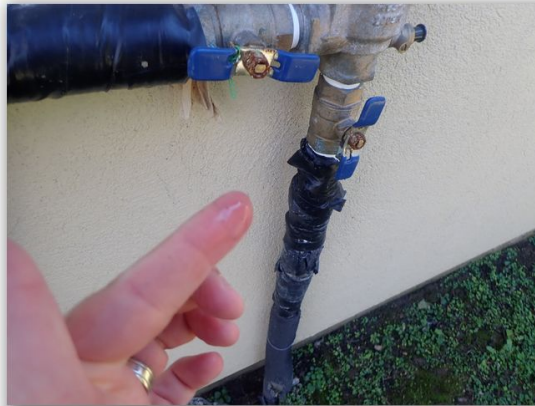
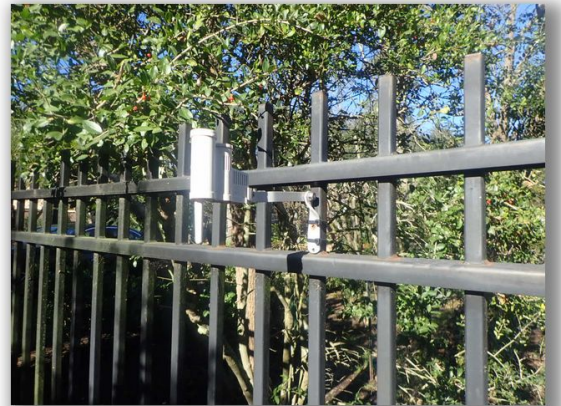
- One or more of the sprinkler heads need to be adjusted and/or straightened so to disperse water properly in station(s); **1, 2, 3, 4, 5, 6, 7, 8, 9, 10, 11, 12.**
- There appears to be a sub-surface leak or damaged water lines in station(s); **9.** The cause and remedy should be further evaluated and corrected as necessary.
- There appears to be a leak at the back flow preventer connections. This should be further evaluated and corrected if necessary.

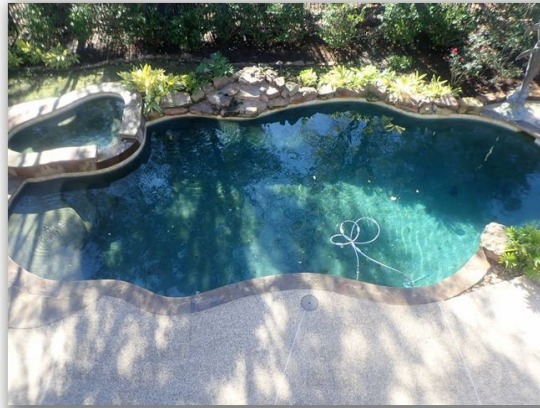
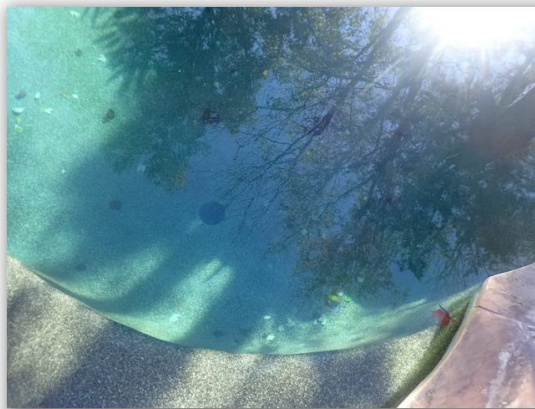
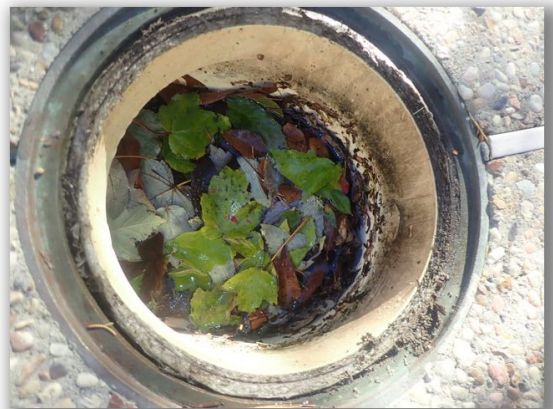
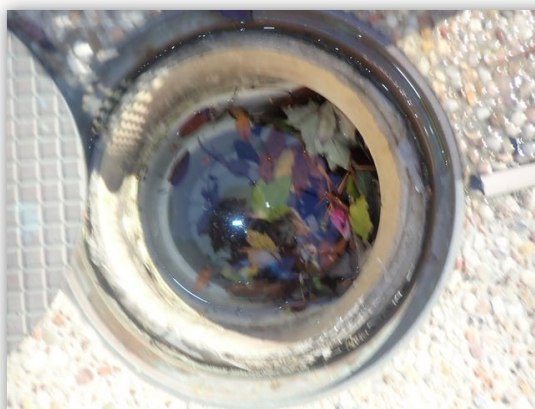
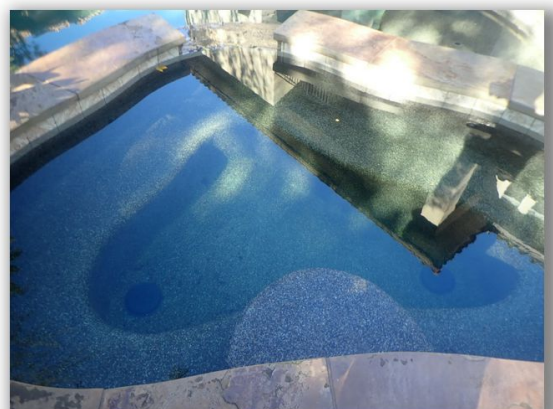
- It is recommended to paint all exposed PVC pipes to prevent UV break down.
- The filter gauge has a high pressure reading. Filter pressure should be maintained between 5 to 20 psi.
- The pool needs to be cleaned at the time of this inspection.

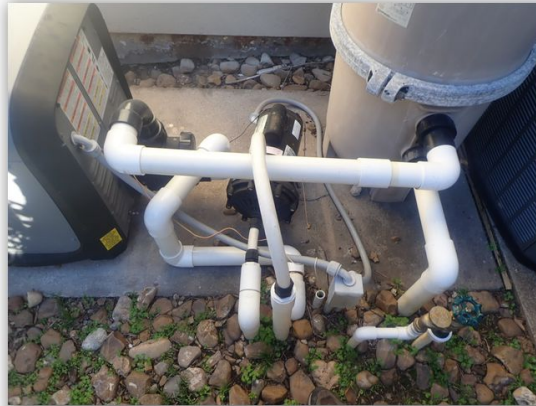
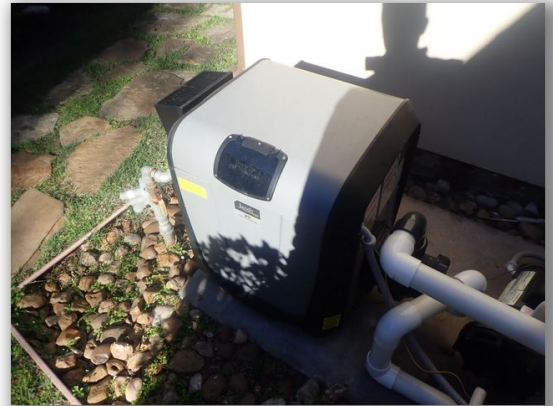
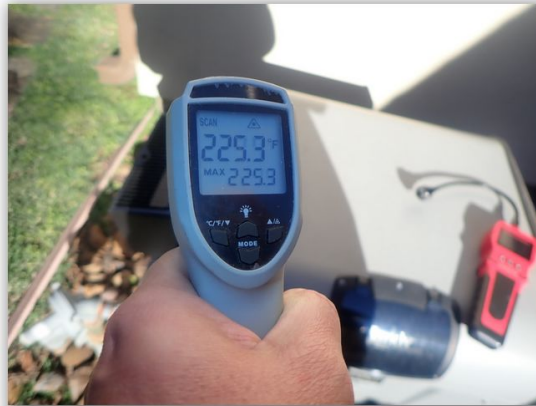
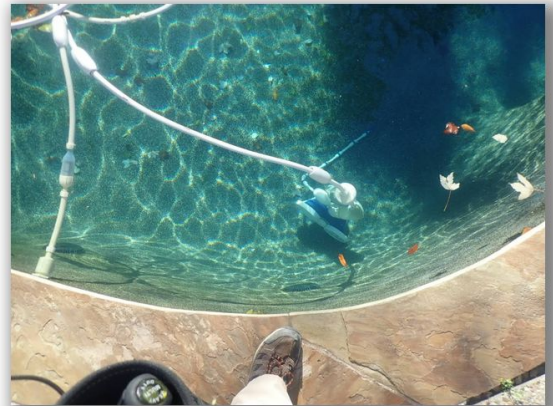
**Notice:** Based on what we were able to observe and our experience with swimming pool, spa and hot tub technology, we submit this inspection report based on the present condition, working under current use and habits of the current occupants of the residence. When performing the inspection, the inspector will keep in consideration the age of the system and normal wear and tear from ordinary use when rendering opinions. All of the pool or spa systems and associated components are inspected and operated in the manual / service settings only. Operating the pool components from indoor control panels or handheld remotes are outside the scope of this inspection.

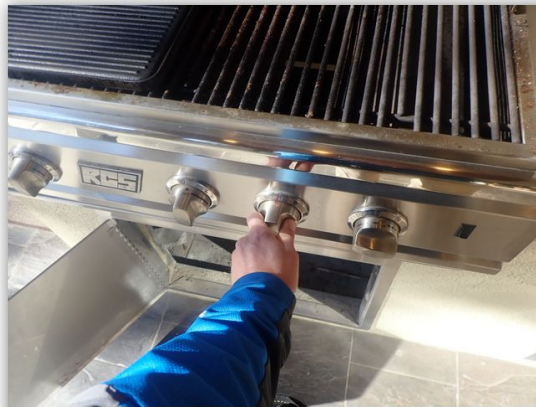
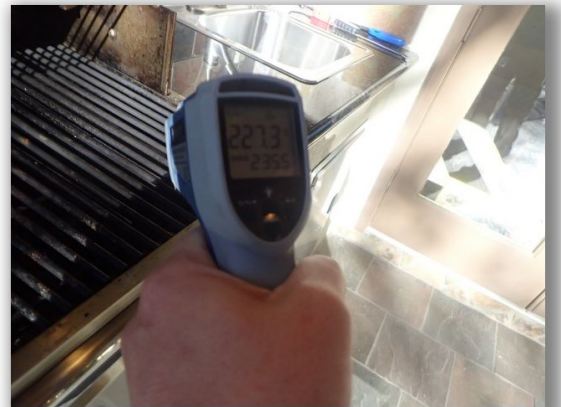
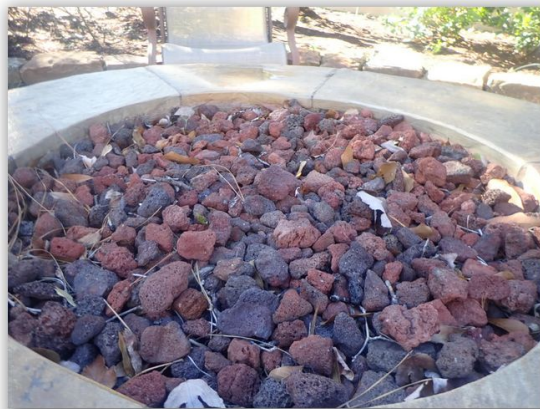
All components were found to be performing and in satisfactory condition on the day of the inspection.

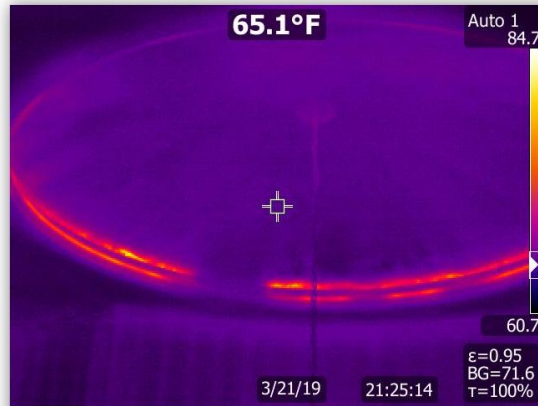
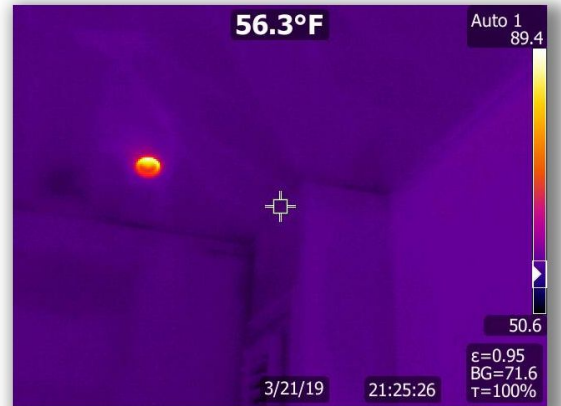
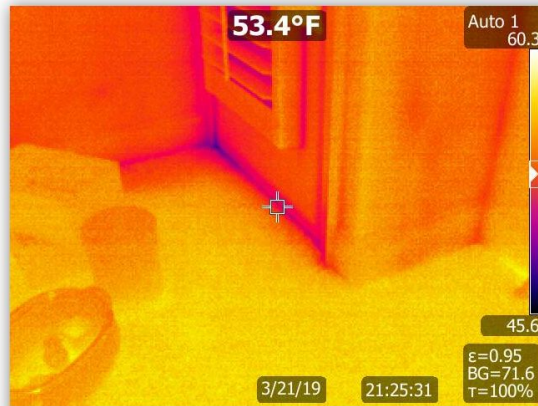
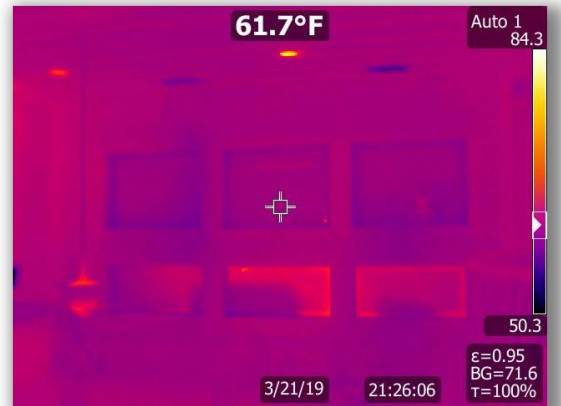
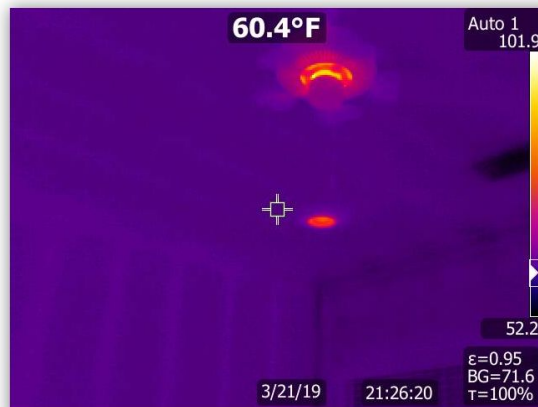
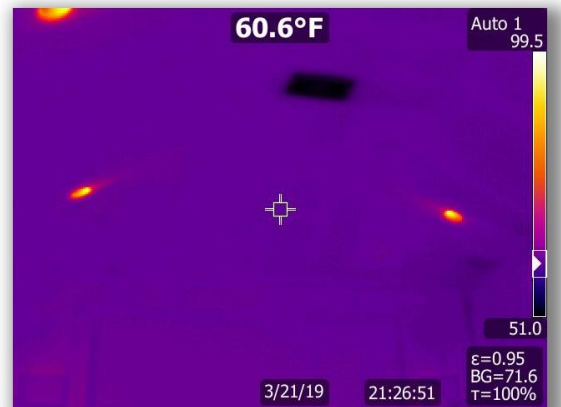
All components were found to be performing and in satisfactory condition on the day of the inspection.

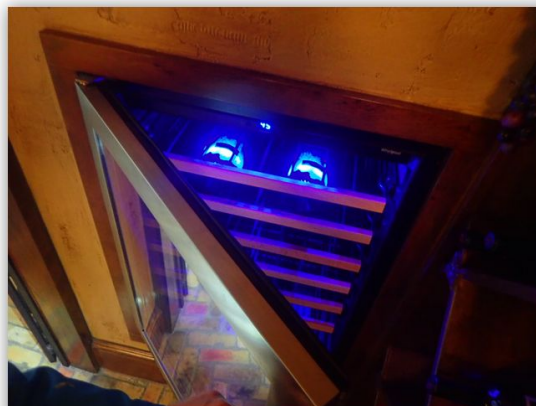
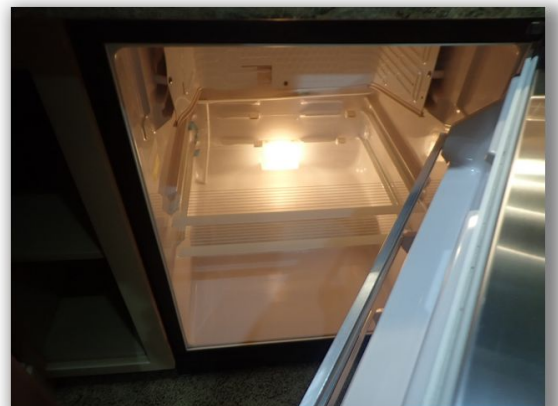
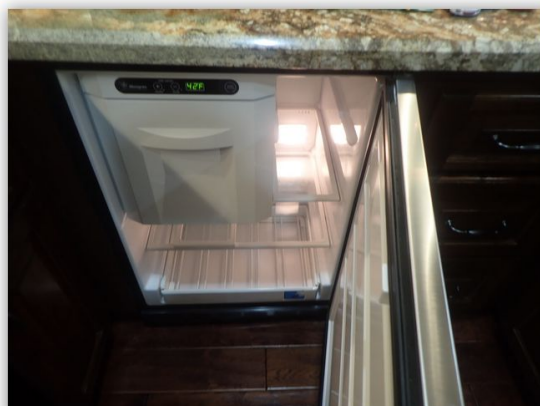
**INSPECTION AGREEMENT**  
**PLEASE READ THIS AGREEMENT CAREFULLY BEFORE SIGNING**

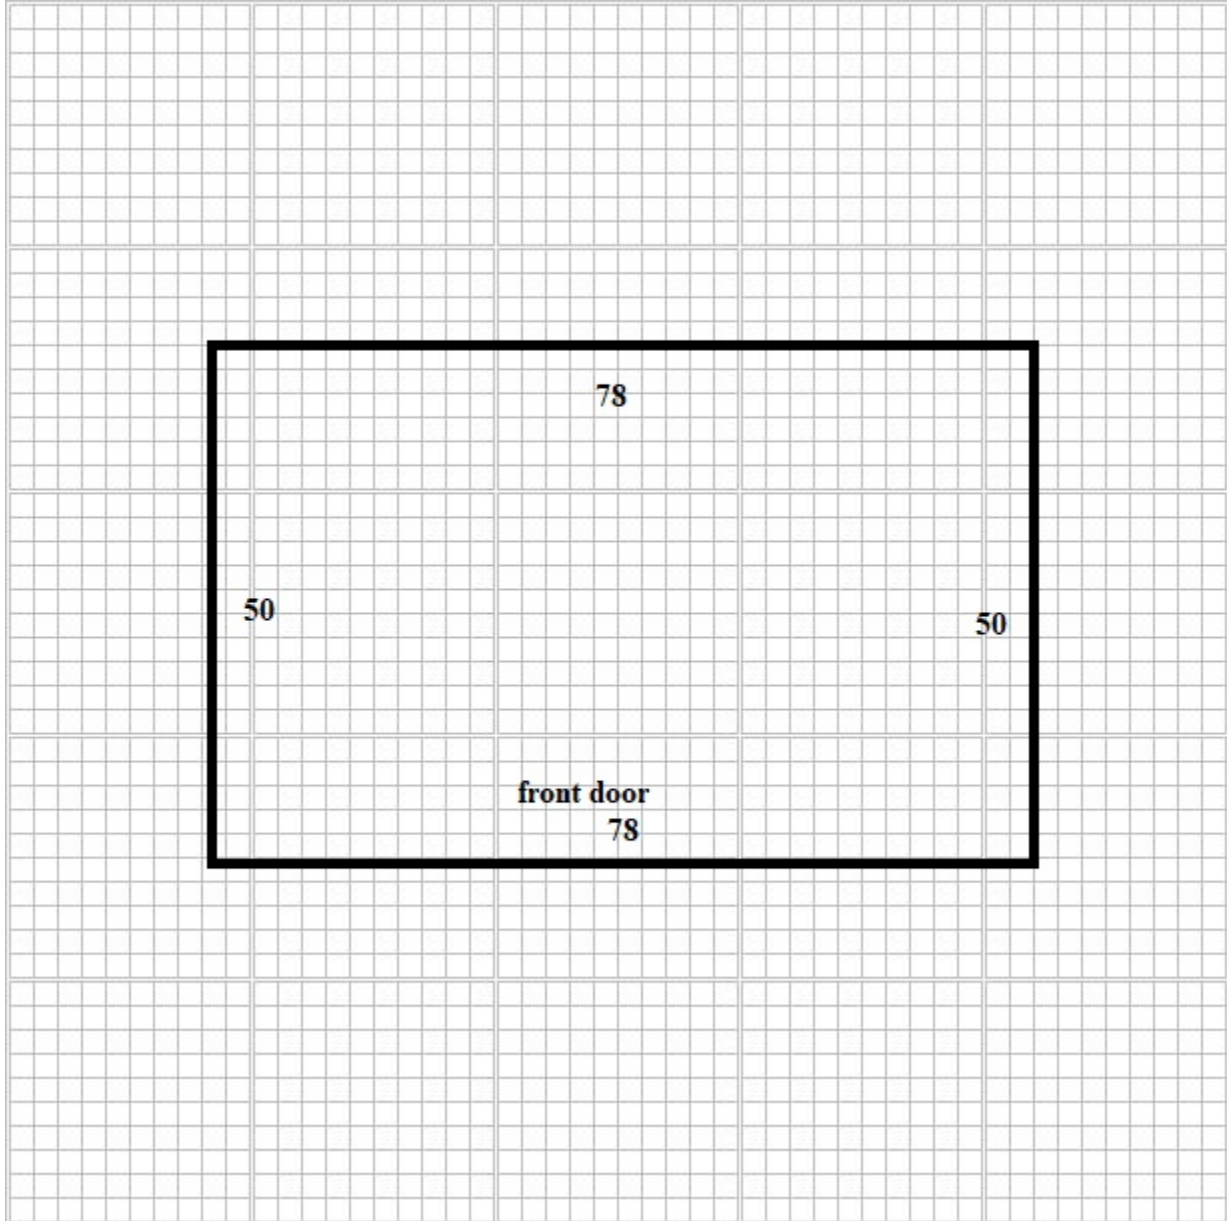
Additional Comments There is no visible evidence of active wood destroying insects found at the time of this inspection.
