713-730-3151

[www.a-actionhouston.com](http://www.a-actionhouston.com)

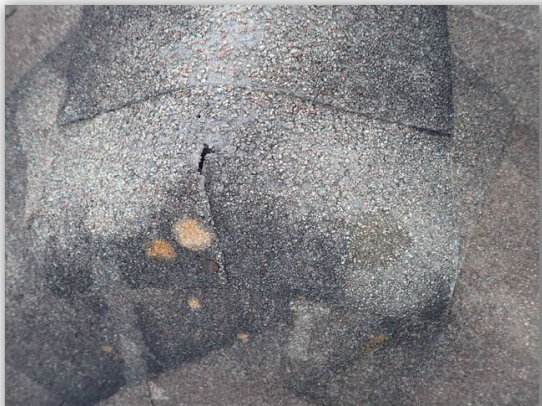
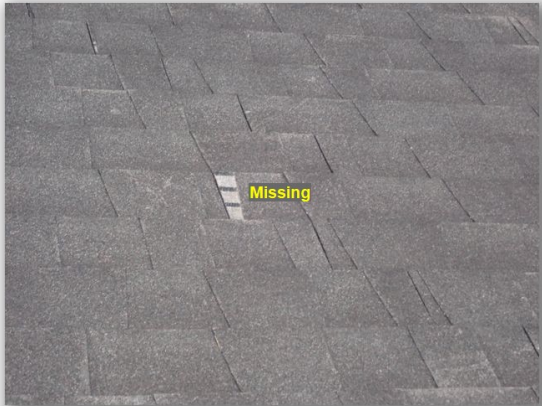
| I=Inspected | NI=Not Inspected | NP=Not Present | D=Deficient |
|---|---|---|---|
| I | NI | NP | D |

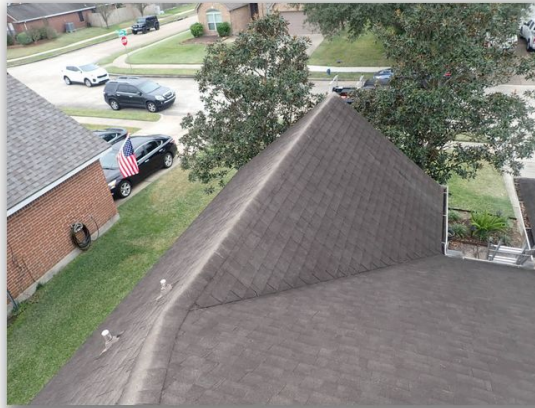
### Flashing Details

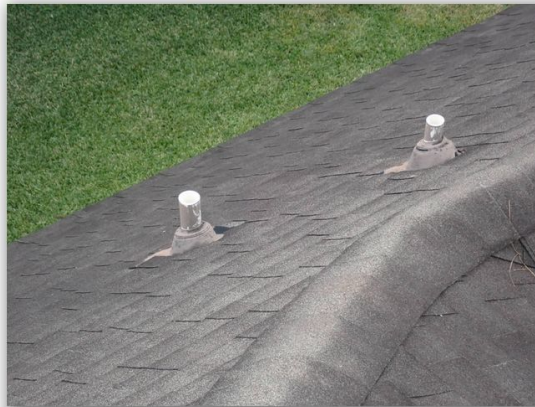
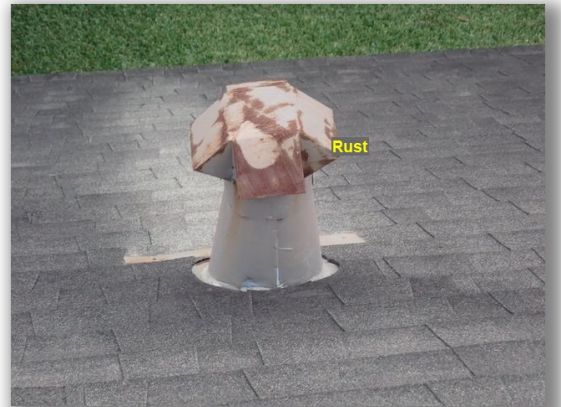
| I=Inspected | NI=Not Inspected | NP=Not Present | D=Deficient |

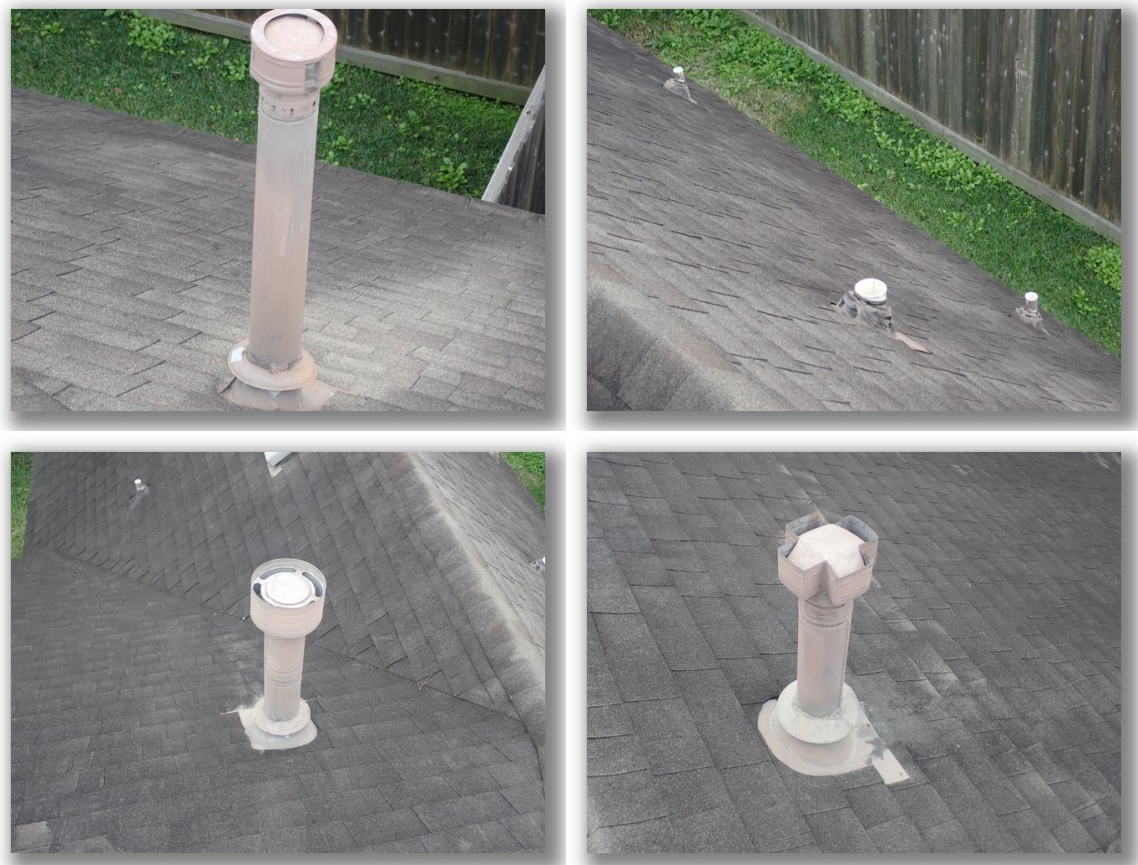
**Notice:** Life expectancy of the roofing material is not covered by this property inspection report. If any concerns exist about the roof covering life expectancy or potential for future problems, a roofing specialist should be consulted. The Inspector cannot offer an opinion or warranty as to whether the roof has leaked in the past, leaks now, or may be subject to future leaks, either expressed or implied.

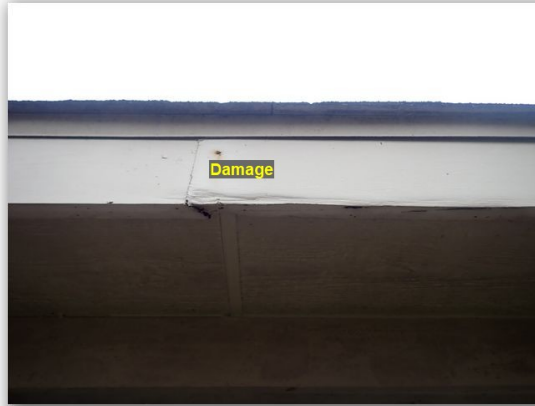
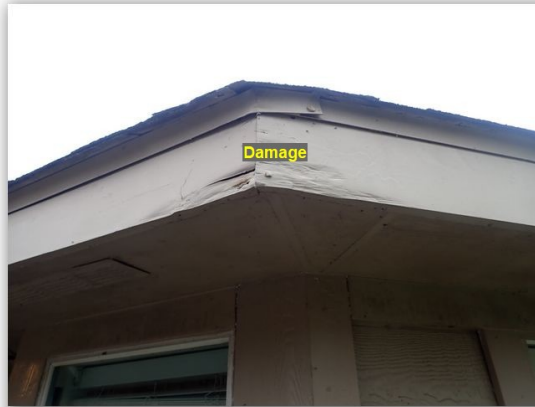
- The fascia board material has some deterioration and/or damage on the east side of the roof structure.

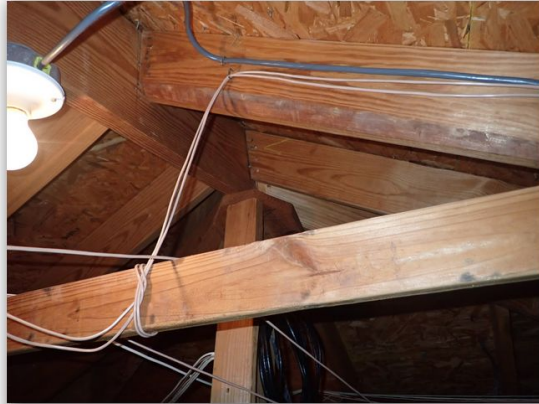
#### Attic Ventilation

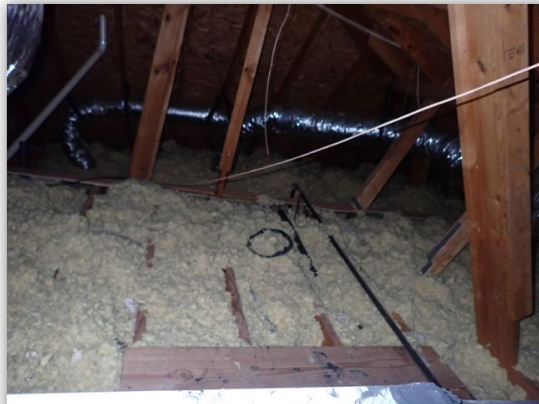
All components were found to be performing and in satisfactory condition on the day of the inspection.

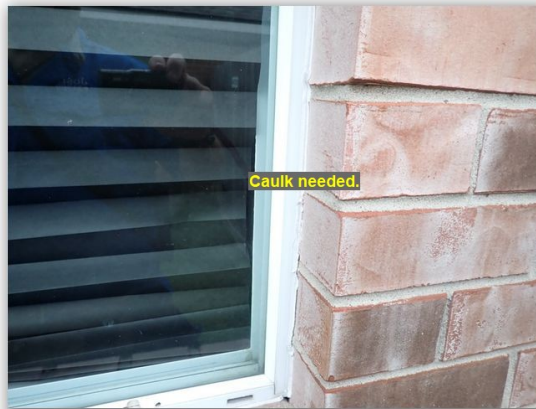
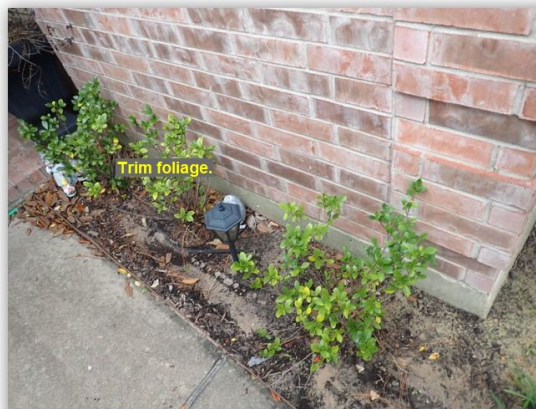
**Note:** Minor mortar and/or brick cracks were observed in the exterior veneer on the west side of the structure.

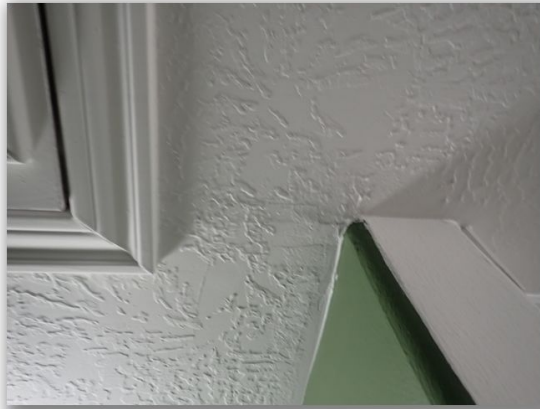
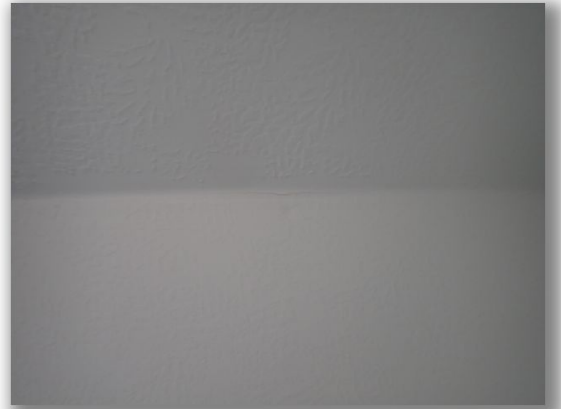
**Note:** Nail heads were observed to be pushing through the interior finish in one or more locations.

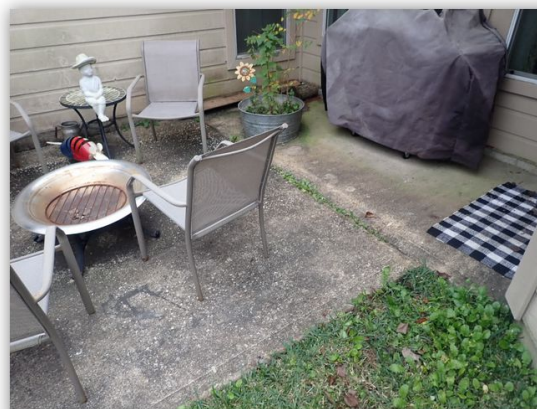
All components were found to be performing and in satisfactory condition on the day of the inspection.

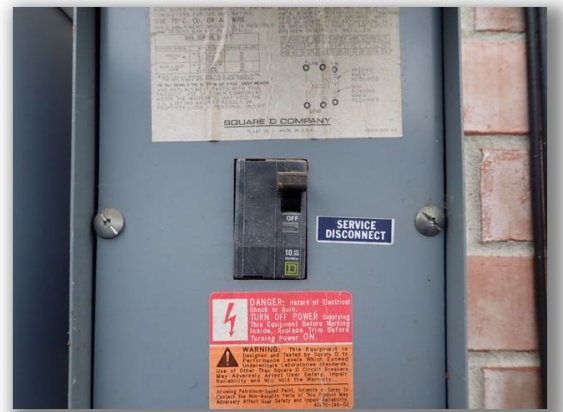
All components were found to be performing and in satisfactory condition on the day of the inspection.

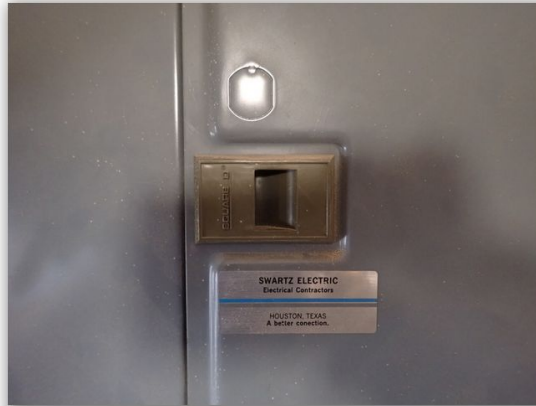
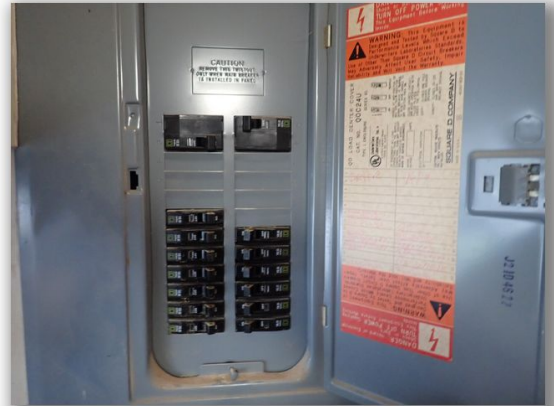
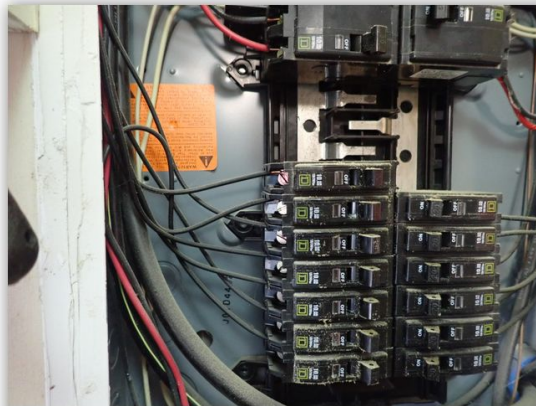
#### Arc-Fault Circuit Interrupter Protection (AFCI)

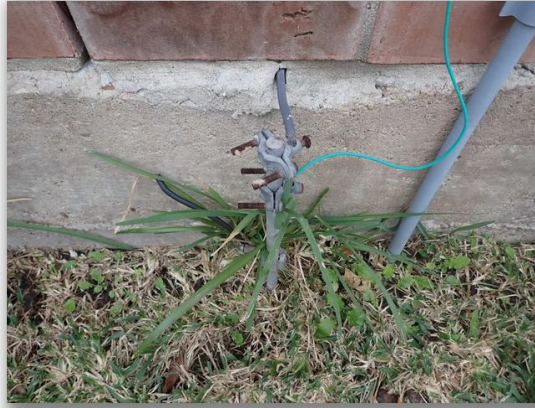
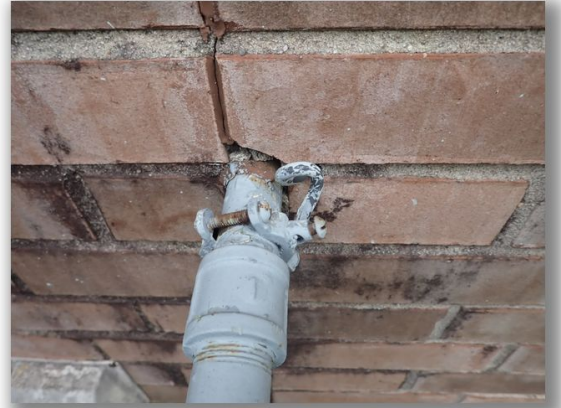
All components were found to be performing and in satisfactory condition on the day of the inspection.

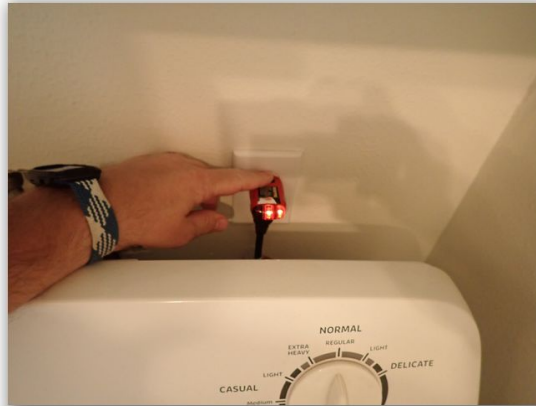
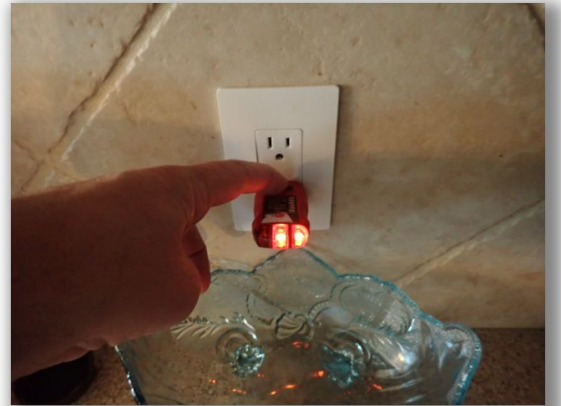
#### Arc-Fault Circuit Interrupter Protection (AFCI)

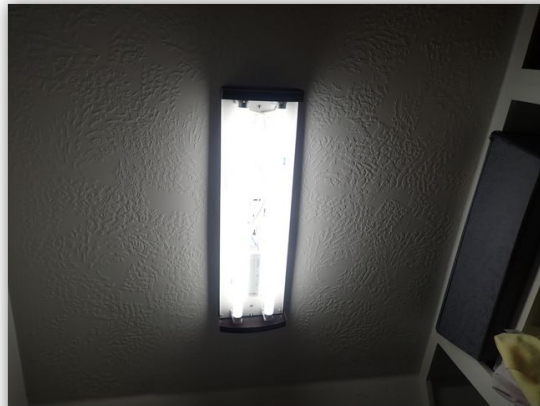
- One or more of the light fixture globes and/or covers are missing in the primary bedroom closet.

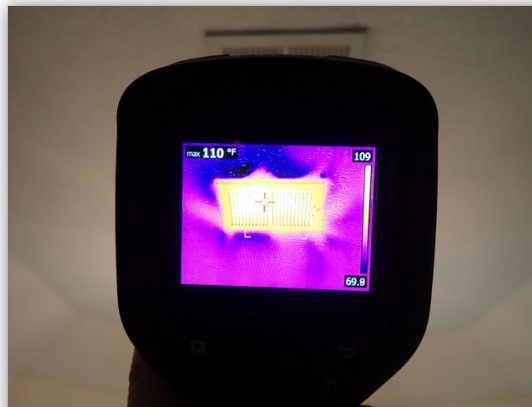
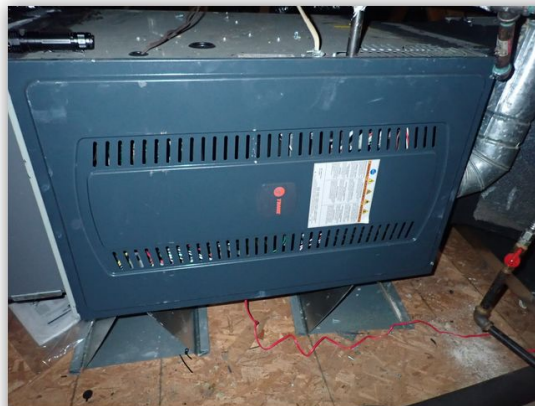
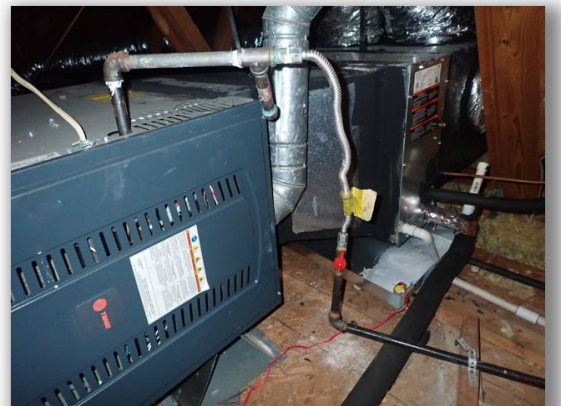
- The air return system currently has two filters in place (Double Filtered). The configuration will adversely affect the return air flow and performance of the HVAC system. This condition should be further evaluated and corrected as necessary.

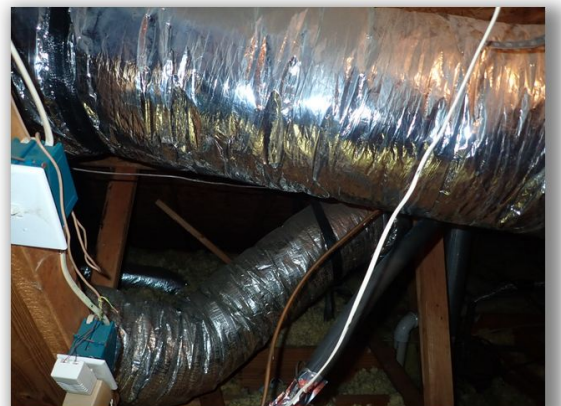
All components were found to be performing and in satisfactory condition on the day of the inspection.

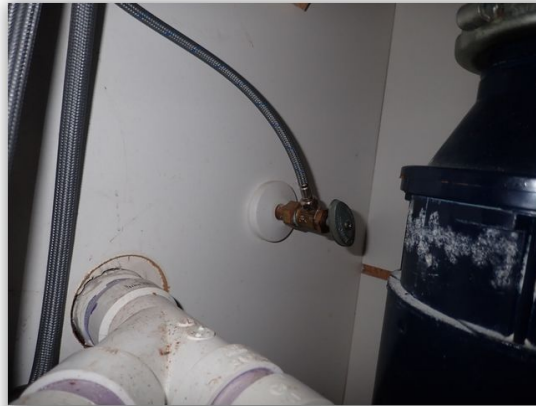
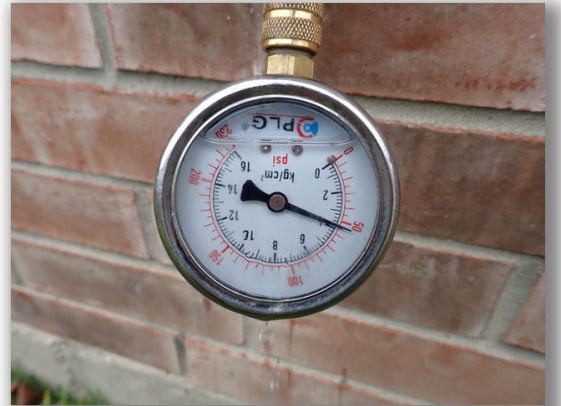
##### Exterior Faucets/Fixtures

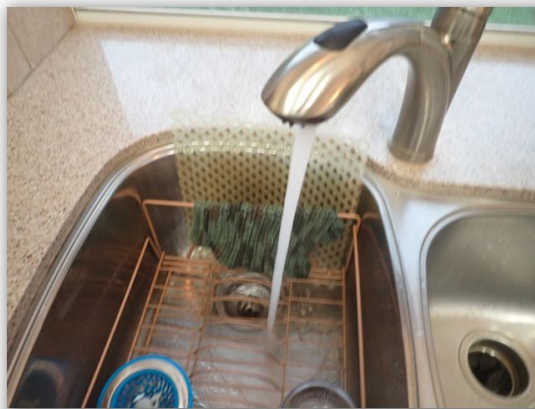
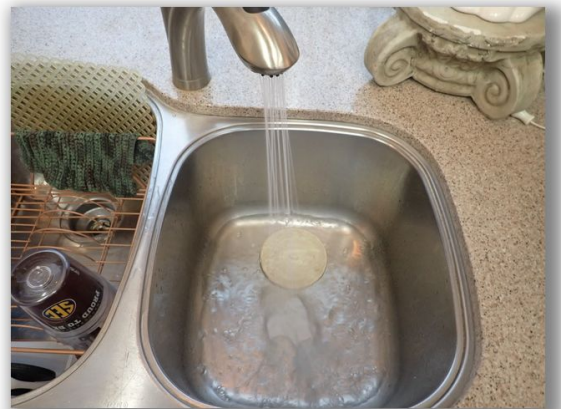
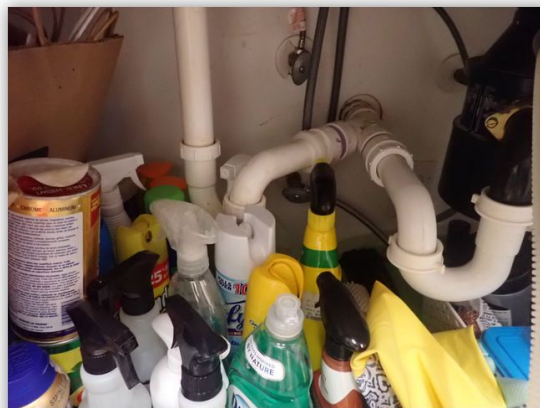
All components were found to be performing and in satisfactory condition on the day of the inspection.

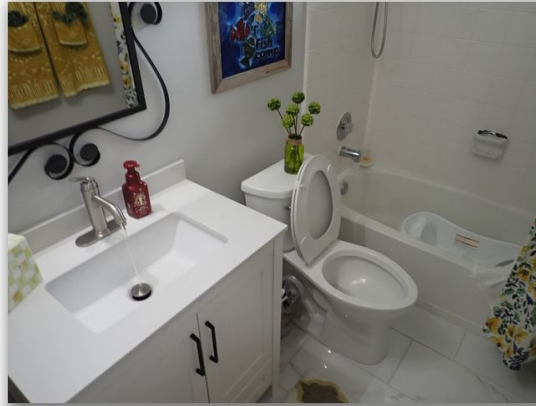
### Primary Bathroom

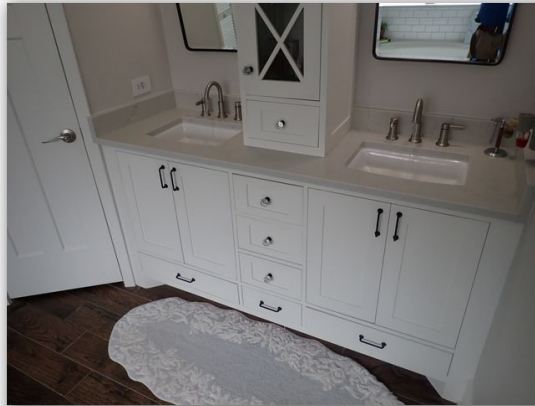
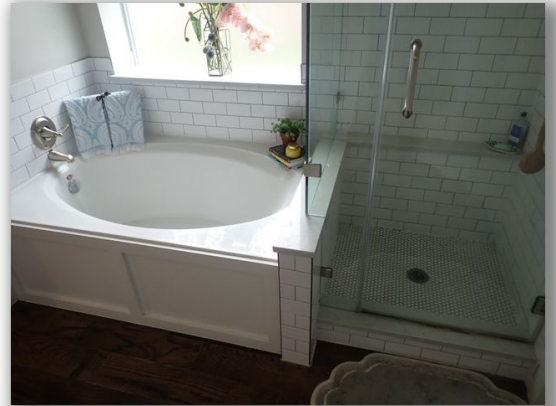
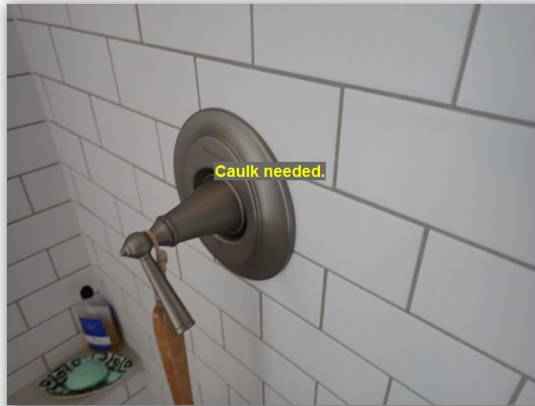
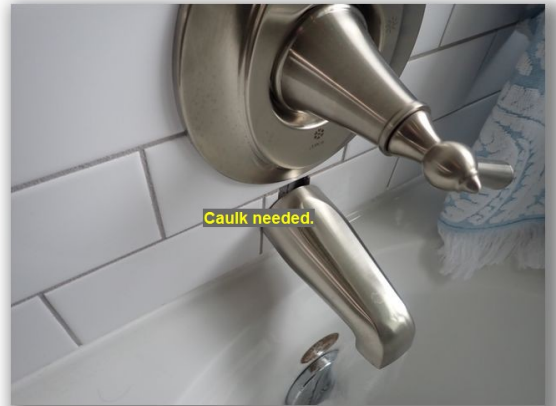
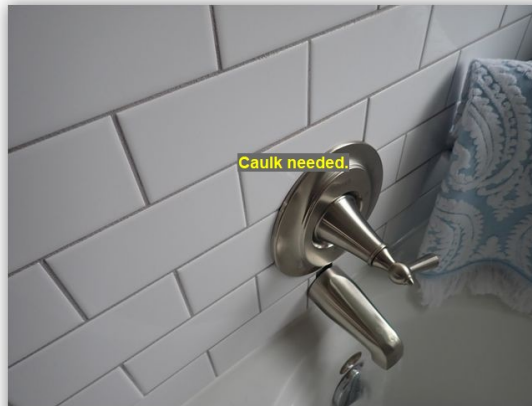
**Notice:** The Inspector has attempted to discover and report conditions requiring further evaluation or repair. However; determining the condition of any component that is not visible and/or accessible, such as plumbing components that are buried, beneath the foundation, located within construction voids or otherwise concealed, and reporting any deficiency that does not appear or become evident during our limited cursory and visual survey is outside the scope of this inspection. **The inspector will not be able to anticipate future events, conditions or changes in performance of any component or system due to changes in use or occupancy. The inspector makes no guarantee or warranty, express or implied, as to future performance of any item, system or component.**

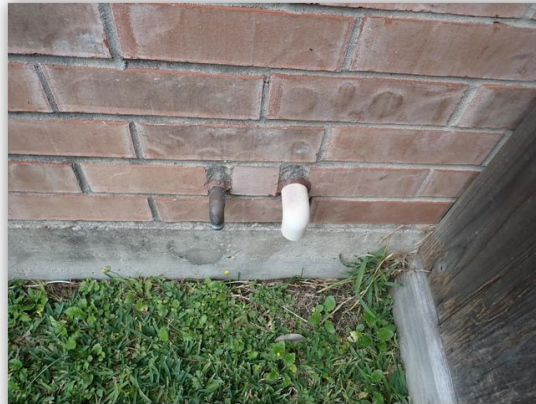
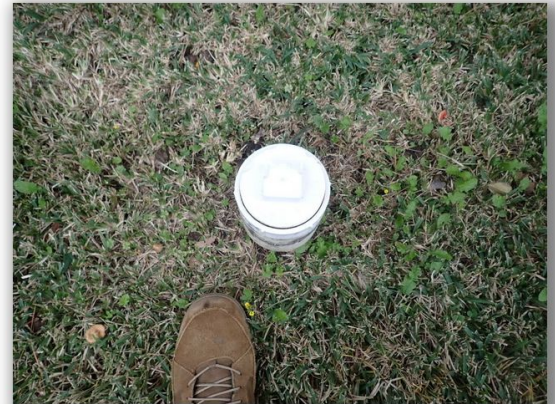
All components were found to be performing and in satisfactory condition on the day of the inspection.

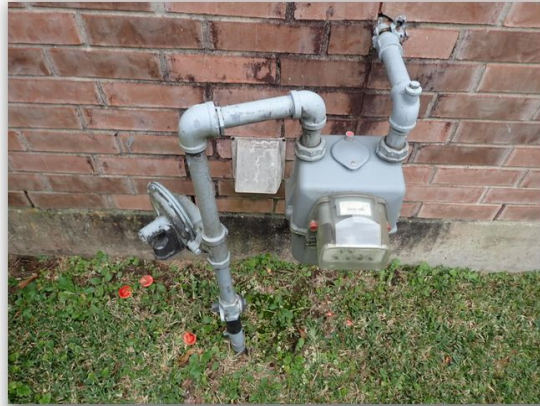
**Notice:** The Inspector will use a combustible gas leak detector on accessible gas lines, joints, unions and connectors and report visible deficiencies found at the time and date of the inspection. The inspector inspects the gas lines from the point they enter the structure and will complete the inspection without digging, damaging property, permanent construction or building finish. When performing the inspection, the inspector will keep in consideration the age of the system and normal wear and tear from ordinary use when rendering opinions.

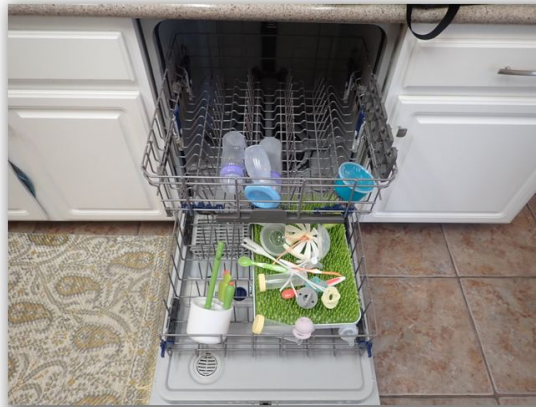
- The dishwasher drain hose is not properly installed to prevent back flow or anti-siphoning. It is recommended that an air gap device or high drain loop be installed in the drain line.

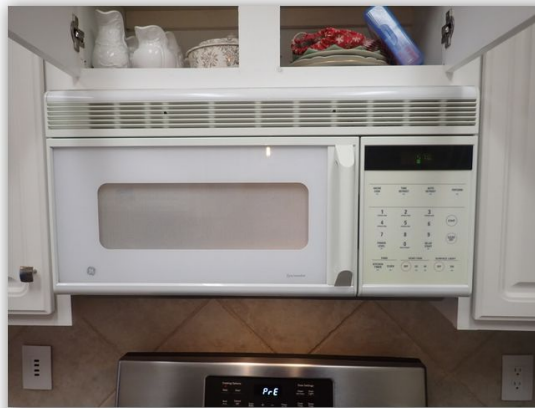
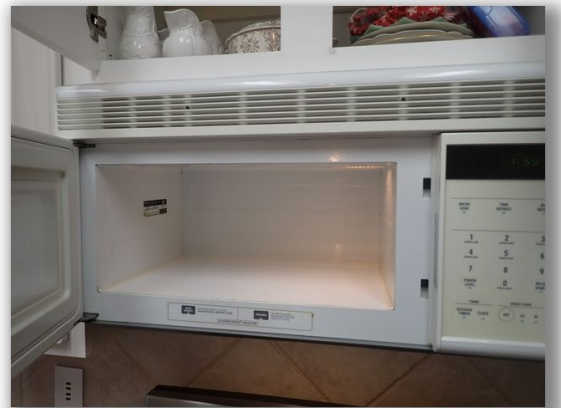
**Additional Notice from the Inspector:** It is the opinion of this inspector that although this component may be functioning as intended or in need of minor repairs, you should be aware that this is an older component and the future life expectancy cannot be determined. You can continue to use and service this component until replacement is necessary.

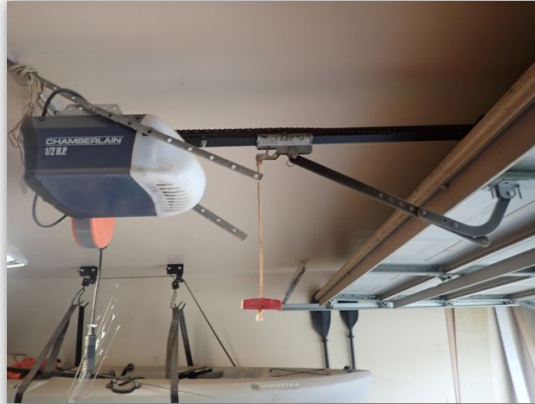
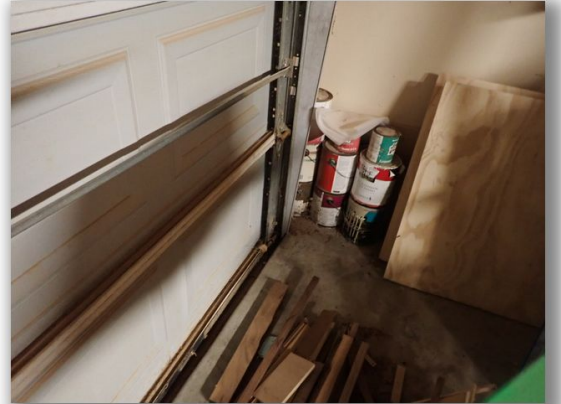
| <input checked="" type="checkbox"/> | <input type="checkbox"/> | <input type="checkbox"/> | <input type="checkbox"/> |

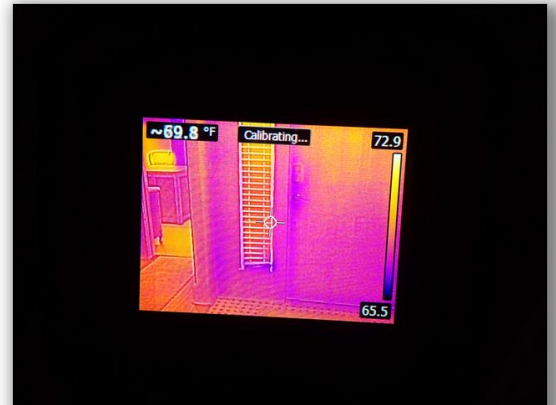
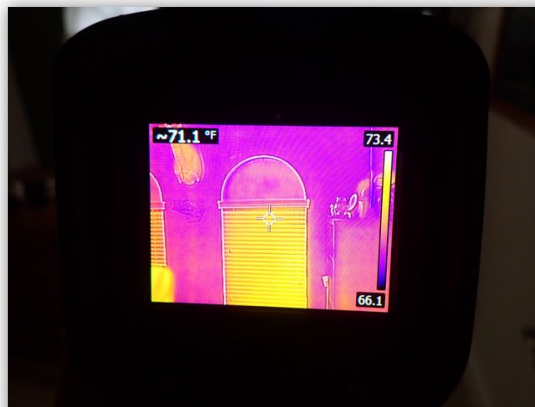
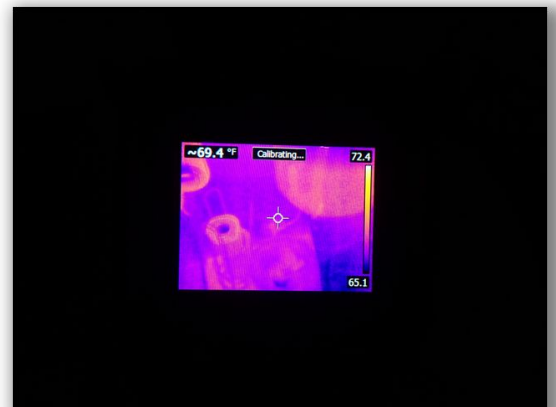
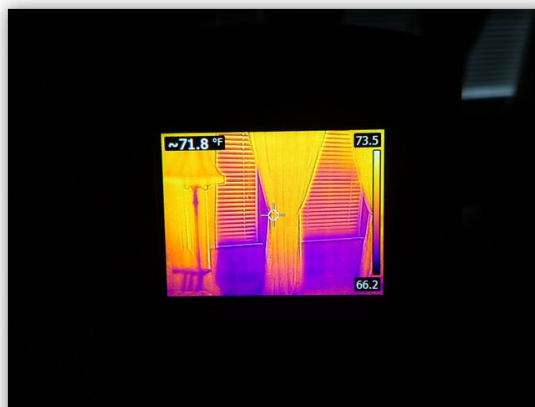
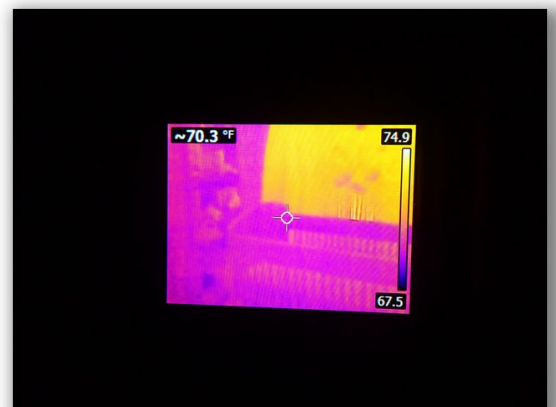
I=Inspected      NI=Not Inspected      NP=Not Present      D=Deficient

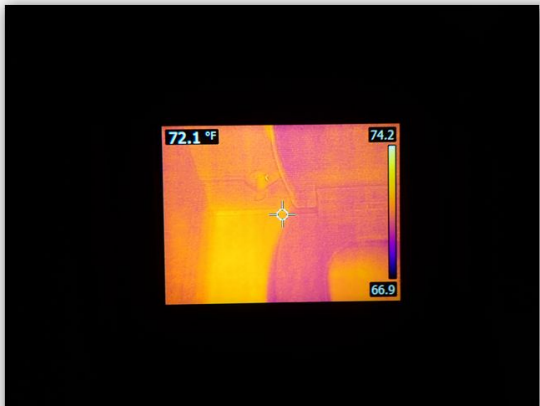
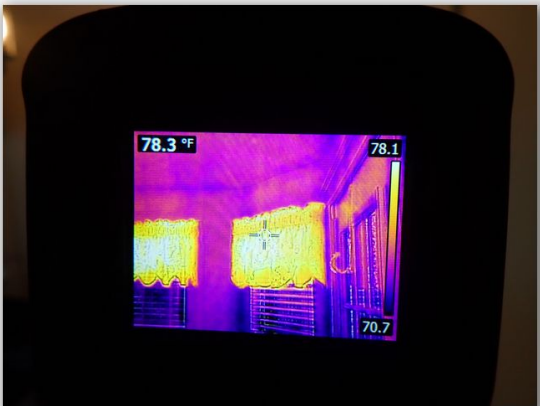
**INSPECTION AGREEMENT**  
**PLEASE READ THIS AGREEMENT CAREFULLY BEFORE SIGNING**

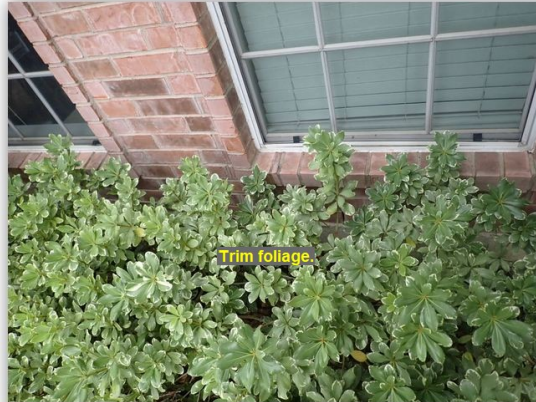
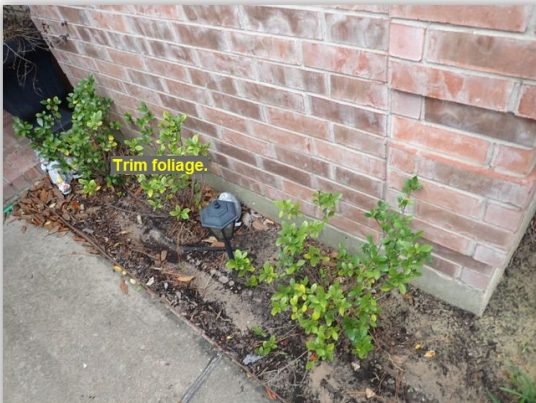
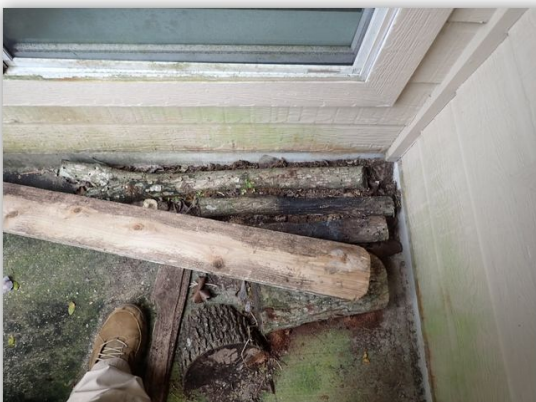
# TEXAS OFFICIAL WOOD DESTROYING INSECT REPORT
