CLADDING MOISTURE REPORT

Cladding Inspection Report

Subject Property : Sample Address, Houston, TX 77077

Evaluator: Joshua Donaho, Lic #23369 11/24/2021
(Name of Inspector) (Date)

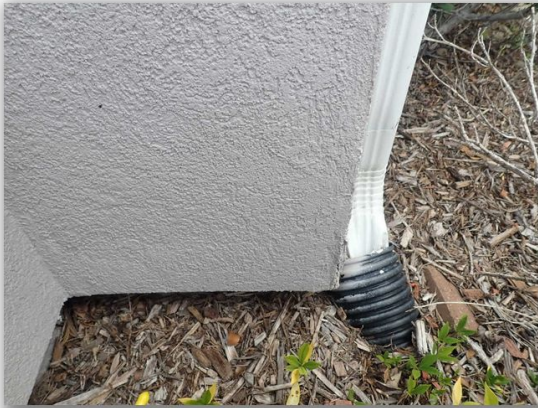
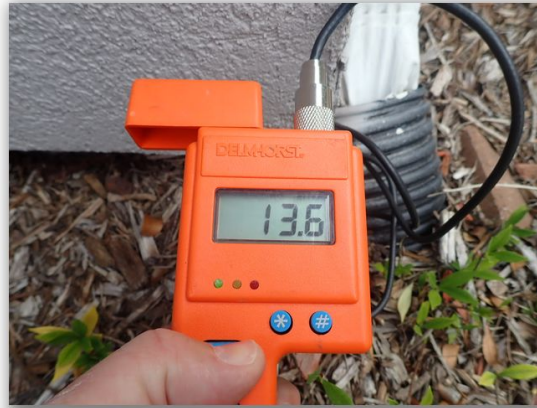
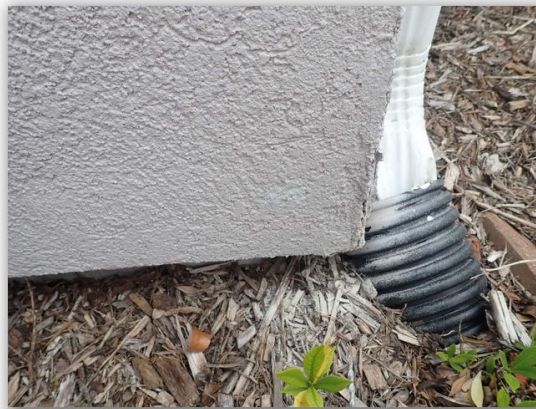
Drill Location F6

Substrate Condition: Compromised

Moisture Reading: 18.2%

- Elevated moisture readings in the substrate were observed at this location. The cause should be further evaluated and corrections made to prevent further damage to the substrate.
- The substrate (sheathing) behind the stucco finishes appear to be compromised. This condition needs to be further evaluated and repaired as necessary. It is my professional opinion that the stucco in the affected areas will need to be removed, the substrate replaced and the stucco finishes replaced.

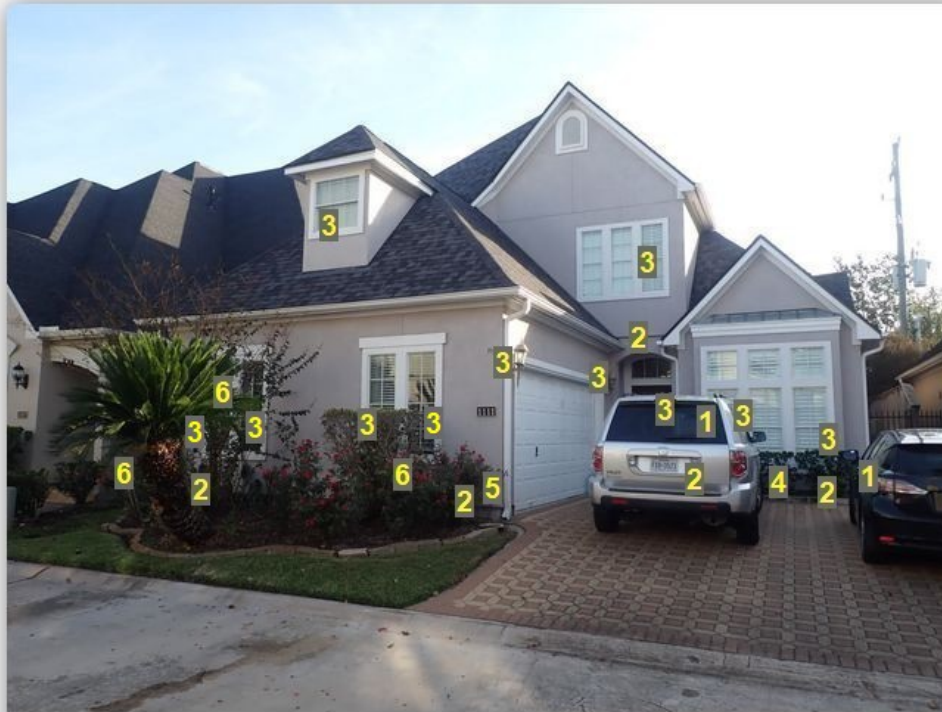
Front Side of Structure: Observations

- Some deterioration and/or damage to the stucco was observed. [Repairs are recommended.](#)
- Rust was observed on the stucco finish. This is an indication that water intrusion behind the stucco finish has occurred. [Repairs are recommended.](#)

- The weep screed was observed to be missing.
- The lower termination weep screed track was observed to be damaged. There are visible defects related to this condition at this time and repairs are recommended.

- There is failing and/or missing sealant at and around the window openings. It is recommended to remove and replace all old and failing sealant around the windows to help prevent water intrusion at these locations. It is recommended to use an industry approved NP1 sealant.
- The area between the exterior cladding / veneer and all of the wall penetrations / openings need to be properly sealed. Areas such as utility connections, downspouts, hose bibbs, lighting fixtures, receptacles etc. It is recommended to use an NP1 sealant.

- The stucco has poor clearance from the finished grade / earth. Under current installation standards, there should be at least 4 to 6-inches of clearance between the finished grade / earth and the stucco material. These condition can cause moisture damage to the stucco finishes and hold moisture within the wall cavities. It is recommended to lower the soil line below the stucco finishes.

- There is foliage in contact with the exterior stucco finishes. It is recommended to trim the foliage at least 18-inches off the exterior walls.

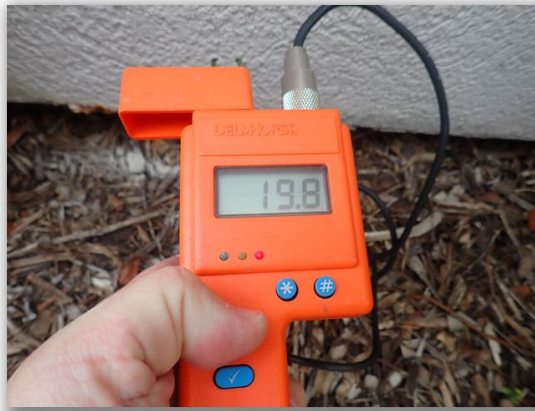
Drill Location E4

Substrate Condition: Compromised

Moisture Reading: 20.6

- Elevated moisture readings in the substrate were observed at this location. The cause should be further evaluated and corrections made to prevent further damage to the substrate.
- The substrate (sheathing) behind the stucco finishes appear to be compromised. This condition needs to be further evaluated and repaired as necessary. It is my professional opinion that the stucco in the affected areas will need to be removed, the substrate replaced and the stucco finishes replaced.

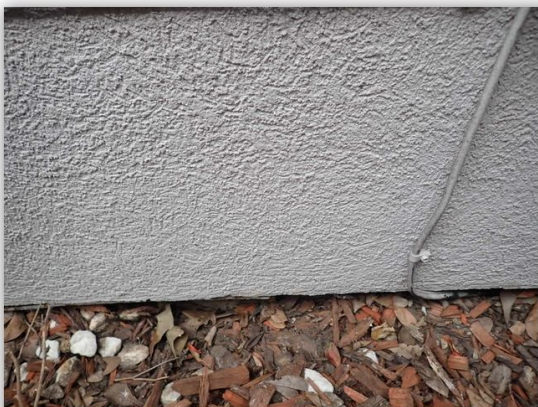
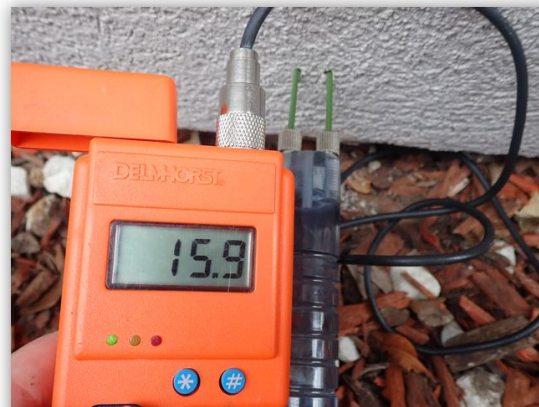
Substrate Condition: Compromised

Moisture Reading: 15.9%

- Elevated moisture readings in the substrate were observed at this location. The cause should be further evaluated and corrections made to prevent further damage to the substrate.
- The substrate (sheathing) behind the stucco finishes appear to be compromised. This condition needs to be further evaluated and repaired as necessary. It is my professional opinion that the stucco in the affected areas will need to be removed, the substrate replaced and the stucco finishes replaced.

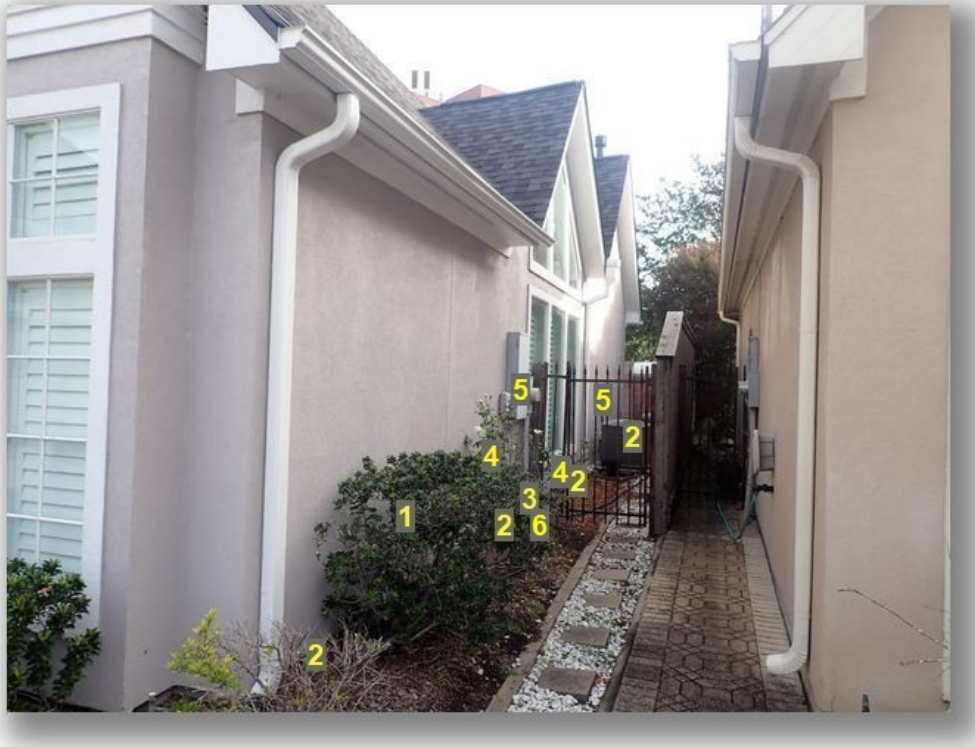
Right Side of Structure: Observations

- There is foliage in contact with the exterior stucco finishes. It is recommended to trim the foliage at least 18-inches off the exterior walls.

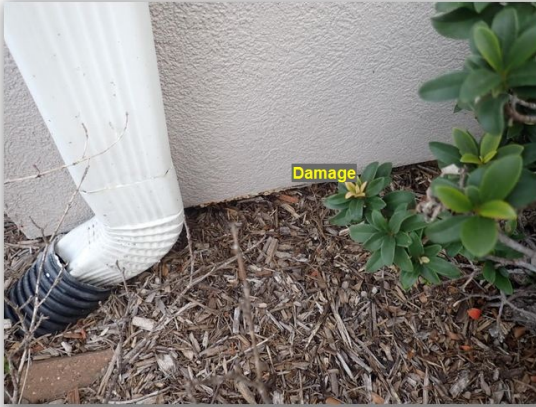
Item Number 2

- The weep screed was observed to be missing.
- The lower track / weep screed was observed to be rusted in one or more locations. There are visible defects related to this condition at this time and repairs are recommended.
