**Sample Report  
1234 Any Street  
Anytown, TX 12345**

**February 28, 2020**

## PROPERTY CONDITION REPORT

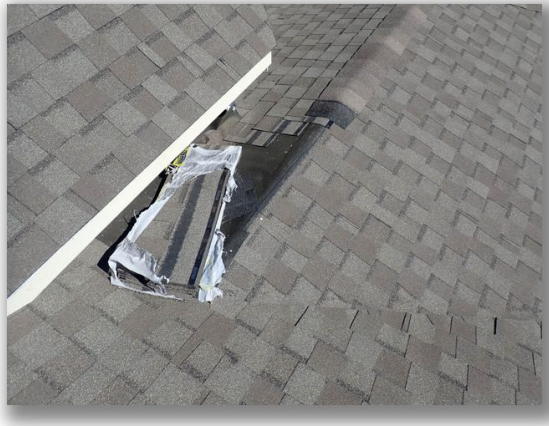
- The drain vent flashing details were observed to be missing on the north, east, west and south sides of the roof structure. This condition could allow water penetration at this point.
- Drip edge flashing details were observed to be missing on the north side, west side of the roof structure. This condition could allow water penetration at this point.

The flashing details needs to be checked, reset or repaired as necessary. The observations made to support the rendering of this opinion are listed but may not be limited to:
