**Sample Report**

**December 8, 2021**

# PROPERTY INSPECTION REPORT FORM

12345 Sample Report, Humble, TX 77346

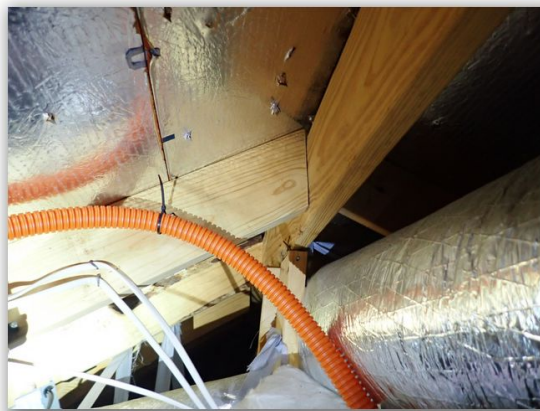
- It is recommended to seal all openings between the soffit and roof covering to prevent pest/rodent intrusion at this point.

**Note:** Visible evidence of rodent activity was observed in the attic area. It is recommended to have a Certified Pest Control Operator further evaluate this condition and make corrections as necessary.

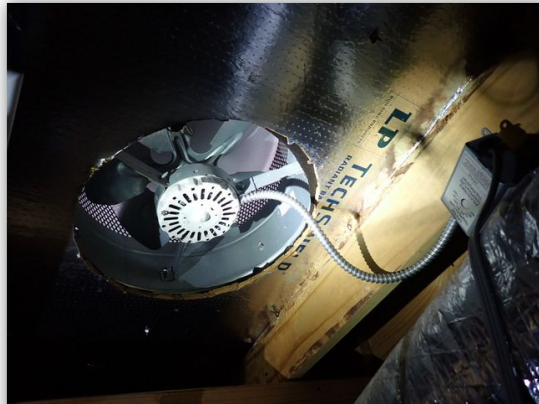
#### Attic Power Vents

- One or more of the attic power ventilators appears to be inoperative.
- One of the power ventilations adjustment knobs were observed to be missing at the time of inspection.

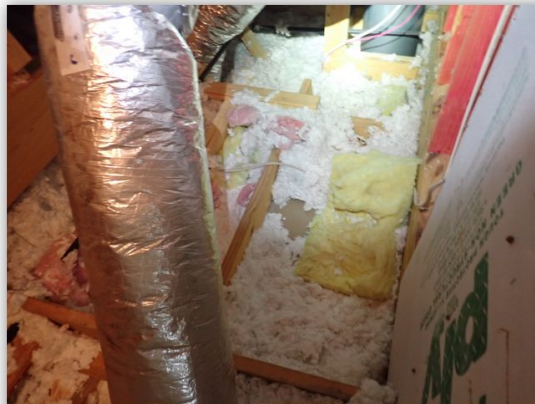
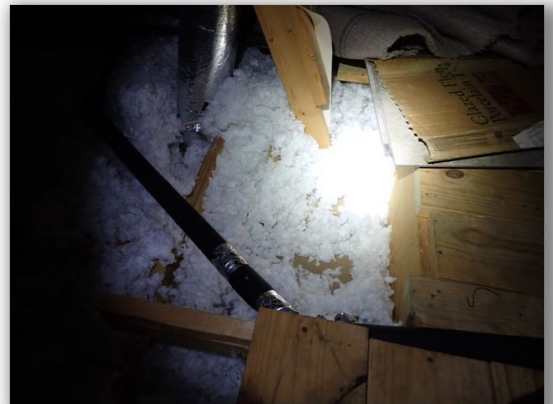
#### Attic Insulation

- The attic floor insulation needs to be redistributed in one or more locations.

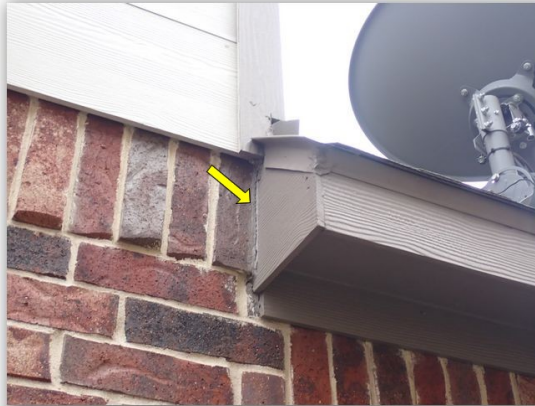
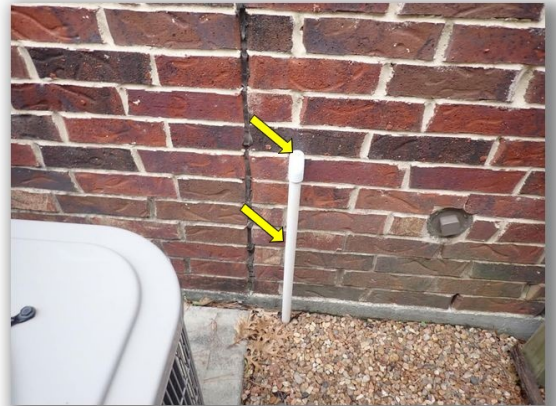
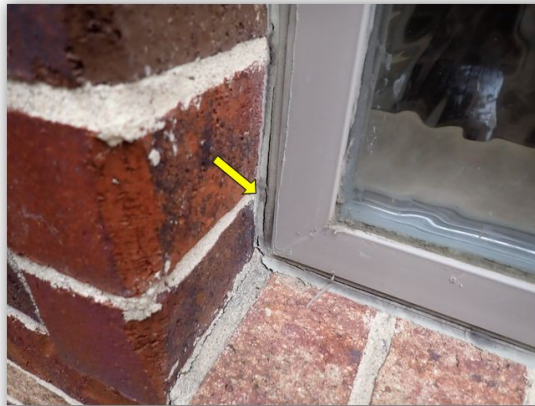
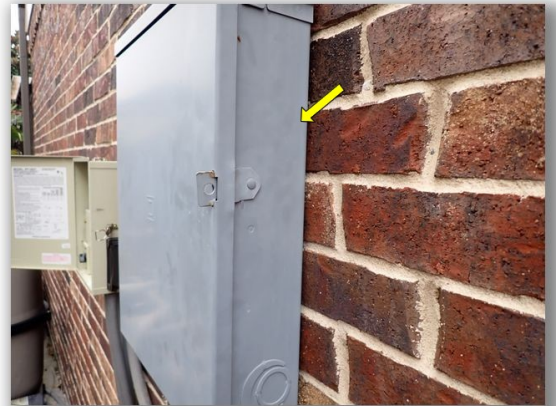
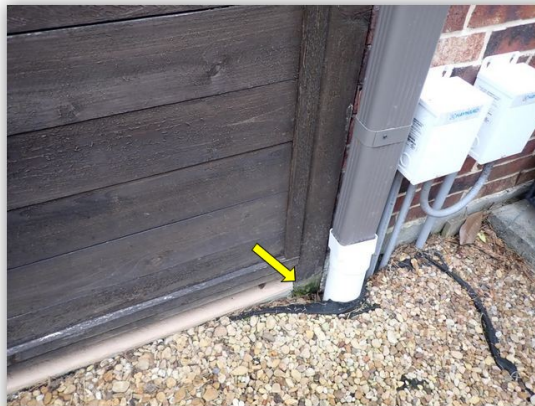
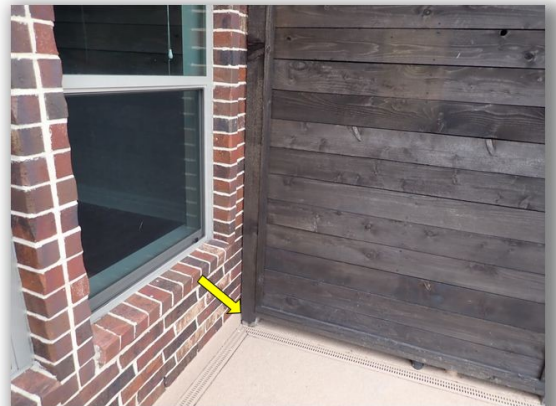
- One or more of the exterior bricks were observed to be loose on the east side of the structure.
- The steel lintels over the exterior doors and windows need to be painted.

- All of the exterior wood type surfaces need a fresh coat of paint.
- The flashing needs to be painted to prevent rust and/or UV damage.

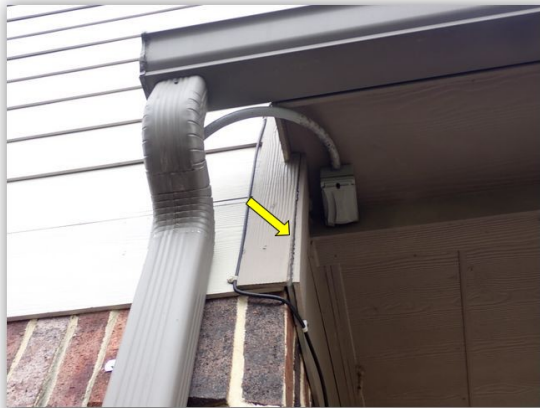
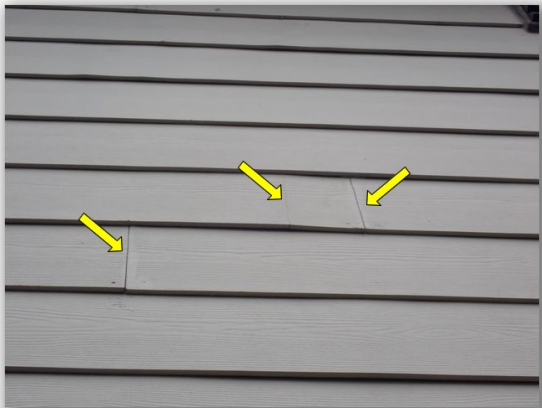
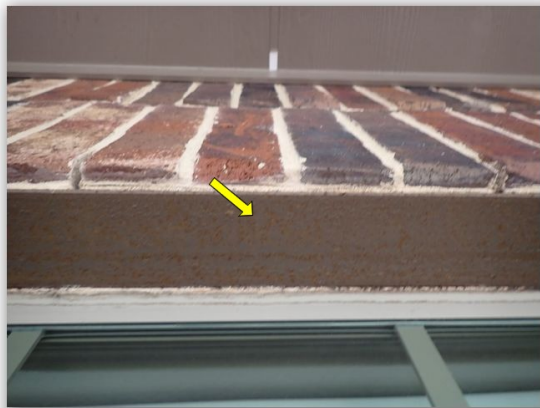
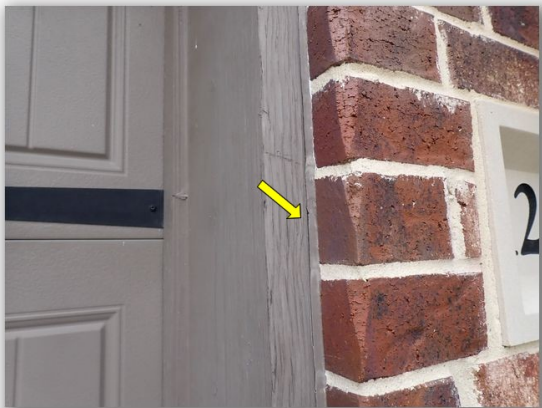
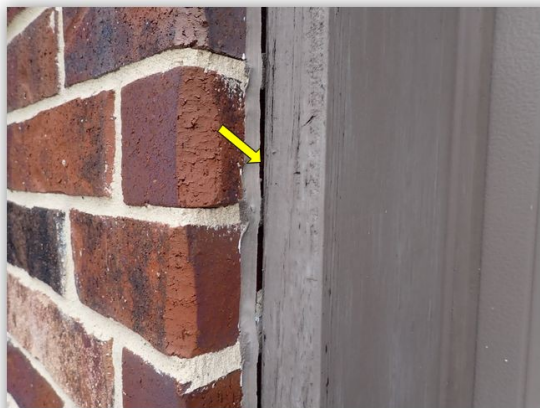
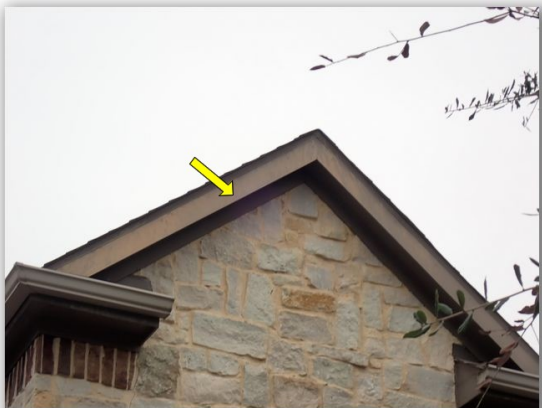
- Mortar improvements are recommended for the exterior masonry veneer on the south side of the structure.
- The exterior veneer / cladding was observed to be pulling loose and needs to be better secured on the north side, east side of the structure.

- The exterior veneer / cladding has some deterioration and/or damage on the east side of the structure.
- All wood to ground contact at the base of the siding should be eliminated. Rotted or damaged siding that is uncovered should be repaired. The siding was observed to be in contact with the finish grade (ground) on the north side of the structure.

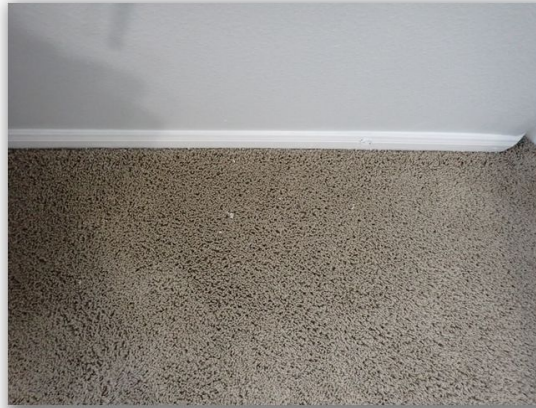
**Floors**

- The floor covering is stained in one or more locations of the home.
- The floor covering is worn and/or damaged in one or more locations of the home.
- The floor covering was observed to be damaged in the upstairs rear corner bedroom.

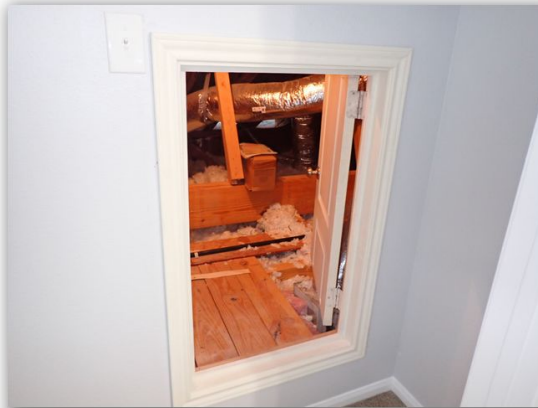
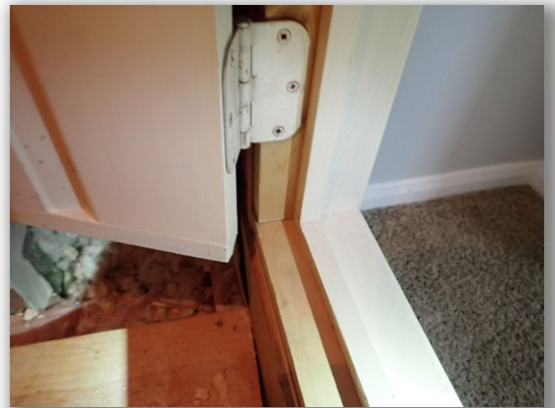
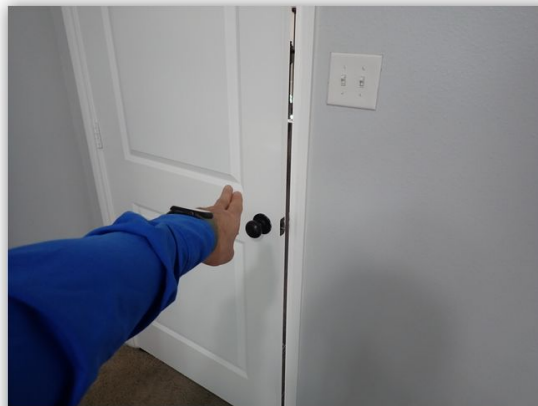
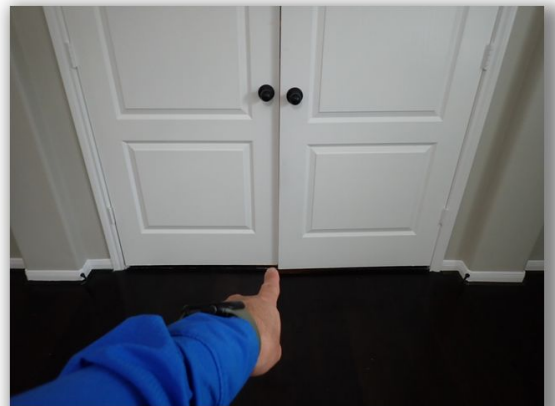
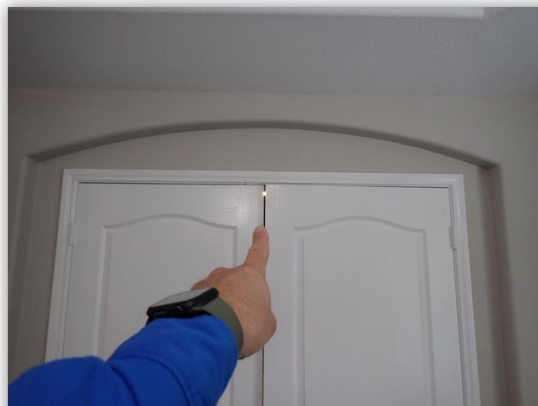
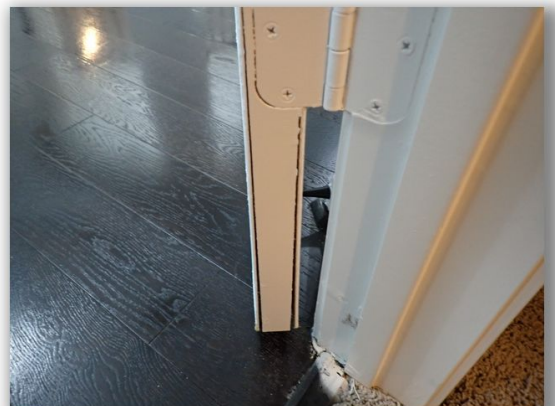
- The walk in attic entry door is not equipped with a self-closing device.
- Weather-stripping improvements are recommended for the walk in attic interior door(s).
- The door is not latching properly to the upstairs hall bathroom, media room.
- The door is sticking to the upstairs front corner bedroom, media room, primary bathroom closet.
- The door frame has some damage to the upstairs side middle bedroom.
- The hollow core door is separating and/or damaged to the media room.

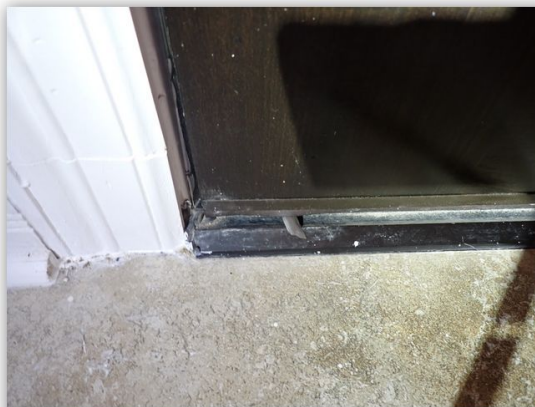
#### Exterior Doors

- Weather-stripping improvements are recommended for the front entry, backyard entry exterior door(s).
- The door is not latching properly to the front entry door.

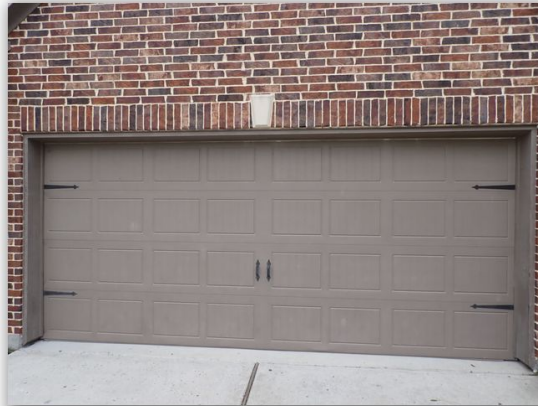
#### Overhead Garage Door

- The weather-stripping at the bottom of the overhead garage door is damaged and repairs or replacement may be necessary.
- It is recommended to lubricate the overhead garage door components, such as rollers, tracks and hinges.

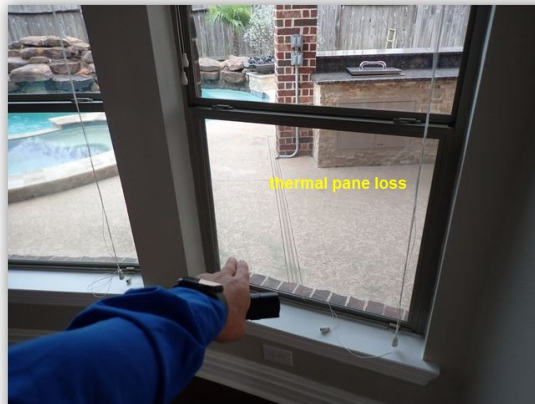
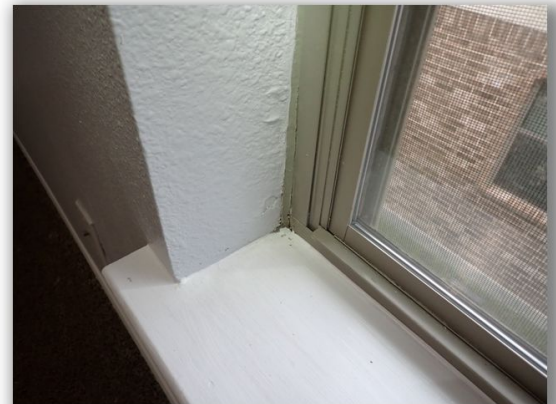
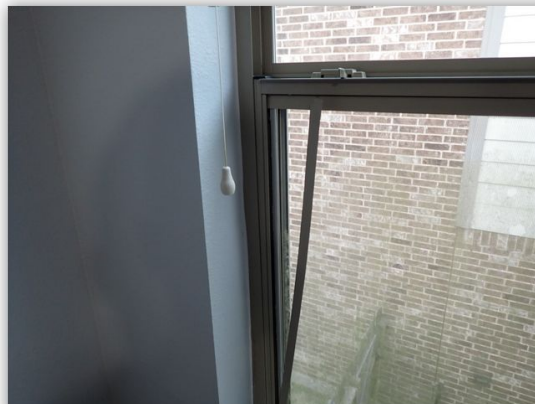
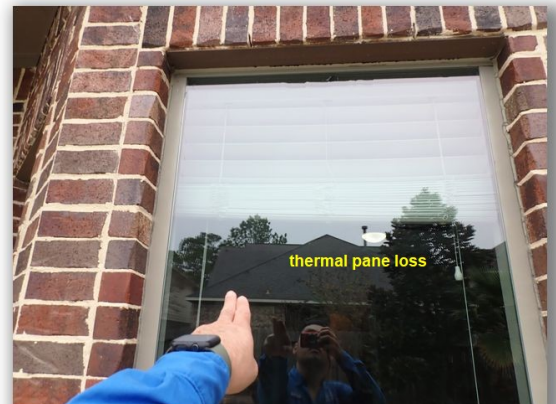
- One or more of the thermal pane windows were observed to have lost their seals. This has resulted in condensation or a fog like film to develop between the panes of glass. The thermal pane windows no longer function as designed when they lose their seal and replacement may be necessary. The windows that have noticeably lost their seals are listed but may not be limited to the following:  
living room, primary bedroom.

- Visible evidence of water intrusion was observed at and/or around the window(s) in the upstairs rear corner bedroom. The cause and remedy should be investigated and corrected as necessary.
- The window weather-stripping is damaged and/or missing at one or more of the windows and improvements are recommended.

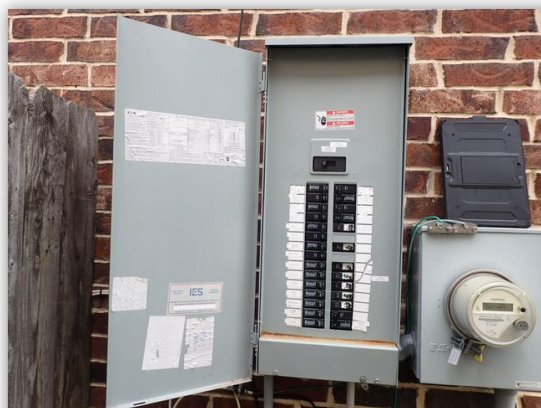
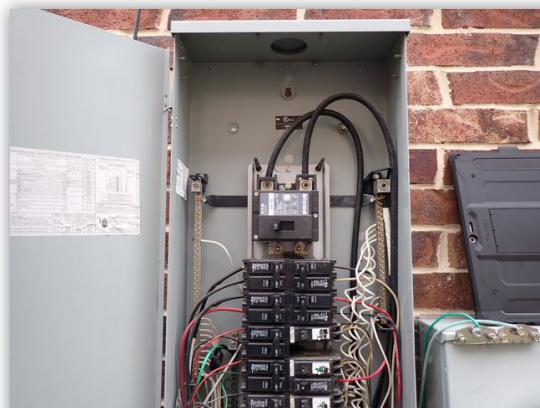
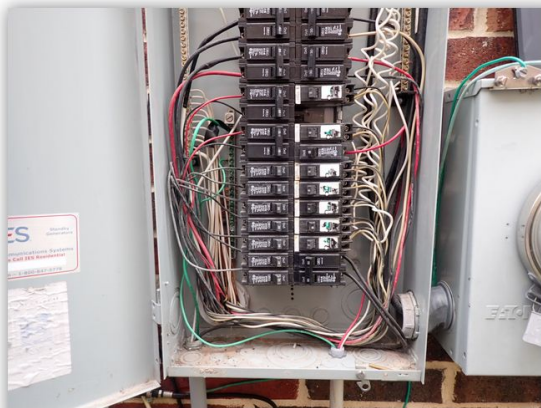
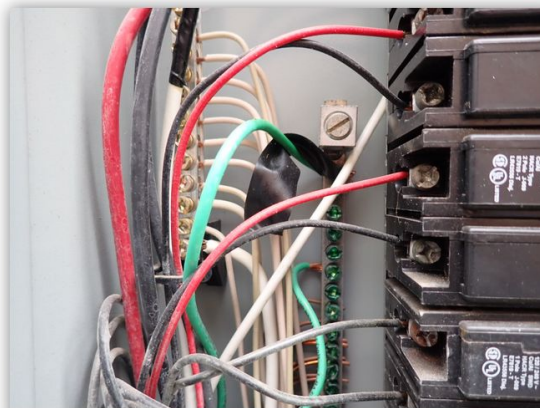
**Arc-Fault Circuit Interrupter Protection (AFCI)**

- One or more of the arc-fault circuit interrupter (AFCI) devices in the electrical cabinet did not trip and/or respond properly when tested. This condition should be further evaluated and corrected as necessary.

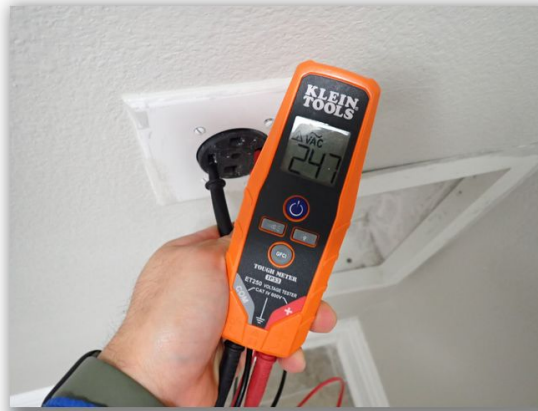
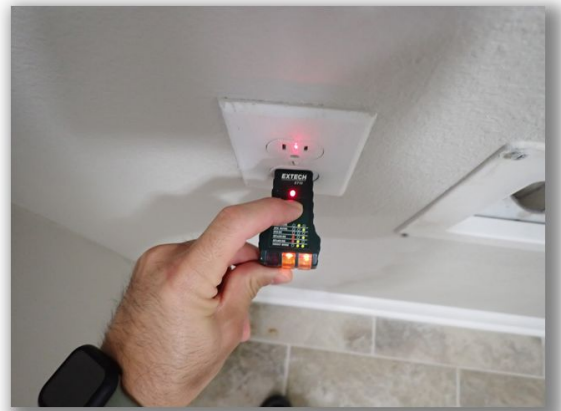
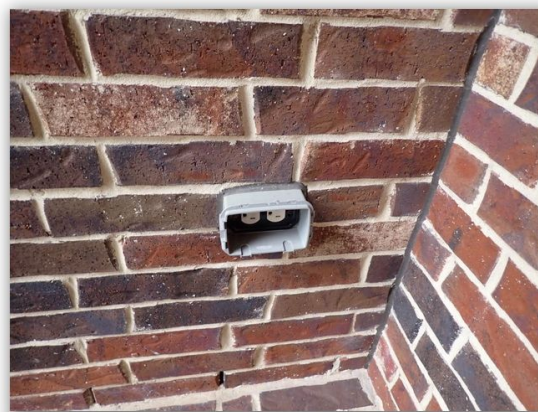
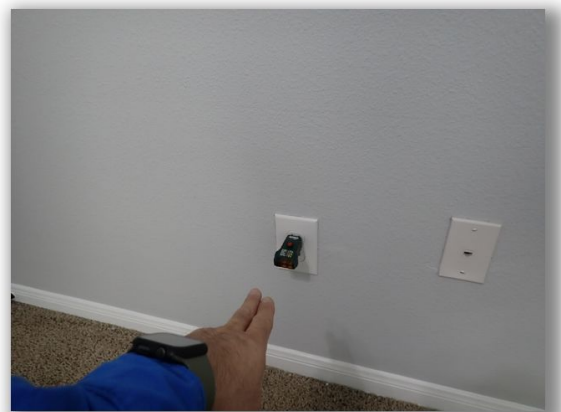
- The laundry room area receptacles do not appear to be connected to a ground fault circuit interrupter (GFCI) device. Under current electrical standards, all of the receptacles in the laundry room area should have GFCI protection.
- All exterior receptacles should have weather tight covers. The receptacle weather cover plate is damaged and/or missing on the front porch.
- One or more of the receptacles were observed to be damaged in the upstairs side middle bedroom.

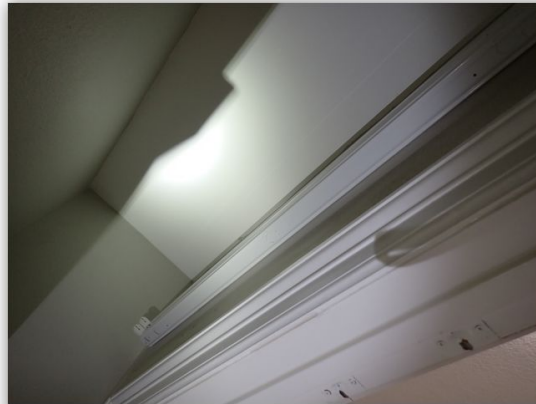
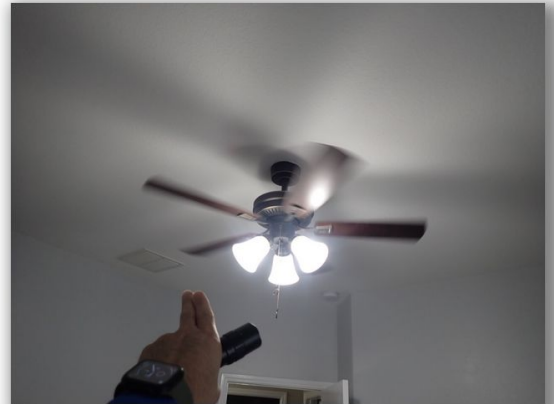
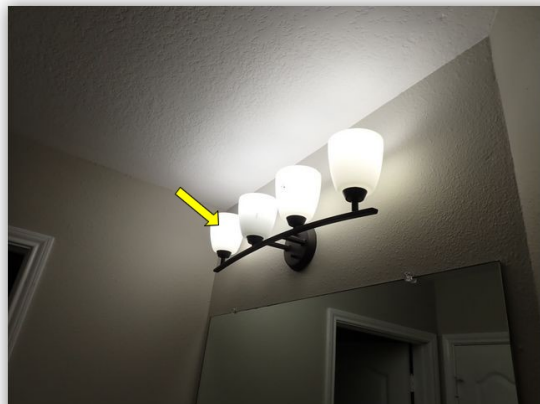
#### Fixtures

- One or more of the light fixtures appear to be inoperative in the pantry. This may be due to a bad bulb or some other unknown condition. This condition should be further evaluated and corrected as necessary.
- The ceiling fan was observed to be noisy when operated in the upstairs rear corner bedroom.
- The ceiling fan is not balanced properly and wobbles when operated in the upstairs side middle bedroom, upstairs rear corner bedroom.
- The upstairs hall bathroom fixture was observed to be flickering at the time of inspection. This condition should be further evaluated.

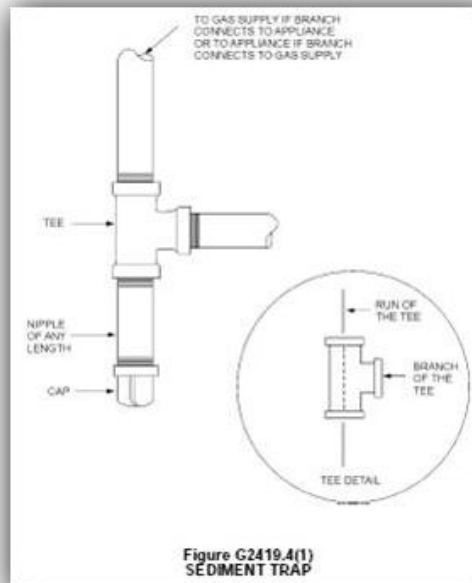
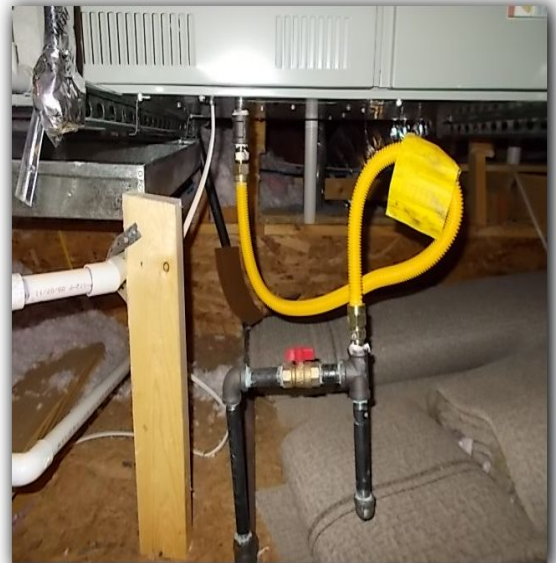
- The heater gas supply line sediment trap was observed to be improperly installed. This condition does not meet current installation requirements and should be corrected.

Samples of correct sediment trap installation.

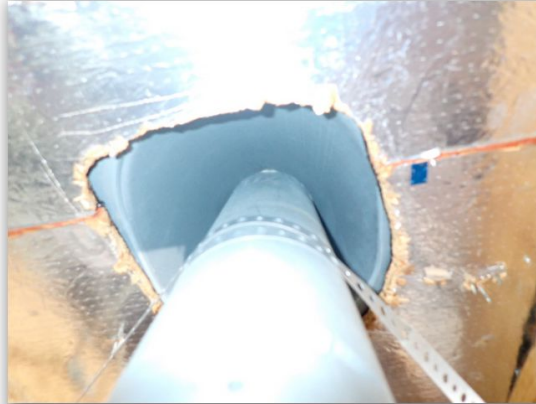
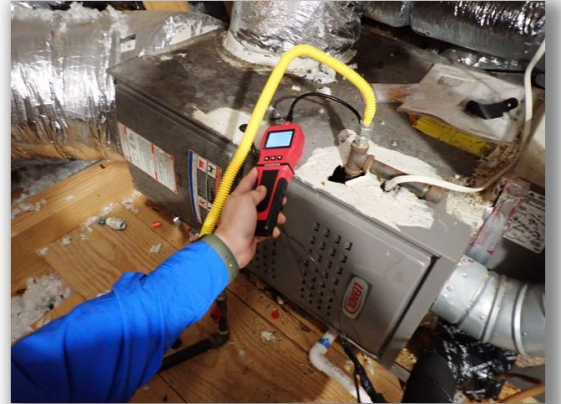
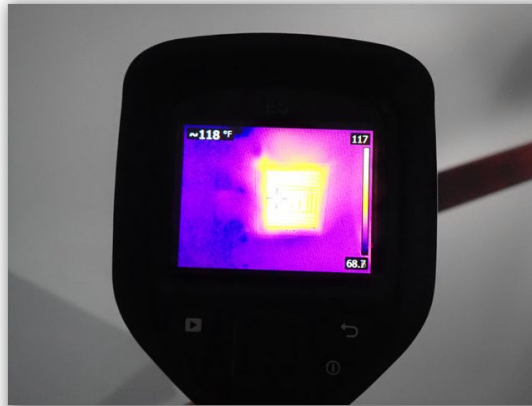
**Central Heating System(downstairs) – Energy Source: Gas**

- The heater gas supply line sediment trap was observed to be improperly installed. This condition does not meet current installation requirements and should be corrected.
- The heating equipment appears to be inoperative at the time of the inspection.

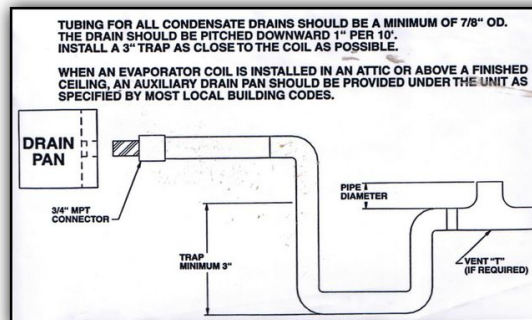
- The dirty air filter should be replaced.
- Air leaks were detected at and around the indoor coil housing. The air leaks should be corrected for improved efficiency.
- The primary condensate drain line is not equipped with a p-trap. Under current mechanical installation standards, the manufacturer requires a p-trap be installed in the primary condensate drain line within 6-inches of the coil housing.

**Note:** The auxiliary/secondary drain pan under the coil housing has some water staining and/or a rust build-up. This would indicate that the pan has held water in the past and should be closely monitored.

**Notice:** The AC system condenser/coil components are not from the same manufacture. When this type of installation occurs, it may void the manufacture warranty on one or more of the system components. It is recommended to obtain documentation as to whether the manufacture warranty has been voided due to the mismatched manufacture installation.

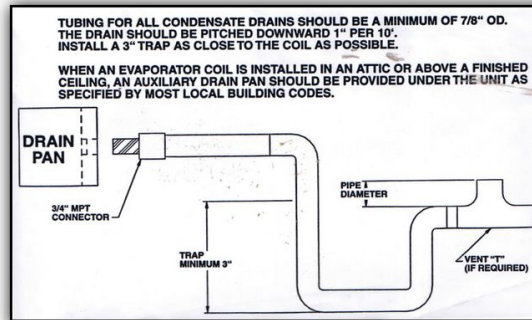
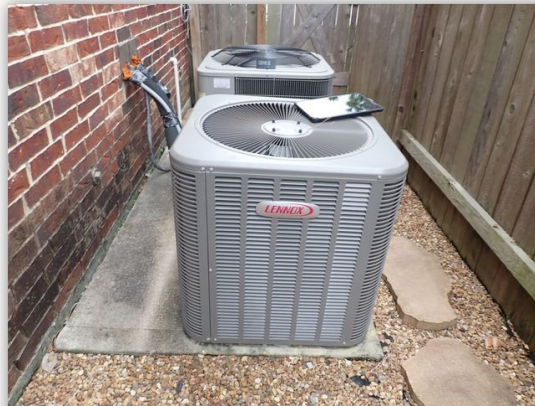
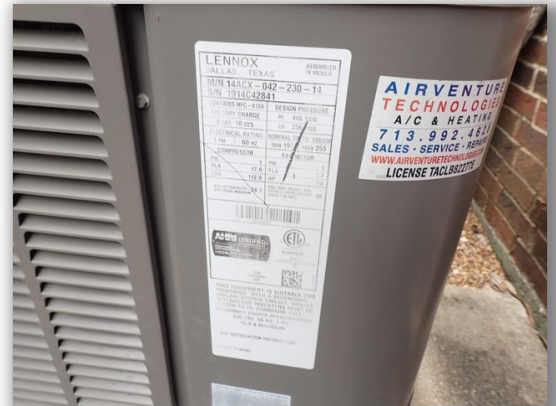
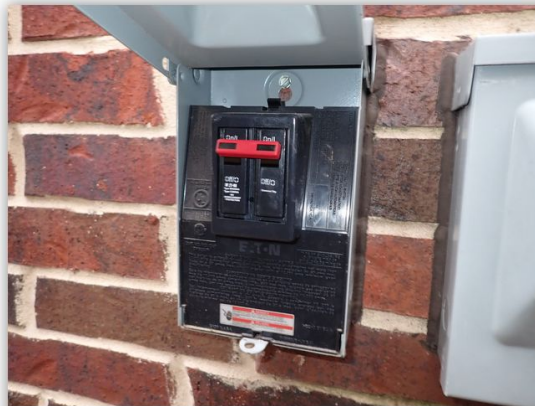
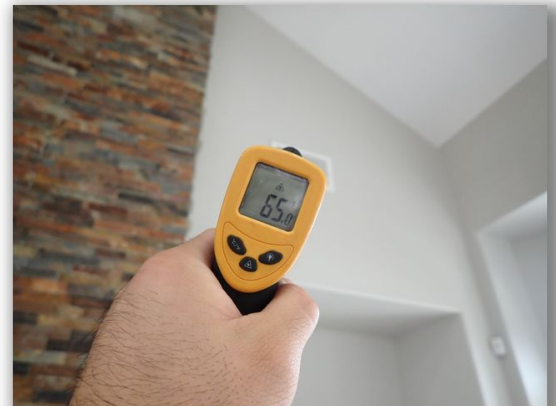
#### Central Cooling System (downstairs)

- The dirty air filter should be replaced.
- **The temperature drop measured across the evaporator coils of the air conditioning system is lower than considered typical. The unit is not cooling properly and servicing is needed.**
- The cooling system appears to be low on freon. This condition should be further evaluated and corrected by a licensed HVAC technician.
- The primary condensate drain line is not equipped with a p-trap. Under current mechanical installation standards, the manufacturer requires a p-trap be installed in the primary condensate drain line within 6-inches of the coil housing.

**Note:** The auxiliary/secondary drain pan under the coil housing has some water staining and/or a rust build-up. This would indicate that the pan has held water in the past and should be closely monitored.

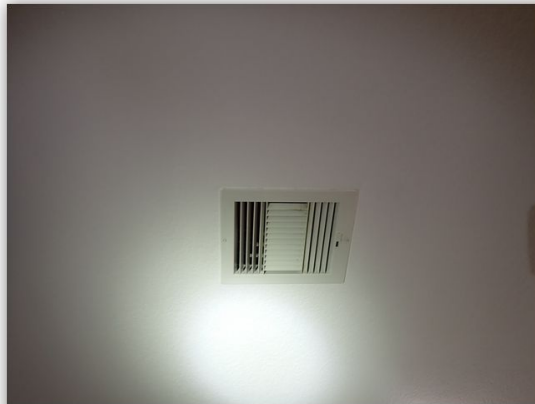
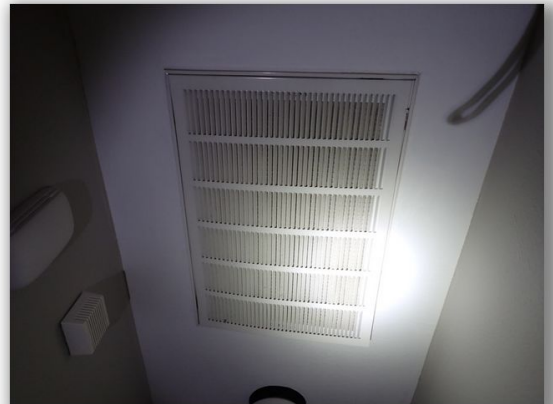
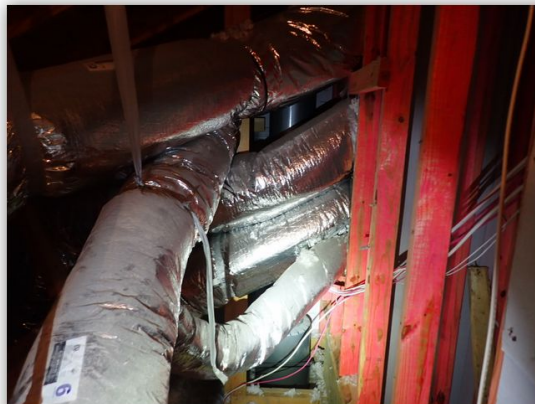
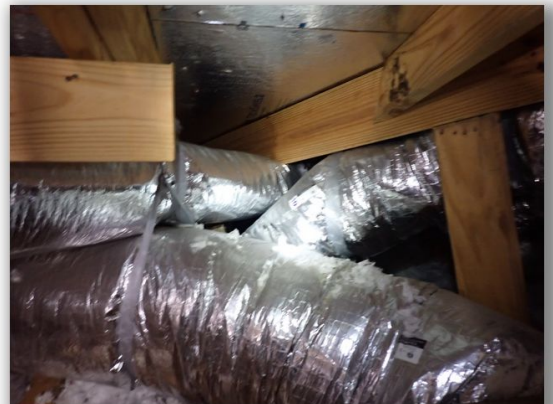
- The duct work in the attic area does not appear to be properly separated to help prevent condensation from developing. It is recommended to separate the duct work with a minimum intervals of 1.5-inches.
- The air-return chase for the HVAC system is dirty and should be cleaned to help maintain good air quality.
- There is visible dust and/or mildew on the air registers in the kitchen. The cause and remedy should be further evaluated. It is recommended to have the air registers and duct system cleaned for air quality purposes.

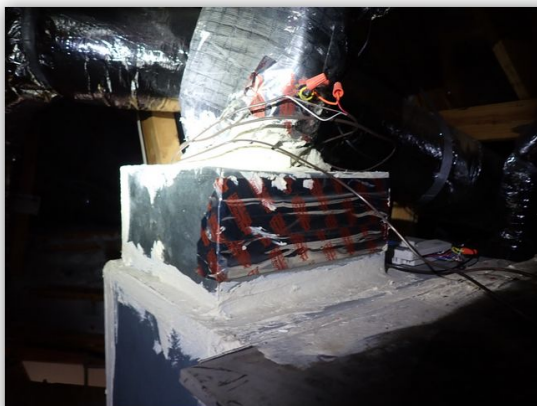
**D. Other**

- The fresh air filter should be replaced every 6 months.

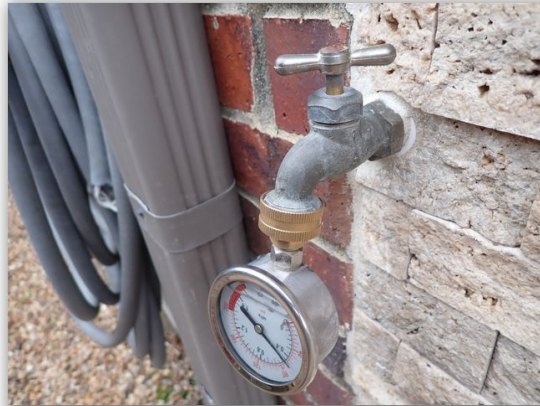
##### Exterior Faucets/Fixtures

- One or more of the exterior water hose bibbs (faucet) do not have a back-flow or anti-siphon device (Vacuum Breakers) in place. **Note:** *This is not uncommon to observe with a home of this age.*

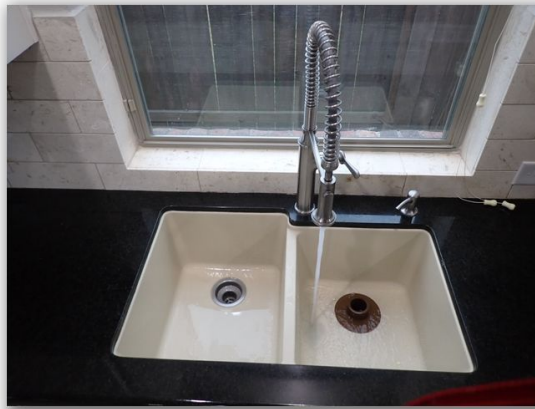
### **Kitchen Sink**

- The shelf in the cabinet under the sink is damaged.

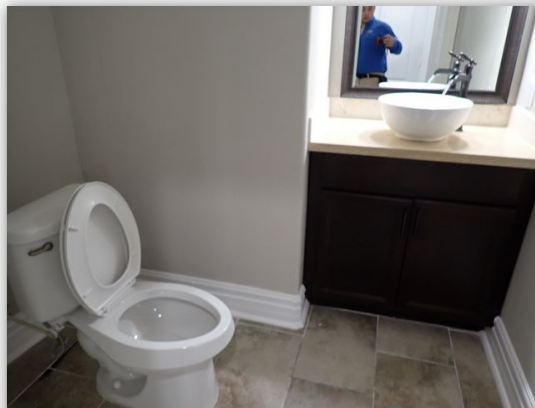
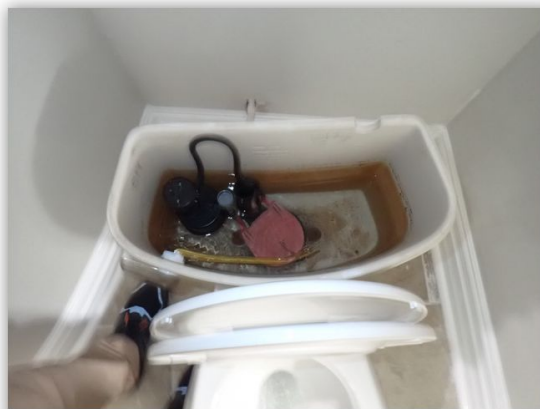
*Commode / Toilet*

- The commode is loose at the floor mount.

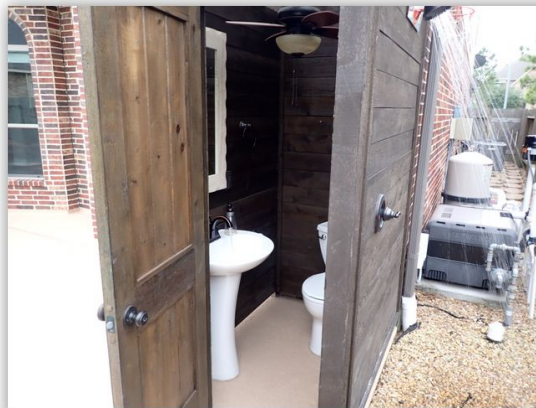
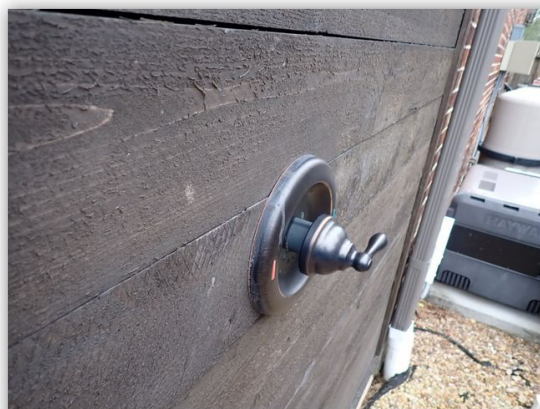
### **Pool Bathroom**

- The faucet assembly is not sealed at the wall. This condition has the potential to allow water to leak back into the wall cavity.

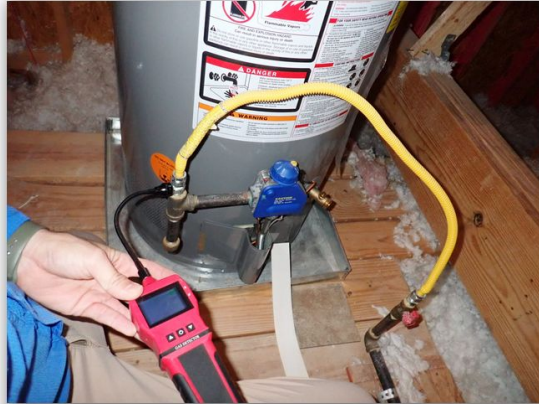
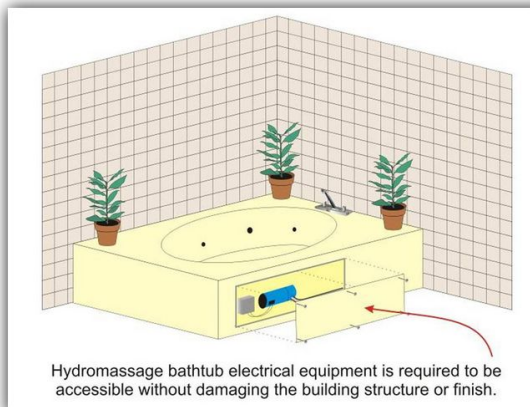
**D. Hydro-Massage Therapy Equipment**

- The access to the hydro-massage therapy equipment motor is not readily accessible and inspection of the equipment lines and motor could not be performed. This does not meet current installation standards.

Hydromassage bathtub electrical equipment is required to be accessible without damaging the building structure or finish.

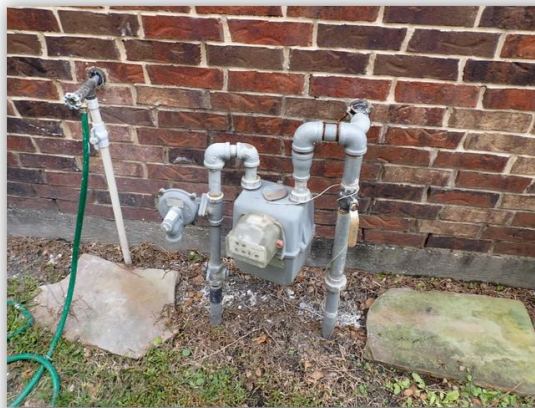
**E. Gas Distribution Systems and Gas Appliances**

- The heater gas supply line sediment trap was observed to be improperly installed. This condition does not meet current installation requirements and should be corrected.

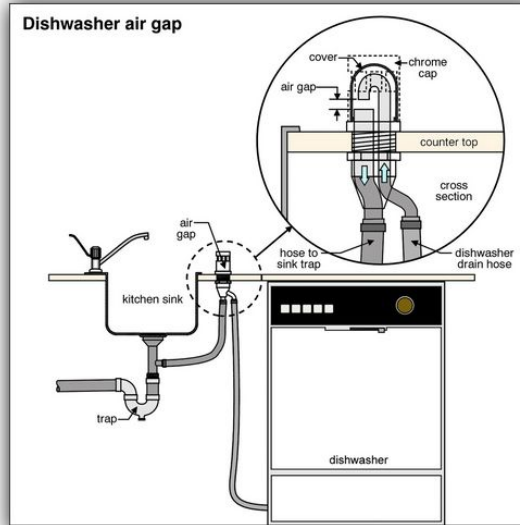
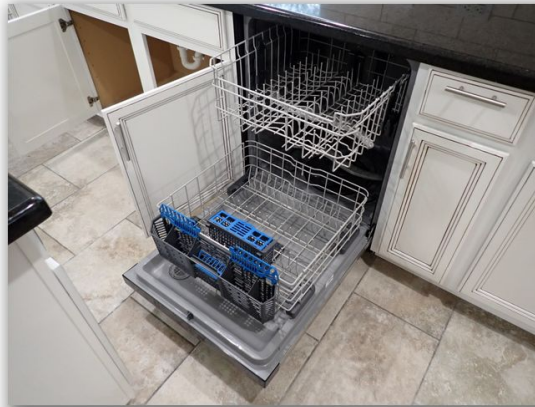
- The dishwasher drain hose is not properly installed to prevent back flow or anti-siphoning. It is recommended that an air gap device or high drain loop be installed in the drain line.

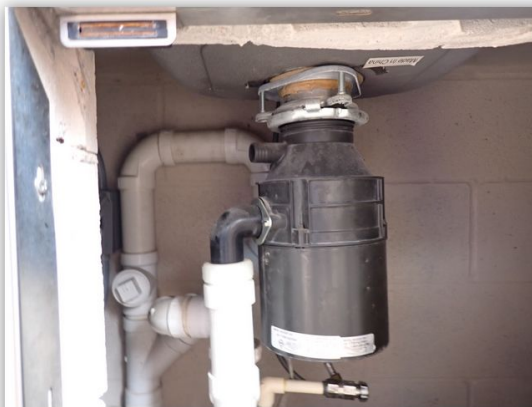
**Food Waste Disposer**

- The splashguard for the food waste disposer is damaged and/or missing.

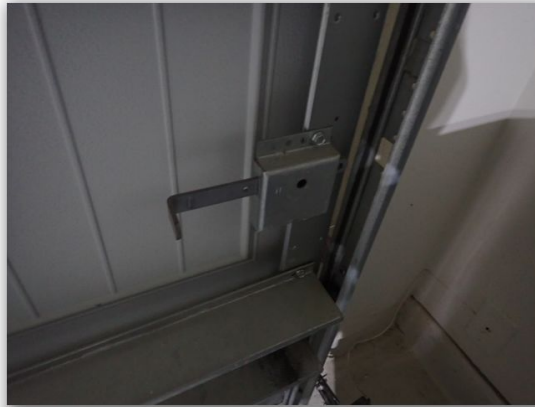
#### G. Garage Door Operators

- When an automatic garage door opener is in use, the manual lock should be disabled or removed.
- The garage door opener chain is loose and needs to be better secured and/or adjusted.
- The garage door opener was unusually noisy when operated. The cause and remedy should be further evaluated and corrected as necessary.
- The overhead garage door does not roll smoothly on the track. It is recommended to tune up the components, such as: rollers, tracks, and hinges to prevent the door failure.

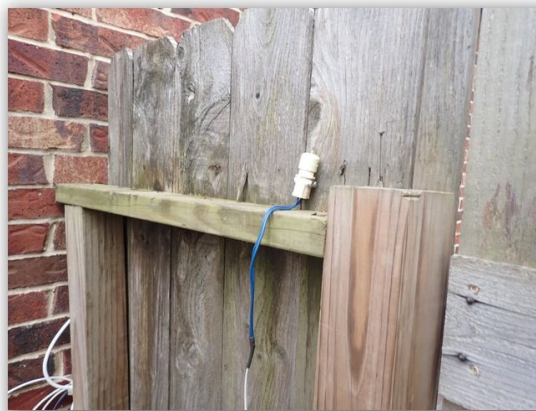
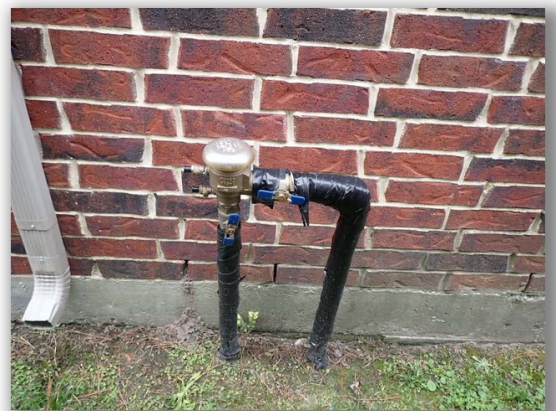
- The exterior moisture (rain/freeze) sensor device does not appear to be properly installed and should be corrected for proper sensor operation.
- One or more of the sprinkler heads need to be adjusted so not to spray water onto the exterior walls, surfaces or windows in stations; **2**.
- One or more of the sprinkler heads need to be adjusted and/or straightened so to disperse water properly in station(s); **2**.
- One or more of the sprinkler heads were observed to be damaged and/or missing in station(s); **2, 3**.
- Sprinkler station(s) **1** did not respond when tested in the manual setting. The cause and remedy should be further evaluated and corrected as necessary.

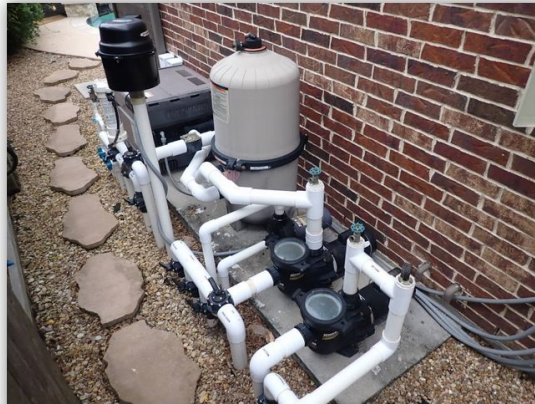
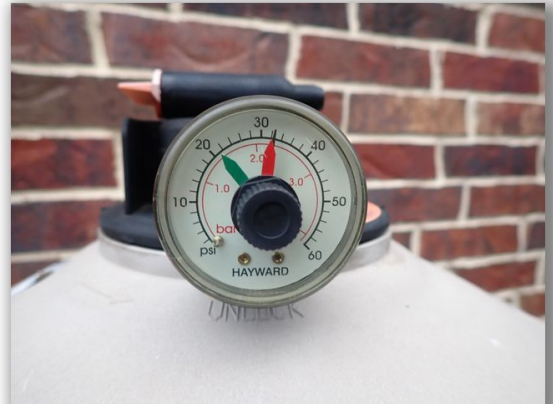
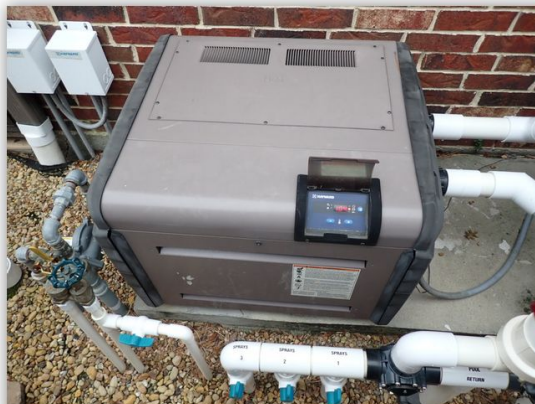
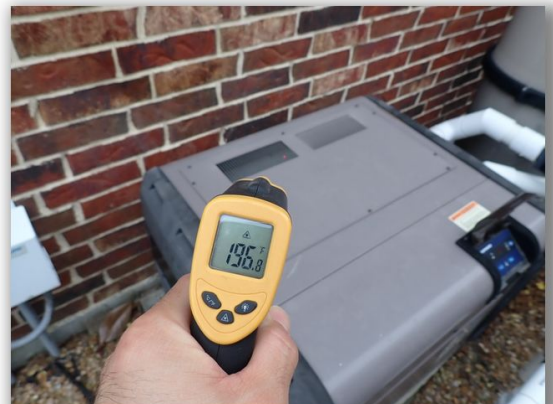
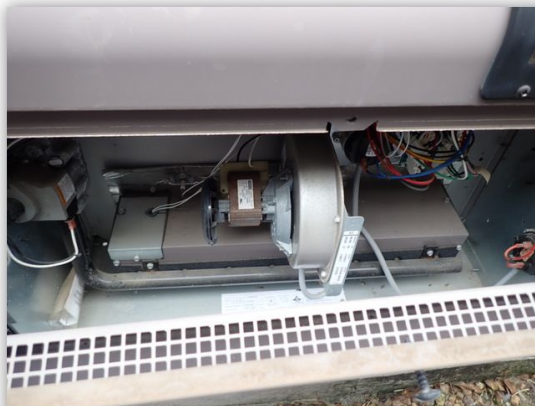
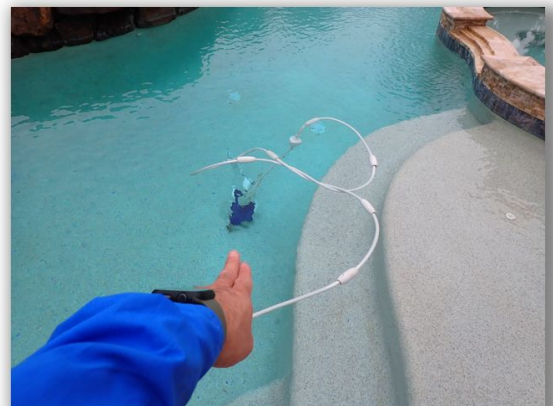
Some of the pool and/or spa components appear to have deficiencies that are beyond normal. The buyer should have this condition further evaluated by a pool technician familiar with pool structures and associated pool components for remedial cost estimates. The observations made to support the rendering of this opinion are listed but may not be limited to the following:

- It is recommended to paint all exposed PVC pipes to prevent UV break down.
- The filter gauge has a high pressure reading. Filter pressure should be maintained between 5 to 20 psi.
- The water level in the pool was low at the time of this inspection. This condition needs to be further evaluated and corrected as necessary.
- Some cracking of the deck was observed.
- The sweeper does not appear to be performing properly at this time.

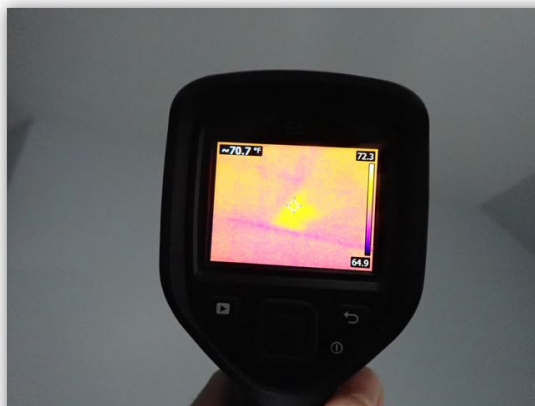
**D. Thermal Imaging / Infrared**

- Missing insulation was observed at the ceiling in the upstairs rear corner bedroom.

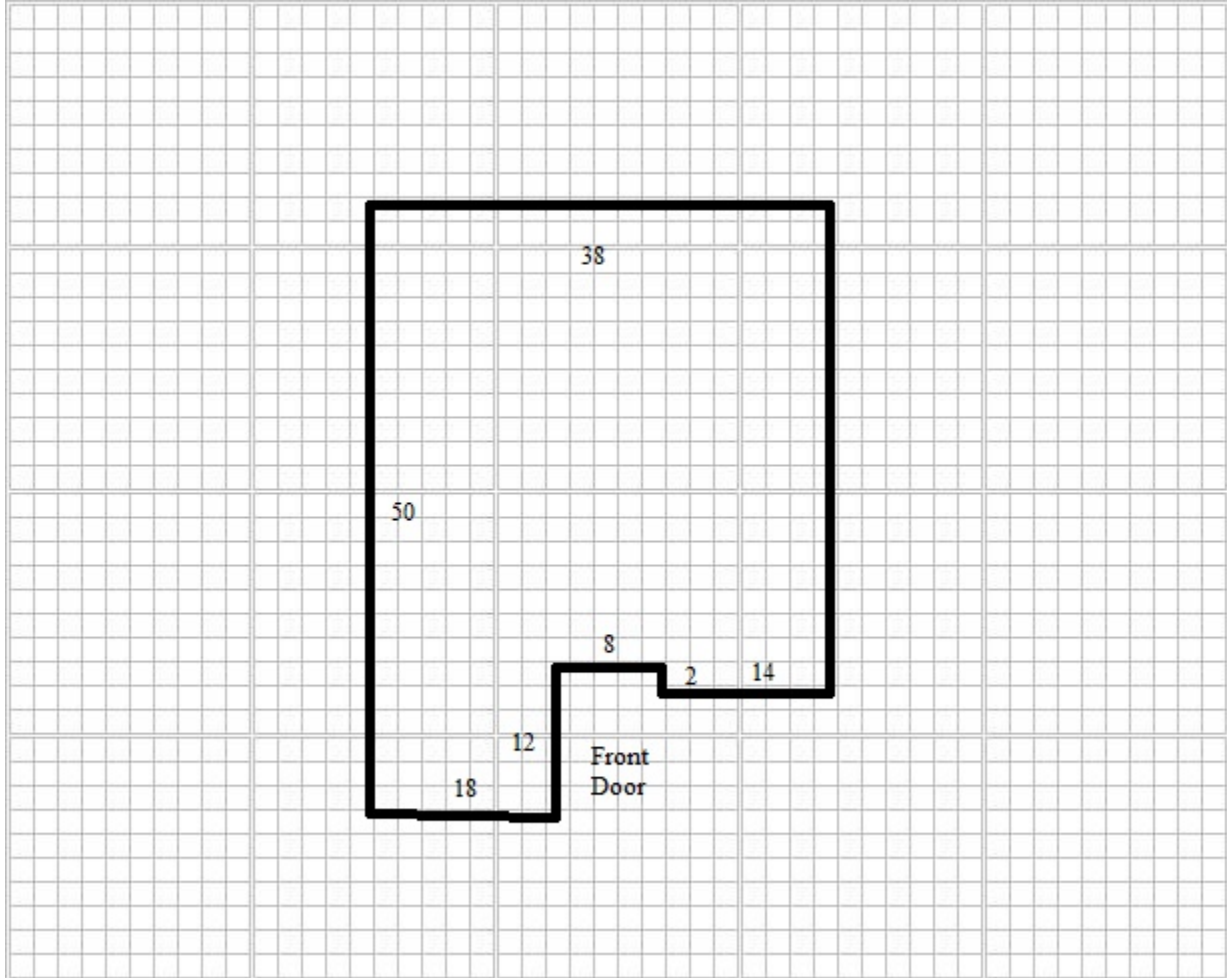
Additional Comments There is no visible evidence of active wood destroying insects found at the time of this inspection.
